# AEROSPACE INFORMATION REPORT

**SAE** AIR1707

## Patterns of O-ring Failures

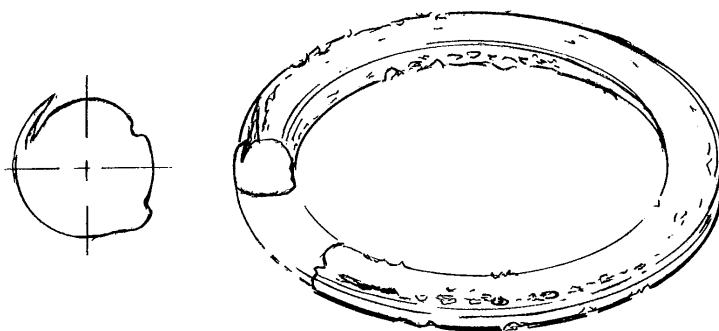
- 3.2.2 Appearance: Exhibits many small nibbles removed from the O-ring adjacent to the downstream clearance area, or a small section of the O-ring may be extruded. Typical of high pressure systems, this process sometimes erodes half of the O-ring cross-section before major leakage occurs.

- 3.2.3 Cause: Clearance is too large, pressure is too high, O-ring is too soft, O-ring is softened and swelled by fluid, clearance increases under pressure, eccentricity causes irregular gap, and corners of O-ring gland are too sharp.

FIGURE 1 - Extrusion and Nibbling

- 3.2.4 Corrective Action: Closer metal fits, use of backup rings or other antiextrusion devices such as cap strips, harder O-ring material, use of O-ring more compatible with system fluid, more rigid or concentric metal components, and break edges of gland to a radius of about 0.001 - 0.002 in. (0.025 - 0.050 mm). T-seals that fit into the same gland may also be substituted.

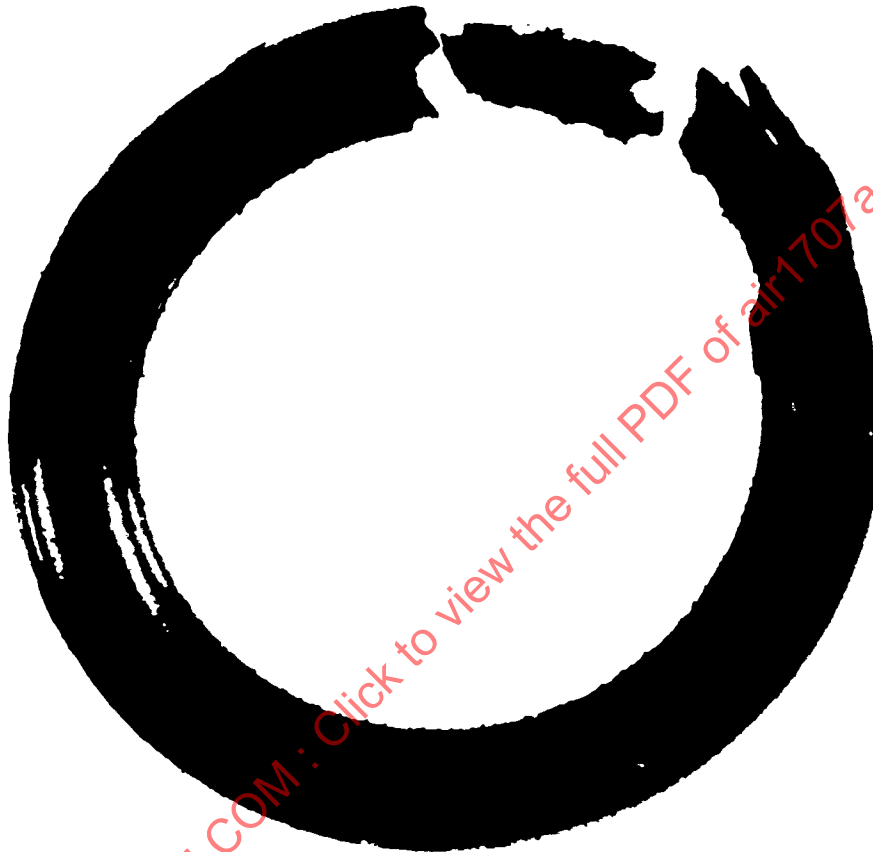
FIGURE 2 - Extrusion and Nibbling

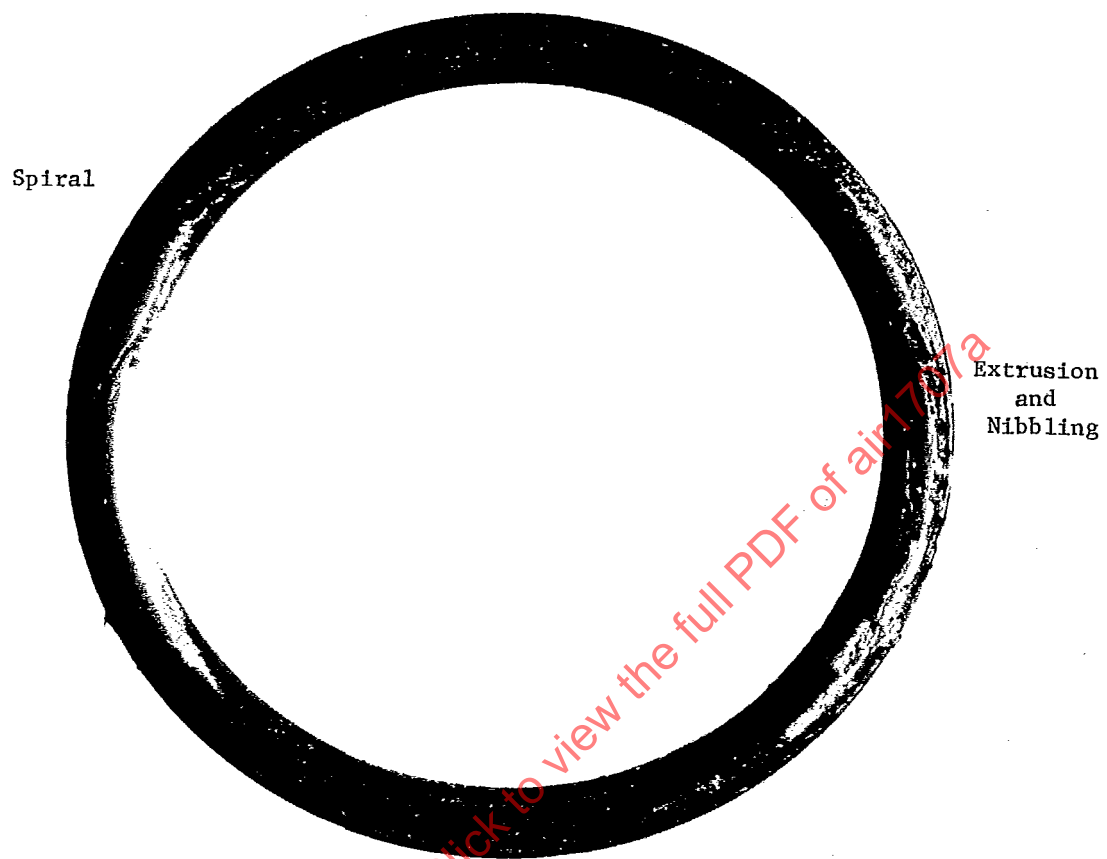
FIGURE 5 - Nibbling and Extrusion

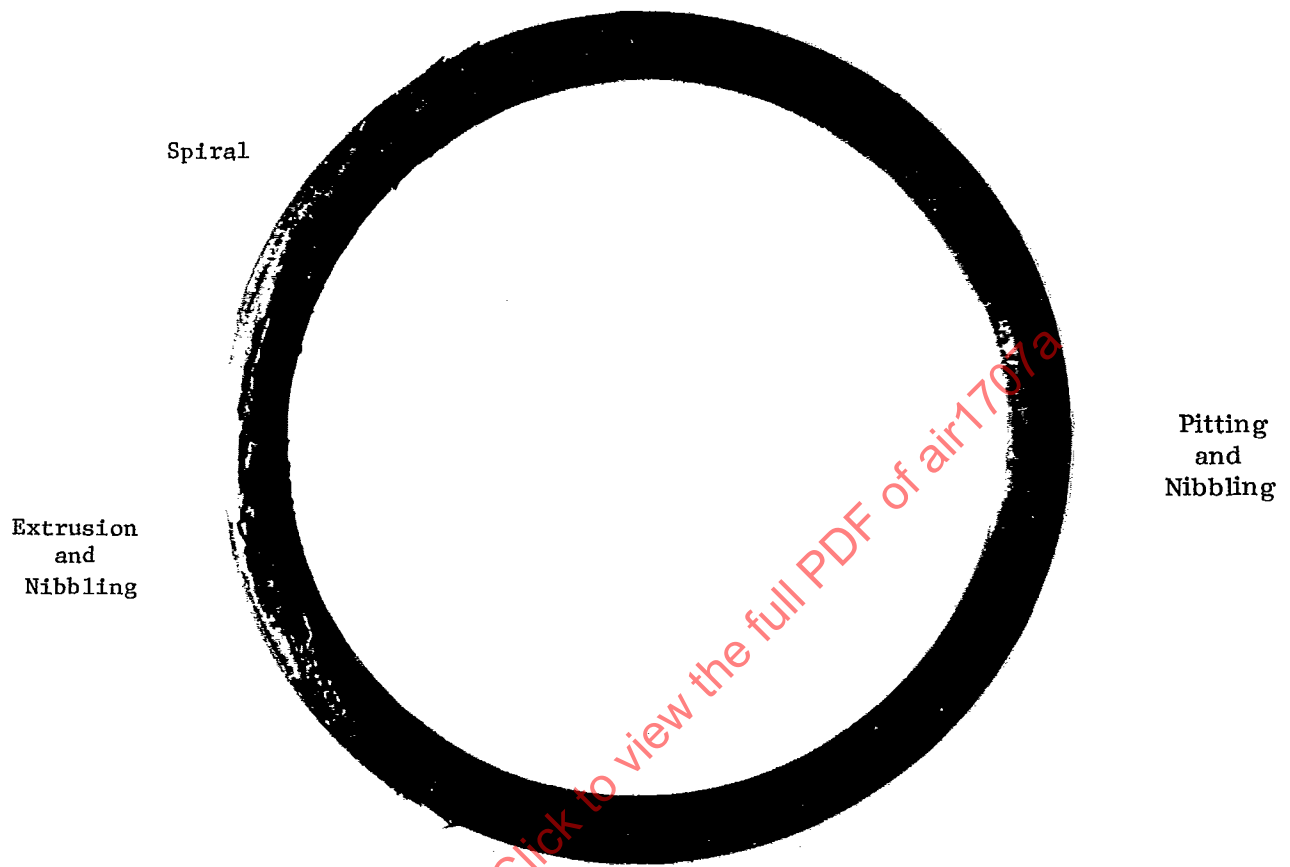
FIGURE 6 - Nibbling, Extrusion, Pitting, and Spiral Failure

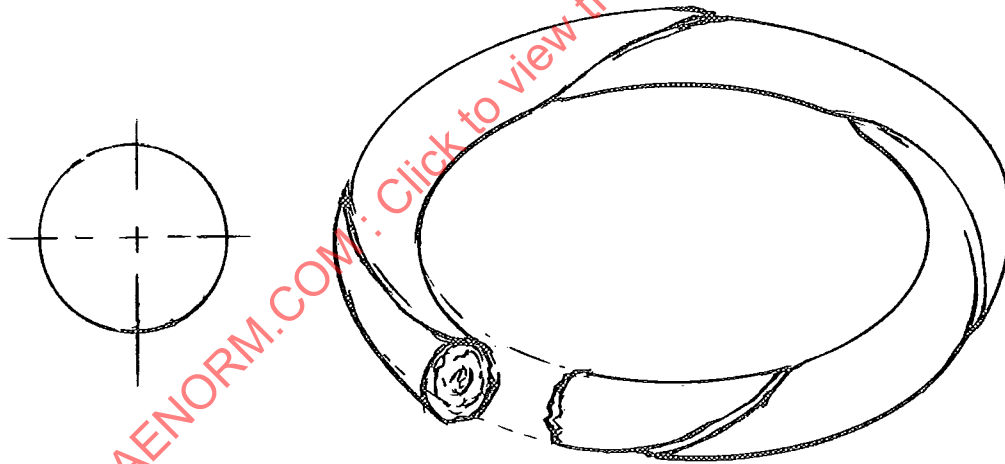
- 3.3.2 Appearance: Exhibits a deep spiral cut (usually at about 45°) into the O-ring cross-section.
- 3.3.3 Cause: Conditions which cause segments of the O-ring to slide and others to roll, simultaneously. The O-ring generally gets pinched or "hung up" at one point of its periphery. Side loads causing the O-ring to get caught in an eccentric component, uneven surface finishes, poor or uneven dispersion of lubricant and stroke speeds contribute.

FIGURE 7 - Spiral Failure

- 3.3.4 Corrective Action: Improve metal surface finish to the 10 - 20  $\mu\text{in.}$  (0.25 - 0.50  $\mu\text{m}$ ) range, improve lubrication, use backups or other antiextrusion devices if possible, reduce gap, and consider seals other than O-rings such as T-seals.

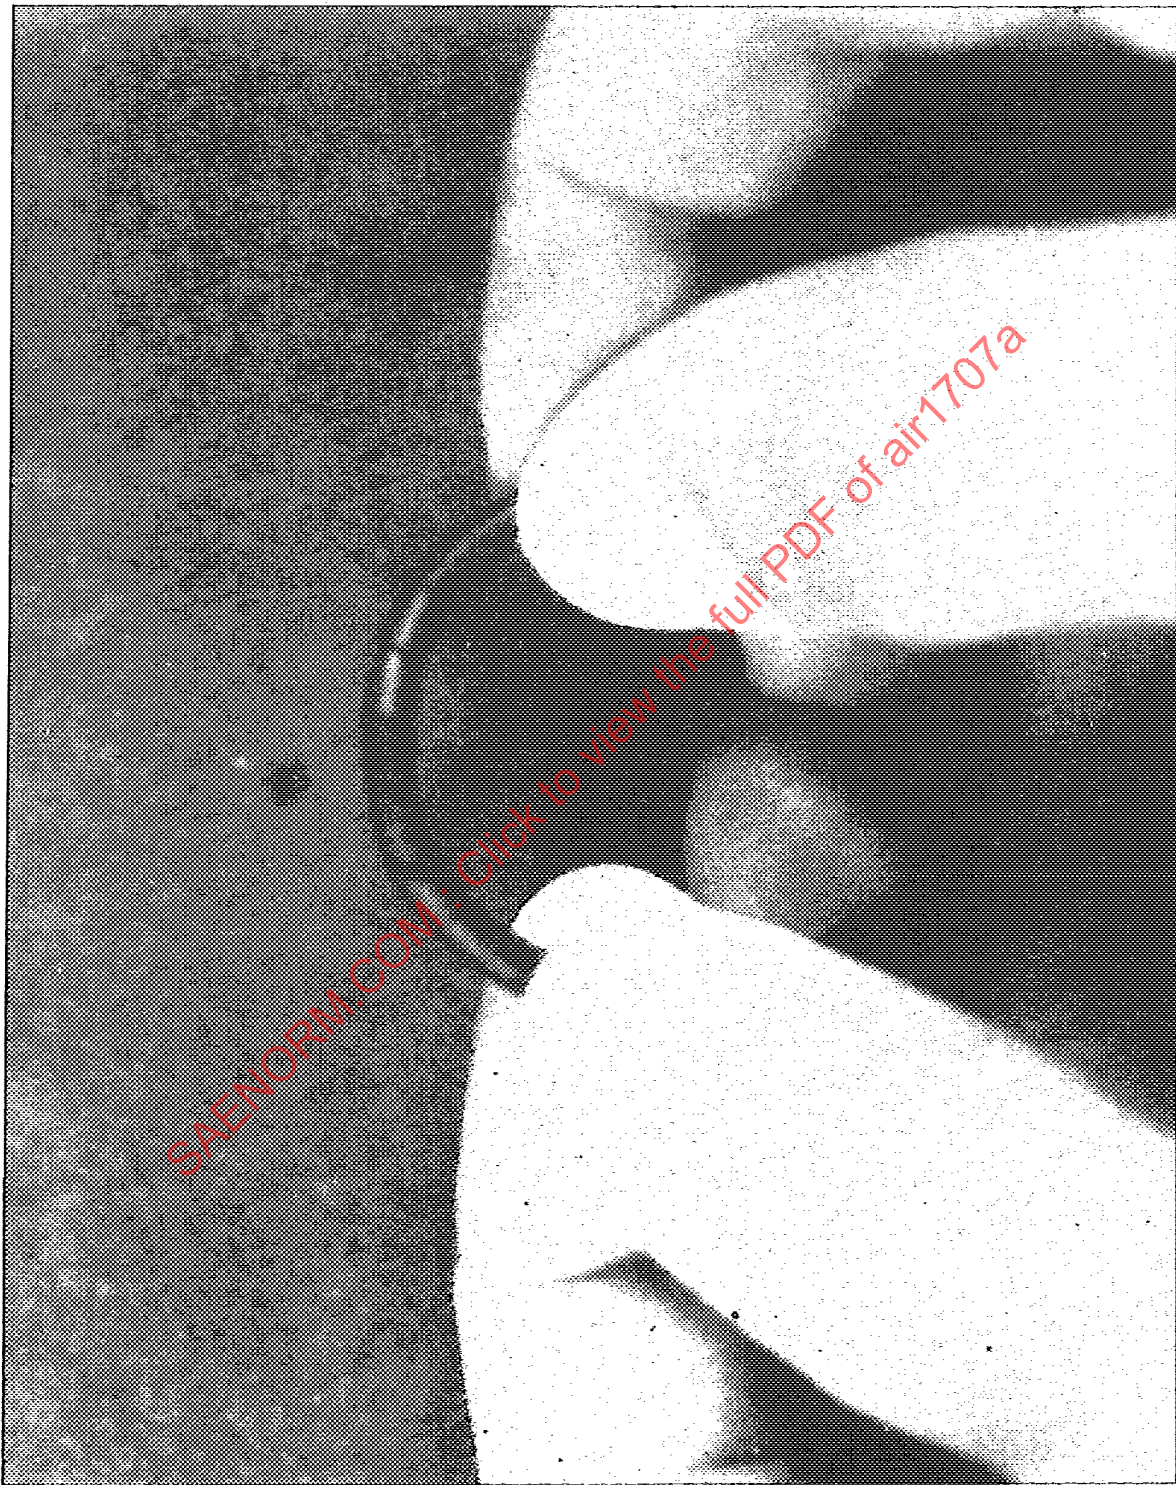
FIGURE 8 - Spiral Failure

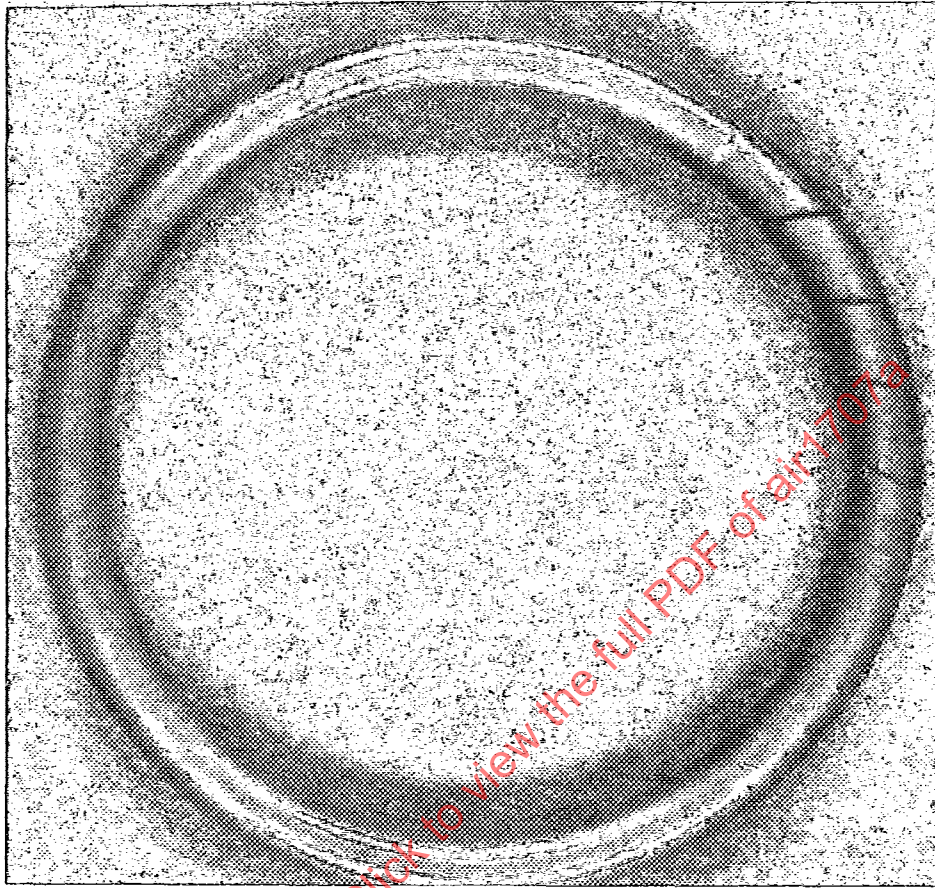
FIGURE 9 - Spiral Failure

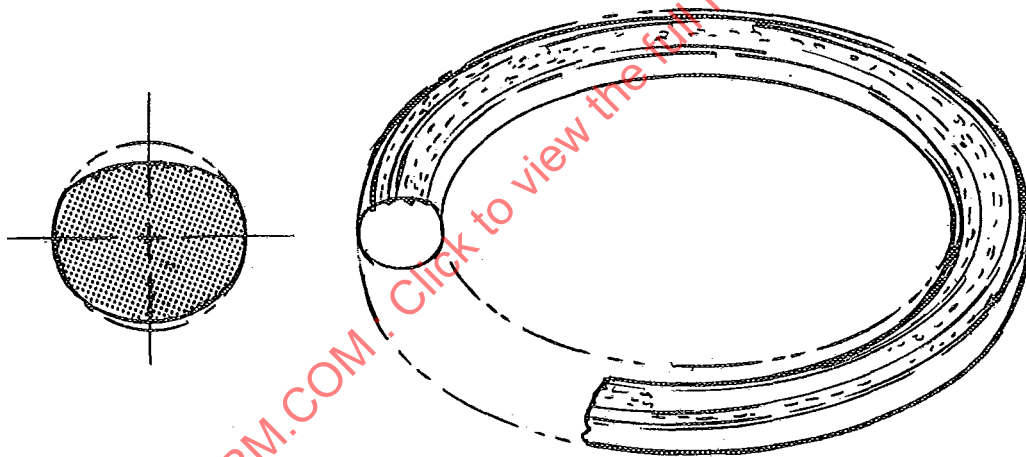
3.4.2 Appearance: Flat area on one side of cross-section of O-ring where moving contact is made with metal component. Frequently shows wear lines on the cross-section parallel to motion of the seal.

3.4.3 Cause: Too rough or too smooth metal surfaces, poor lubrication, high temperatures, or fluid contamination.

FIGURE 10 - Abrasion

3.4.4 Corrective Action: Use recommended metal finishes, provide adequate lubrication, use O-ring material compatible with service temperature, and eliminate fluid contamination. Rapid wear can be expected with finishes below 5  $\mu\text{in.}$  ( $0.13 \mu\text{m}$ ).

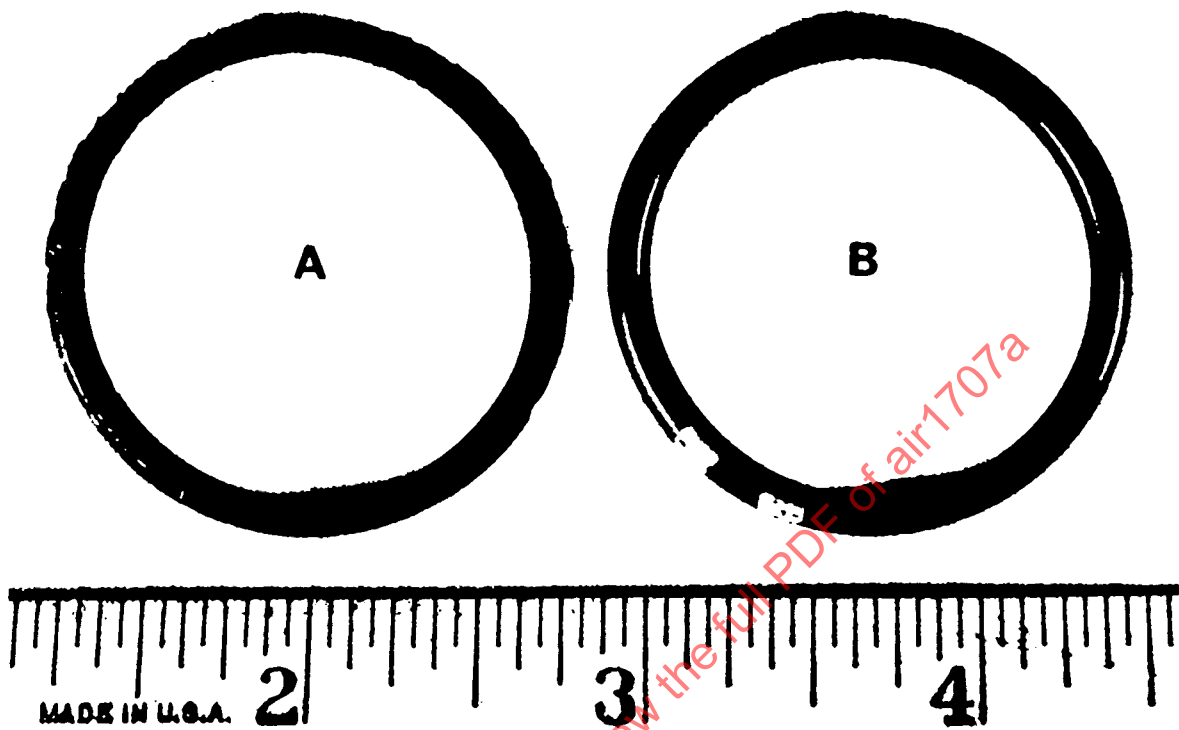
A = Severely abraded and nibbled  
B = Normal condition after same period of service  
Scale as shown

FIGURE 11 - Abrasion

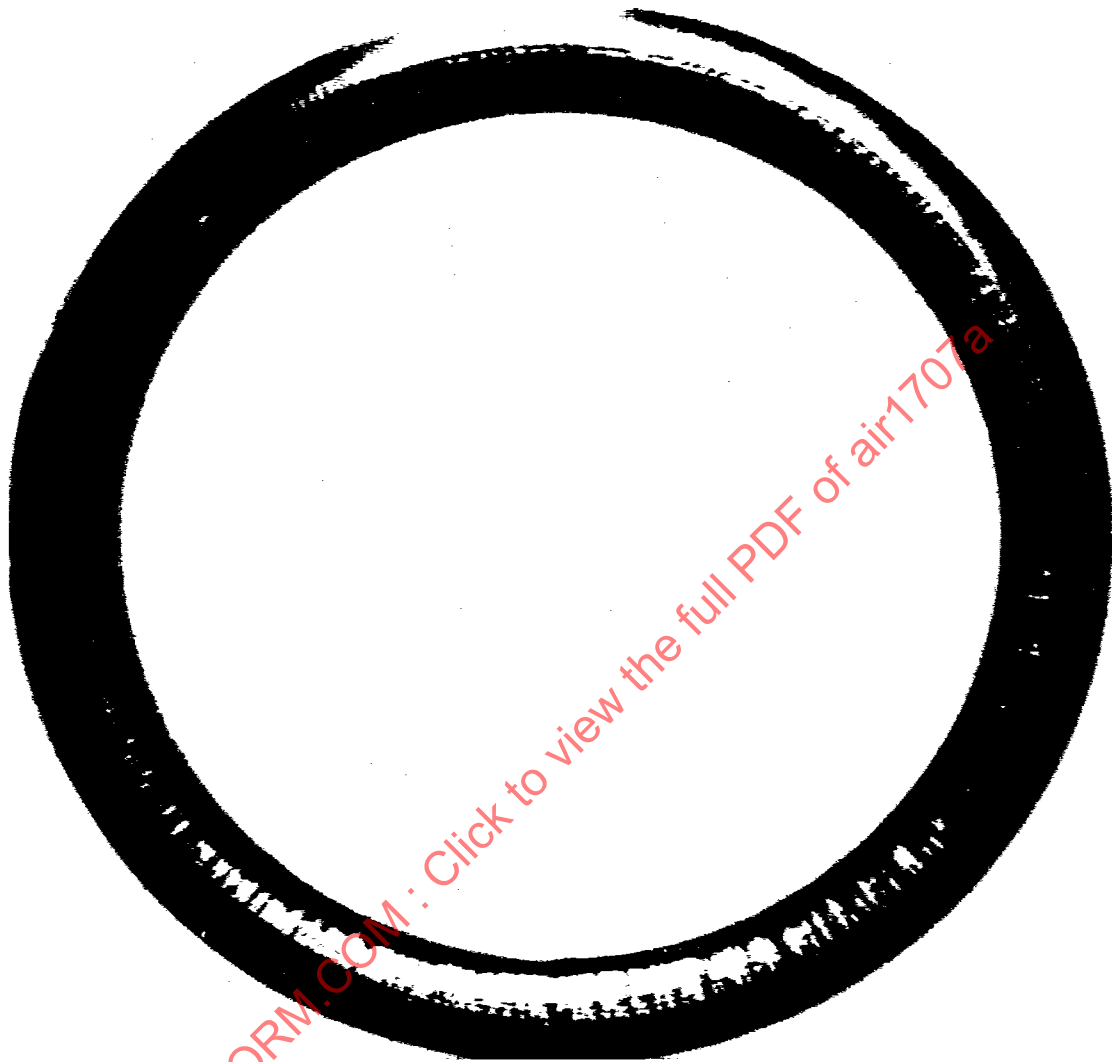
FIGURE 12 - Abrasion

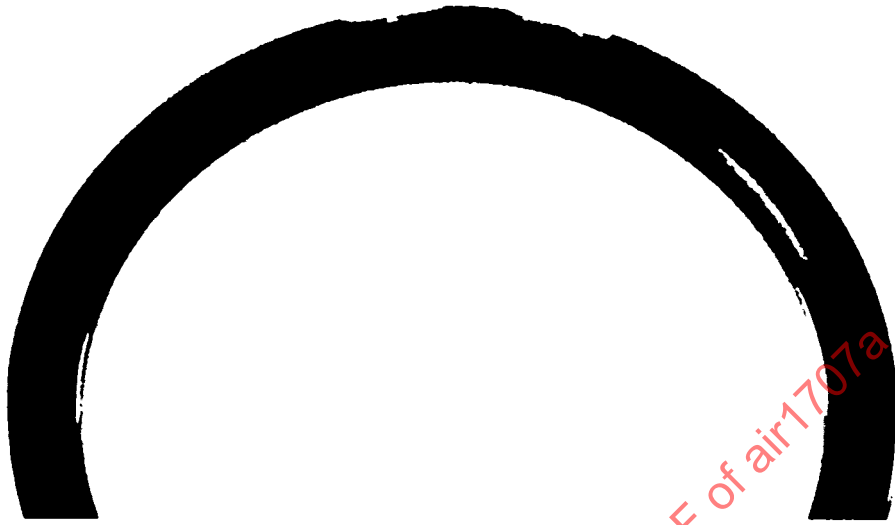
FIGURE 13 - Abrasion at Color Code

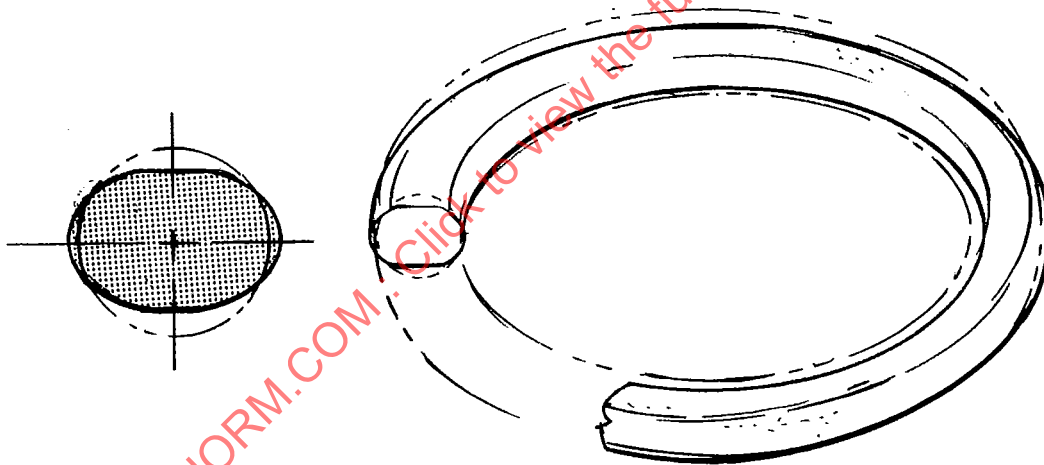
3.5.2 Appearance: Flat area on both sides of O-ring cross-section in the area being squeezed.

3.5.3 Cause: Temperature too high (either environmental or frictional) causing hardening, excessive volume increase from fluid causing overfill, excessive squeeze to achieve seal, O-rings not completely vulcanized, or use of compound with poor set properties.

FIGURE 14 - Compression Set

3.5.4 Corrective Action: Use O-ring material compatible with fluid and temperature service, minimize conditions which increase service temperature, review squeeze to be sure it is proper, and use an improved, low-set compound if available. A good quality, well-inspected O-ring is important.

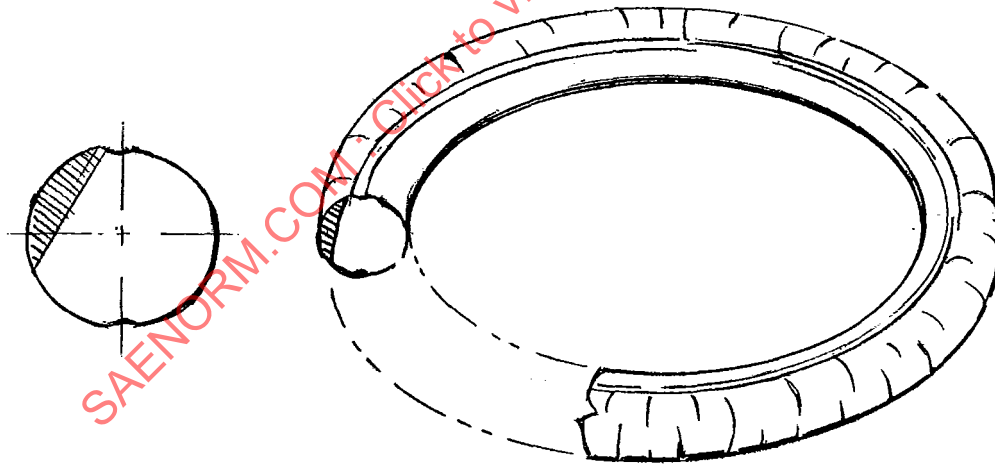
- 3.6.1 Occurrence: Dynamic or static seals under stress and exposed to atmosphere containing ozone and air pollutants.
- 3.6.2 Appearance: Many small cracks perpendicular to the direction of stress may be small enough to be unseen with unaided eye or large enough to progress entirely through the cross-section (also see 3.8.3). Cracking of the outside surface of the O-ring is the most common.

- 3.6.3 Cause: Ozone attacks unsaturated or double bond points in polymer chain of some polymers causing chain scission. Usually, the outside surface, that area exposed to the atmosphere, is where the damage is seen.

FIGURE 16 - Weather or Ozone Cracking

- 3.6.4 Corrective Action: If conditions of service cannot be remedied, the rubber material must be changed. Use rubber materials that are saturated and inherently resistant to ozone attack. Change storage conditions to reduce exposure time to detrimental environment. Sufficient improvement can, at times, be obtained by using rubber compounds with antiozonant additives.

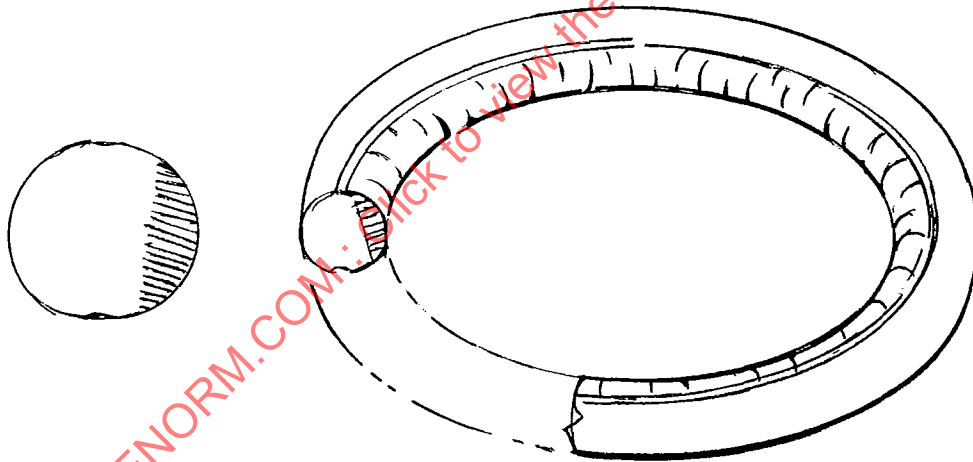
- 3.7.1 Occurrence: Dynamic or static seals subjected to elevated temperatures and atmosphere. Common in pneumatic or air service.
- 3.7.2 Appearance: Hardening of the rubber, which begins at the surface and progresses through the entire O-ring cross-section. Accompanied by high compression set if O-ring is under compression.
- 3.7.3 Cause: Environmental temperature is too high for rubber material, causing hardening due to additional cross-linking in the rubber, evaporation of rubber plasticizer, or oxidation. It may be a combination of these.
- 3.7.4 Corrective Action: Decrease service temperature, use oxidation resistant material with better high-temperature characteristics, or protect surface from oxygen exposure (as wiper seals).
- 3.7.5 Examples:

FIGURE 17 - Hardening and Oxidation

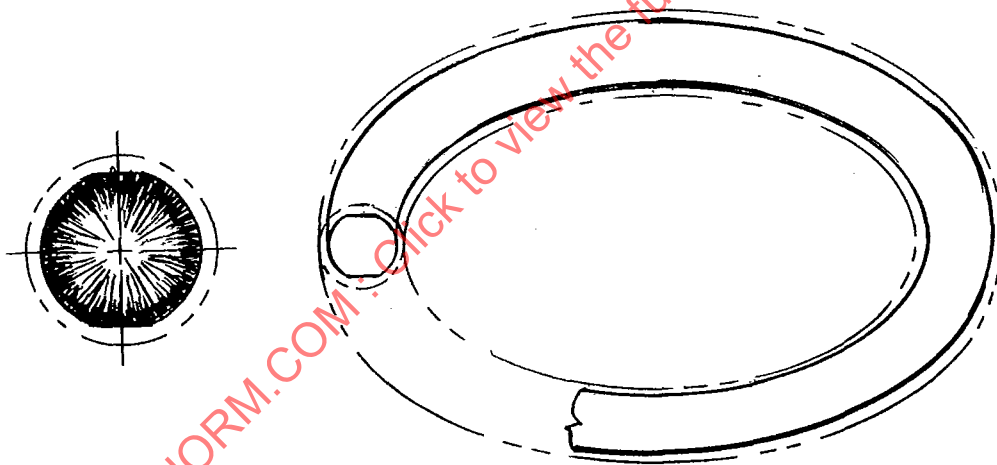
- 3.8.1 Occurrence: Dynamic and static seals usually in fuel systems subject to dry-out periods, but occasionally in other systems.
- 3.8.2 Appearance: Small cracks in stressed area of O-ring cross-section, accompanied by loss in volume.
- 3.8.3 Cause: Extraction of plasticizer by service fluid followed by evaporation of service fluid during dry-out period. Results are hardening of the rubber material and decrease in elongation to the extent that cracks appear where stressed. This condition is accelerated in the presence of ozone.
- 3.8.4 Corrective Action: Assuming service conditions cannot be improved, change to a compatible rubber material with low or no extractable plasticizer content.
- 3.8.5 Examples:

FIGURE 20 - Plasticizer Extraction
