# AEROSPACE INFORMATION REPORT

**AIR4092™****REV. B**

Investigation of PTFE "Melt" Phenomenon for High Pressure Hoses

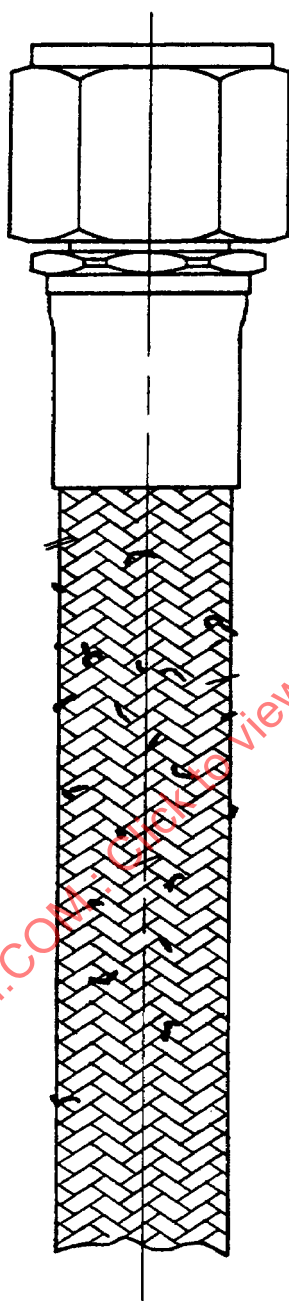
FIGURE 5

1. Bare "230" series, lightweight hose assembly showed heavy Teflon extrusion of PTFE through the braid and some broken braid externally and major deterioration of the innercore internally (see Figures 5 and 6).
2. The "230" series, lightweight hose with integral firesleeve showed light extrusion of PTFE through the braid and some broken braid externally and major deterioration of the innercore internally (see Figures 7 and 8).
3. The "660" series showed no extrusion of PTFE through the braid but did have broken wires externally, and it showed deformation of the innercore but no heat deterioration of the PTFE internally (see Figures 9 and 10).

230-8  
21.3 Hz 16 g  
FAILURE 20 MIN

For hose assembly applications where the hose can be subjected to applied or induced vibration with high displacements along the axis of the hose, use the heavy duty spiral-wrapped type of hose. One typically critical application is the pump discharge hose for main and auxiliary pumps on aircraft. When the application requires an integral firesleeve to meet fire resistance of TSO or AS specifications, consideration can be given to the use of the lightweight hose and firesleeve combination as the most cost effective solution, provided the axial component of the vibration to be experienced does not exceed 0.200 double amplitude for an 18-in length of hose.
