# AEROSPACE INFORMATION REPORT

**SAE AIR4543**

## AEROSPACE HYDRAULICS AND ACTUATION LESSONS LEARNED

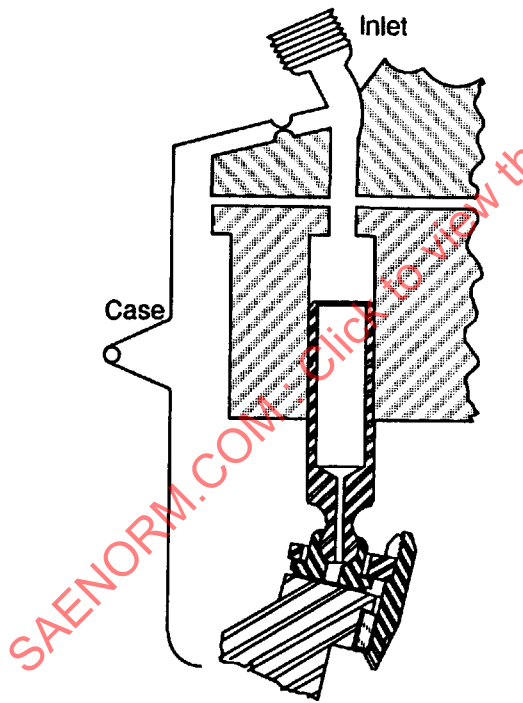
FIGURE 3.1.3 - Pump Overheat and Rapid Wear

PROBLEM: PUMP OVERHEAT AND RAPID WEAR

- ISSUE:
1. Pump case drain line too small
  2. Creates high back pressure (case)
  3. Creates high discharge pressure (flow)
  4. Overheat (pump)
  5. Excessive pump shoe wear

- SOLUTION:
1. Increase line size (case drain)
  2. Use bypass type filters
  3. Reroute line to reduce pressure drop
  4. Internally drain (to inlet) if minimum system demand available

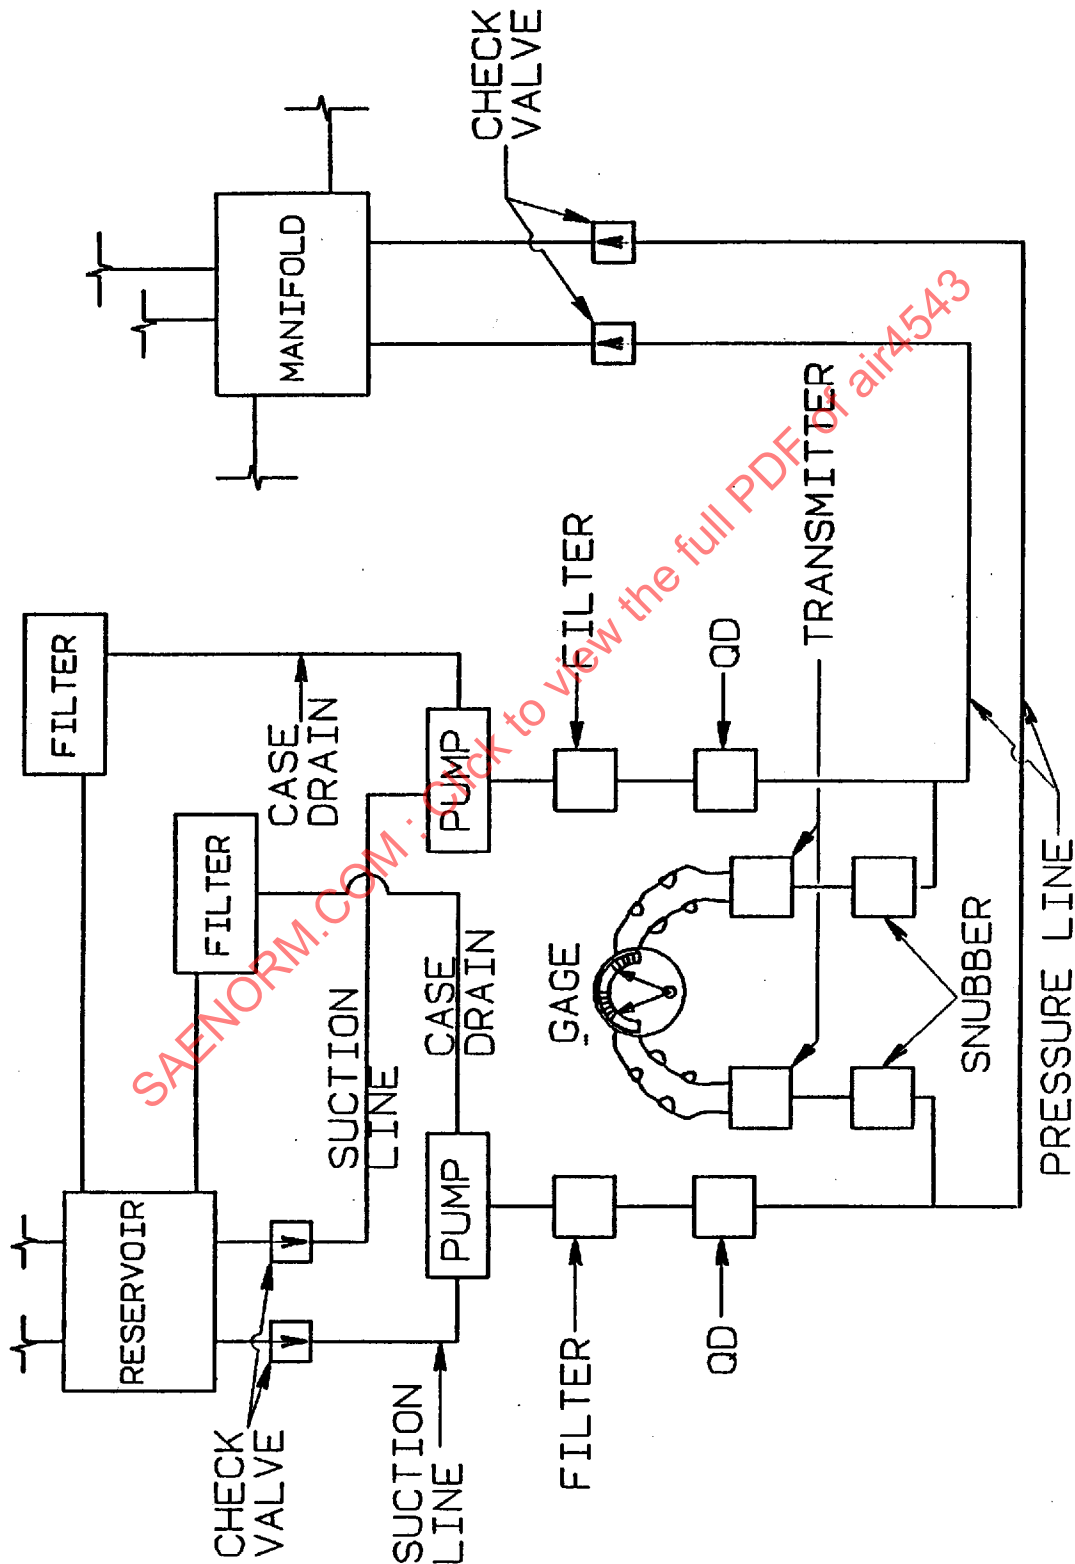
FIGURE 3.1.7 (Continued)

- ISSUE:**
1. On the initial engine run of a twin engine aircraft the R/H pump suction line burst.
  2. The line was replaced and the R/H engine started - no problem.
  3. The L/H engine was started and the R/H suction line burst.
  4. The line was replaced and the L/H engine started - no problem.
  5. The R/H engine was then started and the R/H suction line burst.

- SOLUTION:**
1. The R/H pump compensator was found to have a slightly lower pressure setting than required.
  2. A failed pump outlet check valve created a reverse pumping situation on the R/H side.
  3. Pump and check valve were replaced.

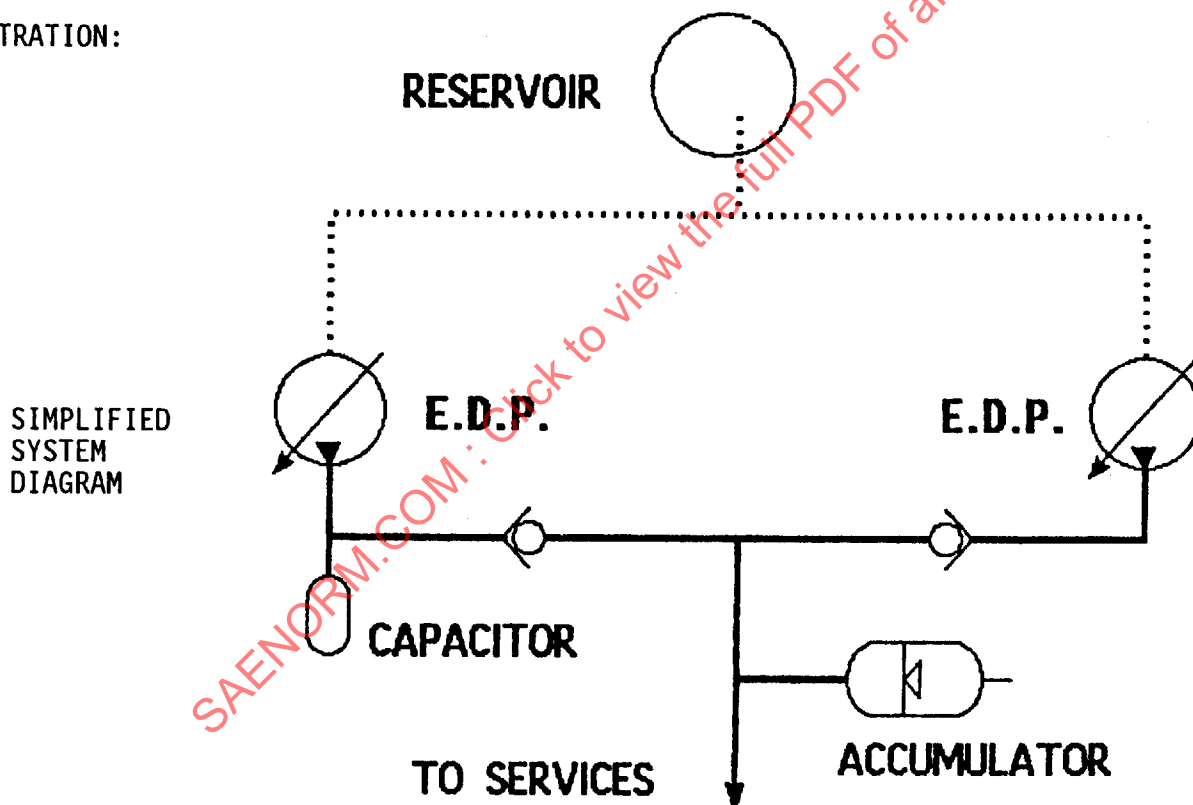
**FIGURE 3.1.8 - Hydraulic System Noise**

**PROBLEM:** HYDRAULIC SYSTEM NOISE

- ISSUE:**
1. With a twin engine driven pump (E.D.P.) hydraulic system, there were complaints of noise, although not encountered with:
    - a. Earlier production aircraft;
    - b. When system is pressurized by ground rigs.
  2. Resonance condition occurred in the shortest line downstream of E.D.P. due to the reduced volume of the high pressure part of the hydraulic system.

- SOLUTION:**
1. Initially increase the accumulator size to that previously fitted.
  2. Finally, revert to a smaller accumulator and add a "capacitor" (a small pressure vessel (22 in<sup>3</sup>) to the system).

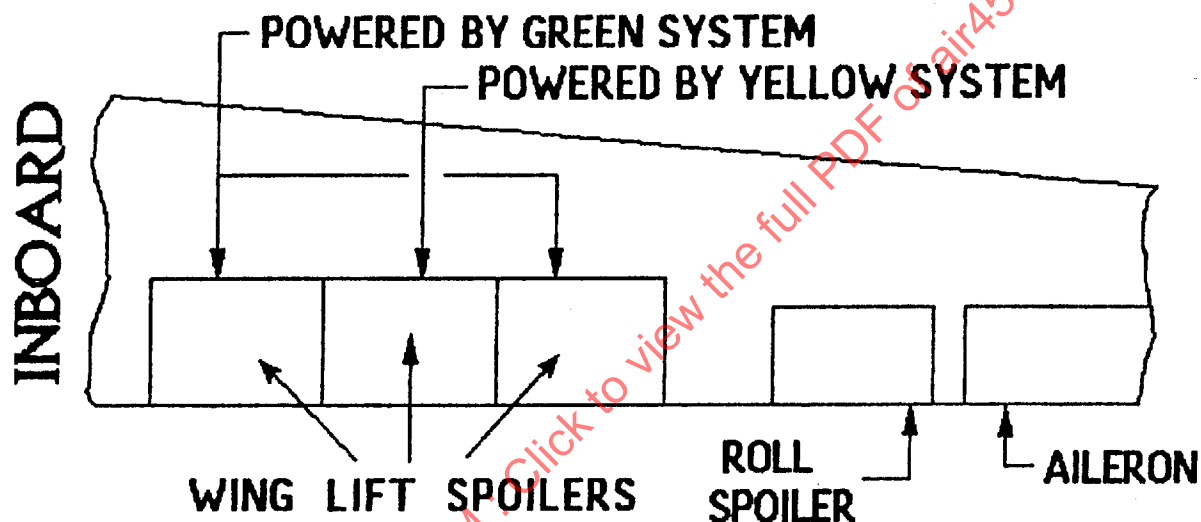
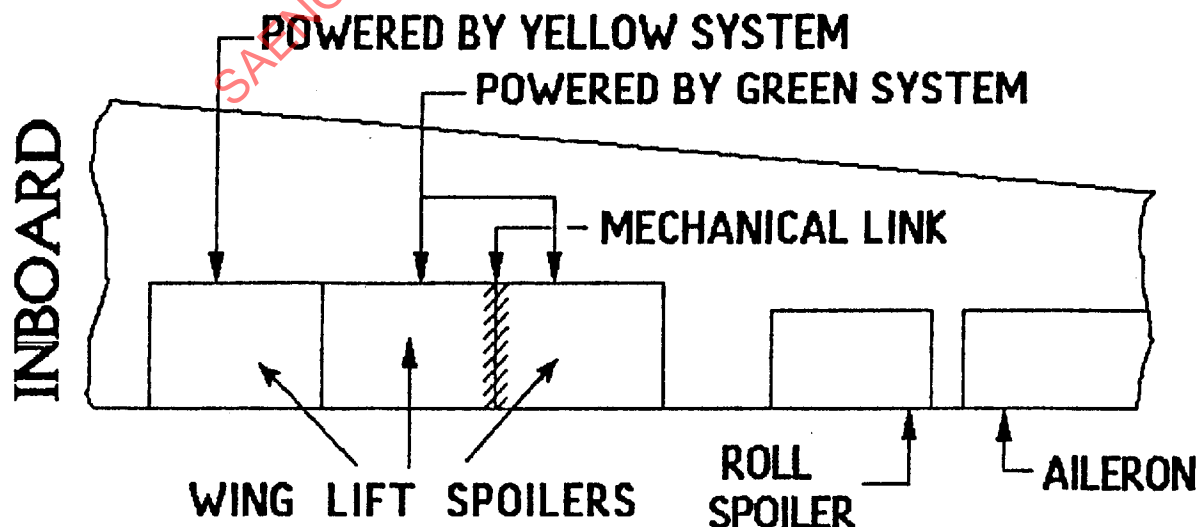
FIGURE 3.1.9 - Effect of JAR/FAR Requirement on Flight Control Surface Operation

- ISSUE:**
1. Noncompliance with JAR/FAR 25.671:
  2. A single failure of a flight control surface attachment point could cause a catastrophic event.
  3. The center or outboard ground lift spoiler panel could deploy following the failure of the eye end attachment point, for example, such that an inadvertent rolling moment could not be controlled.

- SOLUTION:**
1. Reroute hydraulic supplies to the lift spoilers and link the center and outboard panels.

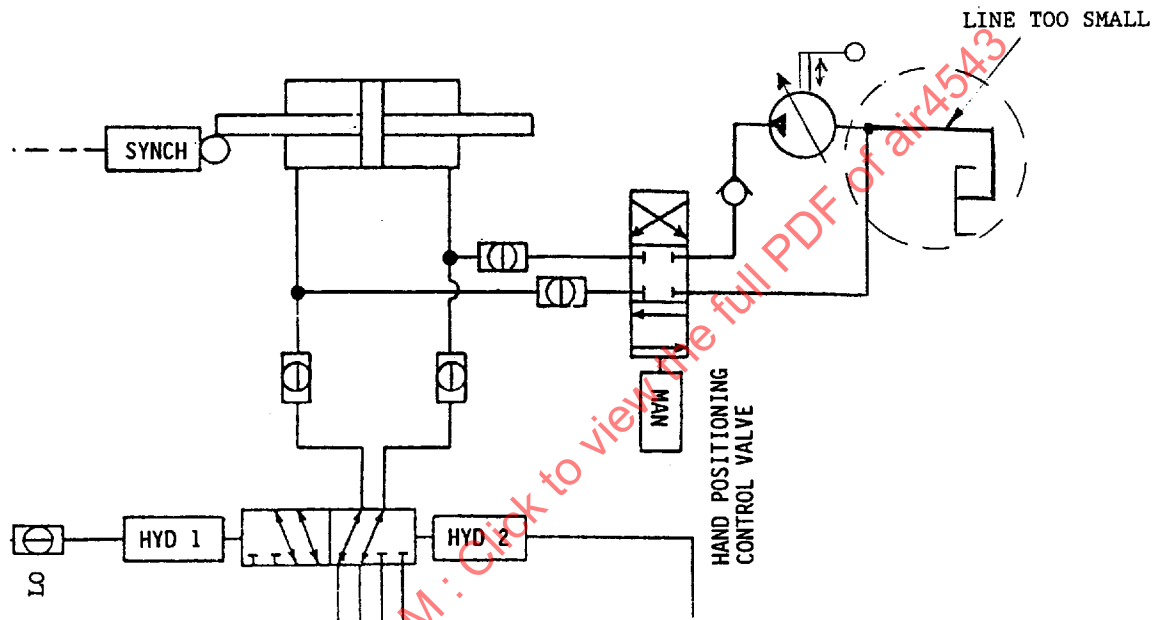
**FIGURE 3.1.13 - Inadequately Sized Hand Pump Suction Line**

**PROBLEM:** INADEQUATELY SIZED HAND PUMP SUCTION LINE

**SOLUTION:** The variable displacement hand pump discharges fluid as the pump handle is stroked in each direction. However, analysis indicated that the pump takes suction only when the pump is stroked in one direction. As a result, considerable flow is required from the unpressurized reservoir during the suction stroke even though the cylinder is balanced (equal volume for each direction of travel). The diameter of the make-up line from the reservoir to the pump suction had been sized for minimal flow and had to be increased to obtain rated pump capacity.

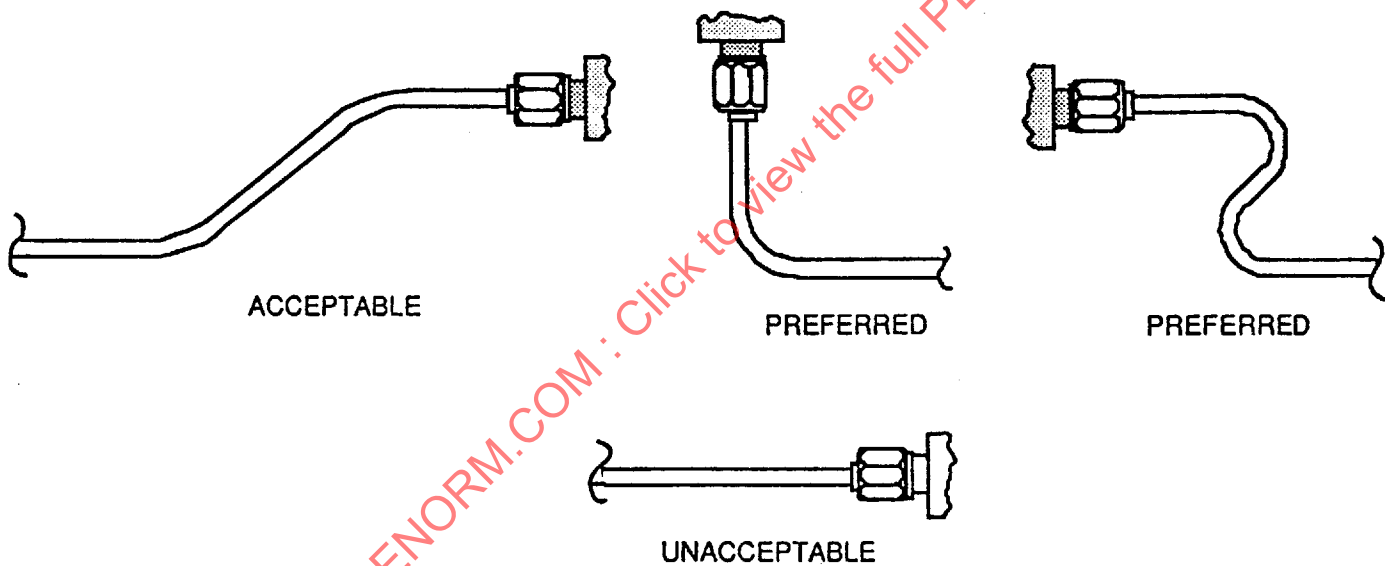
**FIGURE 3.1.14 - Hydraulic Component Installation/Tubing Tolerances**

- ISSUE:**
1. During initial installations, tubes without flexibility cannot be sufficiently extended for fit.
  2. Tubes without flexibility sustain damage from pressure surges and vibration.

**SOLUTION:** Incorporate bend(s) in the hydraulic tubing to increase the tolerances and dissipate surges.

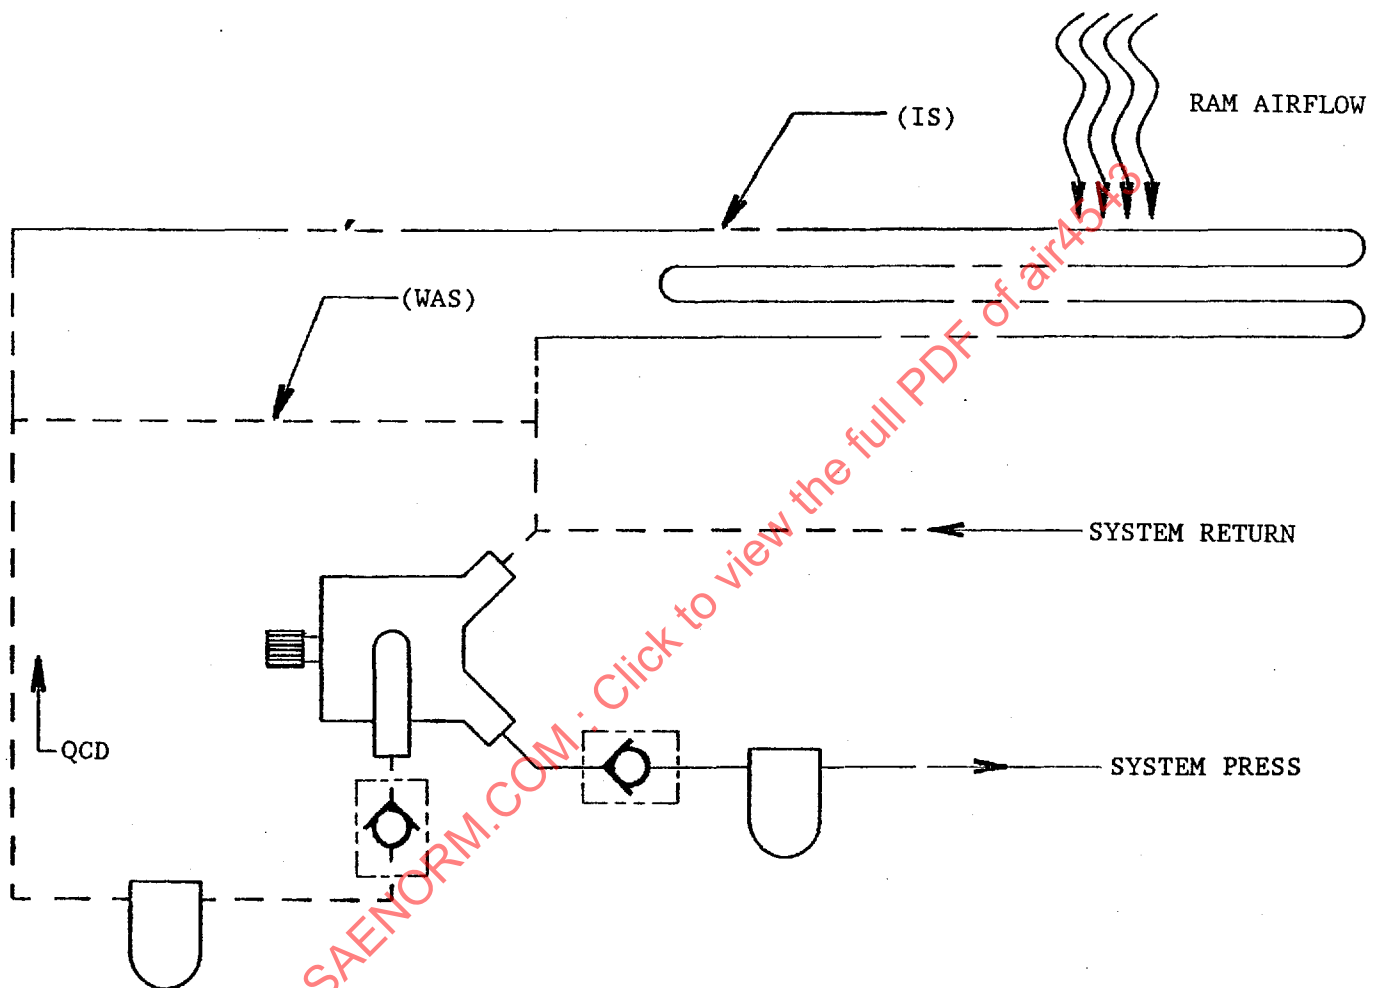
**FIGURE 3.1.16 - System Overheat Caused by Inefficient Pump and Lack of Heat Exchanger**

**PROBLEM:** SYSTEM OVERHEAT CAUSED BY INEFFICIENT PUMP AND LACK OF HEAT EXCHANGER

**ISSUE:** System can exceed 275°F

- SOLUTION:**
1. Revise the specifications to buy the pump with guaranteed efficiency and case drain flow over the life of the pump.
  2. Increase the case drain line diameter and the filter housing size.
  3. Reroute the case drain line to increase surface area and also expose to area with ram air.

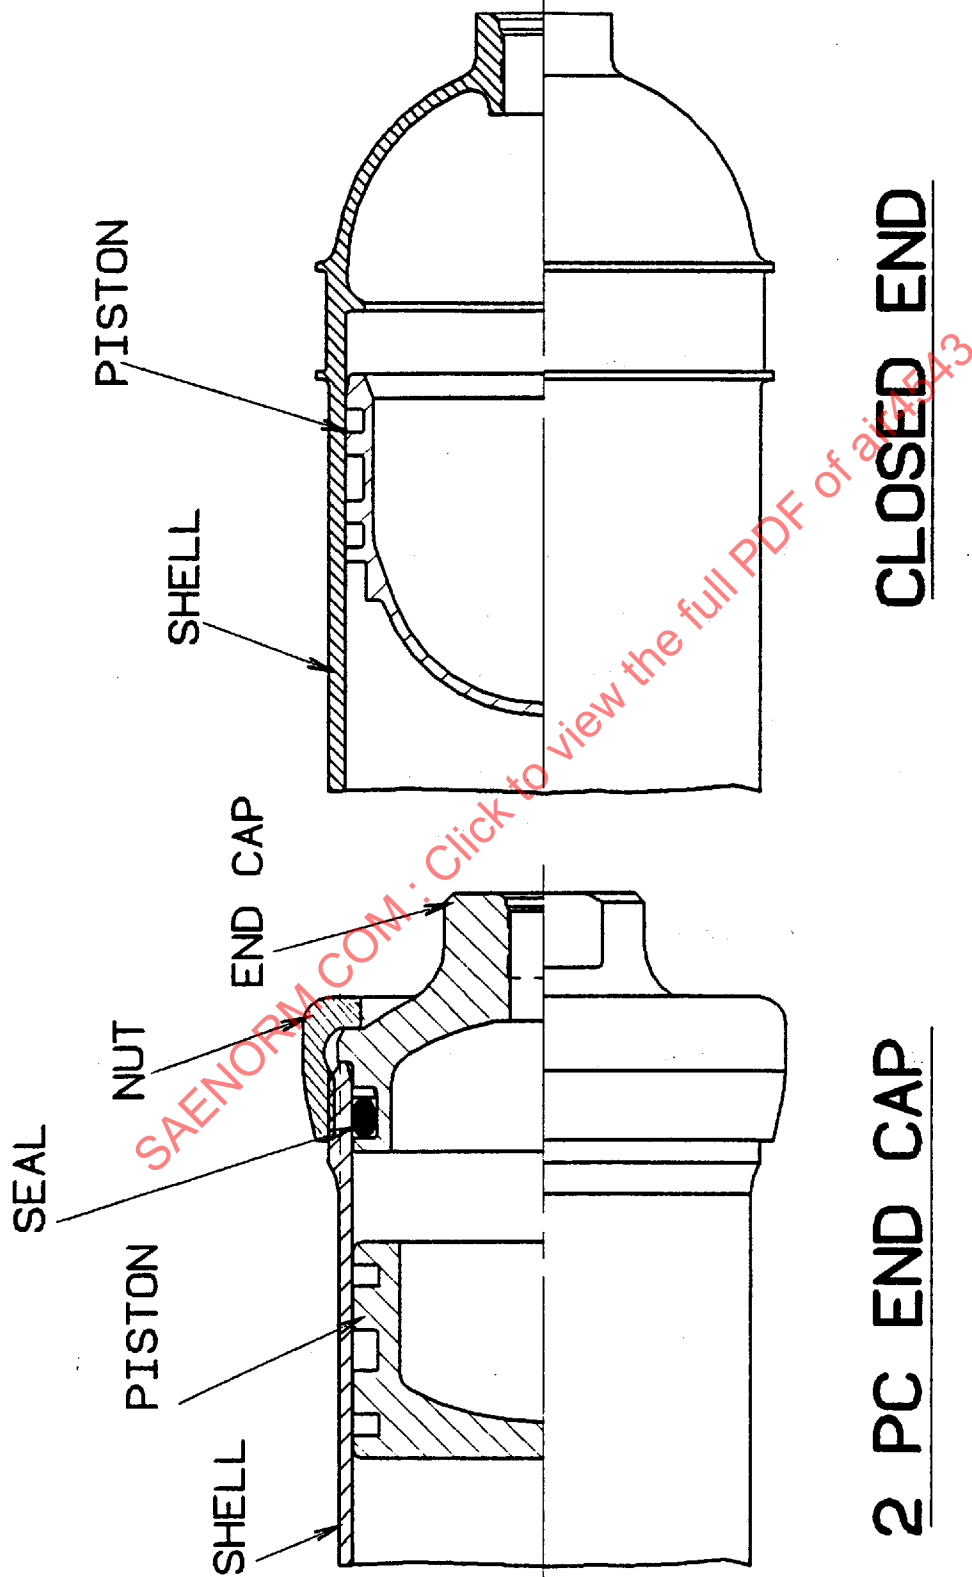
FIGURE 3.2.1.1 (Continued)

**PROBLEM:** EXCESSIVE OR PREMATURE LEAKAGE ACROSS ACCUMULATOR SEALS

**ISSUE:** Gas leaking into the system can cause a loss of aircraft or system.

1. Ensure that the chrome plate is controlled to minimize cracking (cracks inherent in chrome plating process).
2. Ensure that the seal compound meets all temperature, pressure, and pressure discharge requirements. Minimize the compression set and explosive decompression.
3. Use the closed end cap on gas side (eliminate static seal).
4. Improve the seal concept to improve sealing capability (multiple seals, metal bellows, etc.).

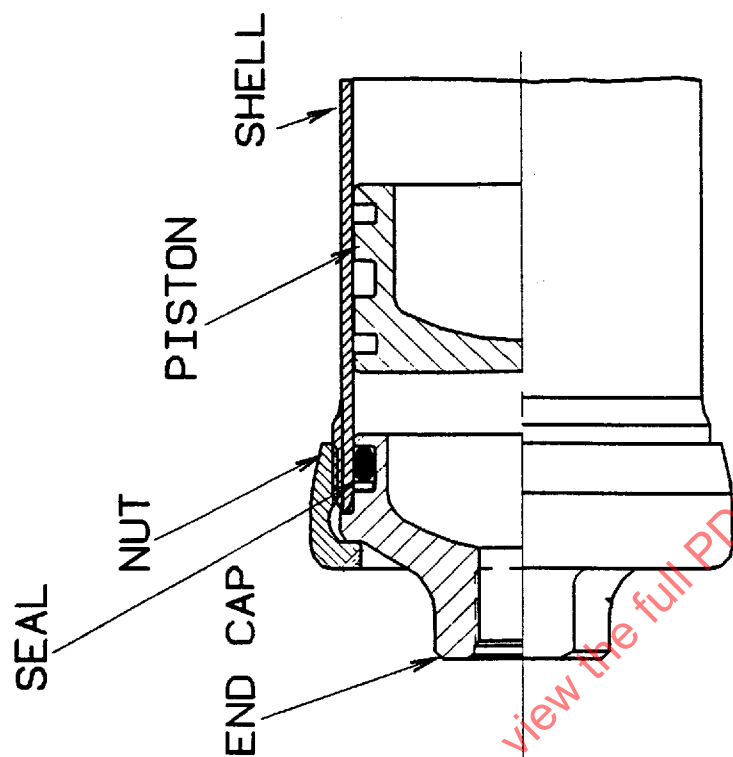
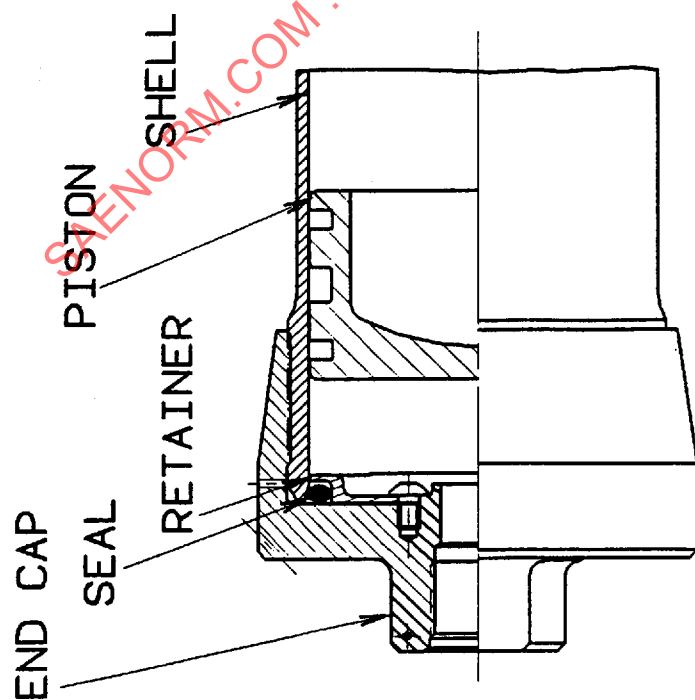
FIGURE 3.2.1.2 (Continued)

**PROBLEM:** PREMATURE FAILURE OF ACCUMULATOR END CAPS

**ISSUE:** Failed accumulators are an extreme hazard to aircraft.

- SOLUTION:**
1. Replace aluminum with steel or equivalent.
  2. Ensure that equipment is used at design pressure.
  3. Use two piece end cap design to distribute stresses (steel nut and aluminum gland).
  4. Use the closed end cap on gas side.
  5. Use materials with good fracture toughness - slow crack propogation.
  6. Provide adequate corrosion protection.

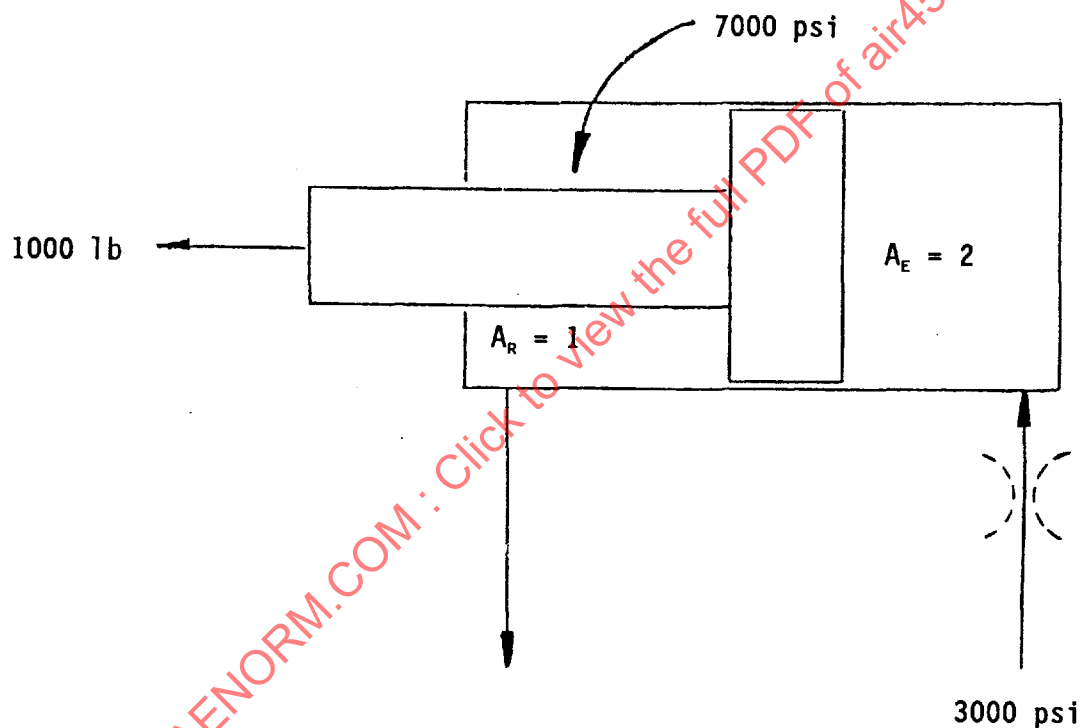
**FIGURE 3.2.2.1 - Pressure Intensification in Extending Cylinder**

**ISSUE:** There have been many cases where designers failed to recognize the high pressure that can occur on the retract side of a cylinder due to pressure intensification and/or an aiding load.

**SOLUTION:** Include a restrictor in the extend line so that the extend pressure is reduced to an acceptable level.

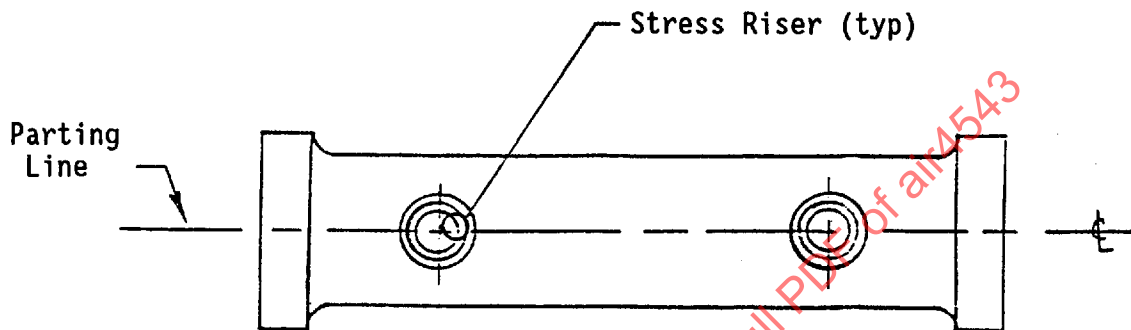
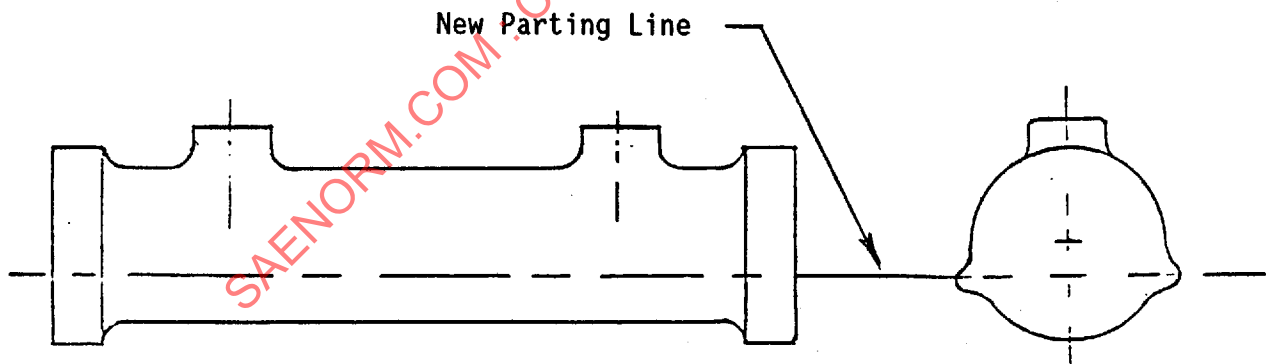
**FIGURE 3.2.2.4 - Fatigue Failures in Cylinders With Parting Line Through Ports**

**ISSUE:** The parting line placement on the cylinder centerline for "shallow draw" forging creates stress risers at the ports and at the thinnest section of the cylinder. This can result in fatigue failures or shortened life (see Illustration 1).

**SOLUTION:** Relocate the parting line off the cylinder centerline and completely off the ports (see Illustration 2).

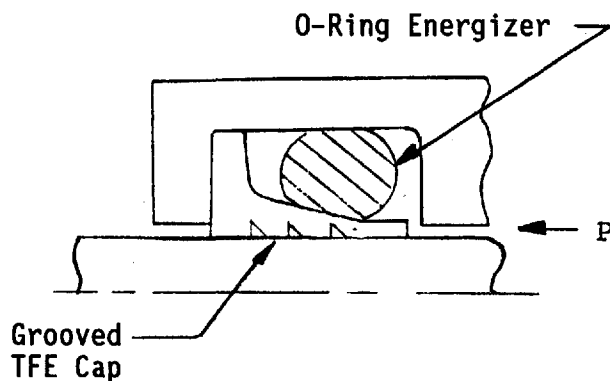
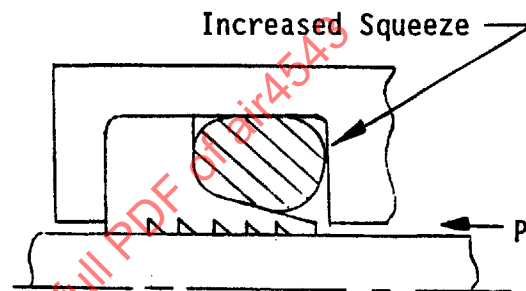
**ISSUE:** Actuators designed and qualified for low friction (manual reversion) applications sometimes fail leakage tests for no apparent reason. TFE capped rod seals, such as shown in Illustration 1, are usually employed to meet low friction.

- SOLUTION:**
1. Low friction simultaneously with low leakage is a contradiction and a challenge. Analyses and development tests in concert with seal supplier(s) is required early to arrive at optimum seal configuration. (Reference Table 1.)
  2. Strive to qualify at least one alternate seal to preclude production and delivery problems later.
  3. Roughening the surface of the seal with a mild abrasive prior to assembly can improve leakage. However, improvement is only temporary and uncontrolled process is undesirable.
  4. Typical Example: An actuator with nine capped seals suddenly experienced a 50% rejection rate after several years of production. Rejections were eliminated by increasing squeeze (fill) from 51% to 91% and increasing the number of grooves (see Illustration 2). The friction penalty was doubled, but the total friction was still well within the 104# limit.

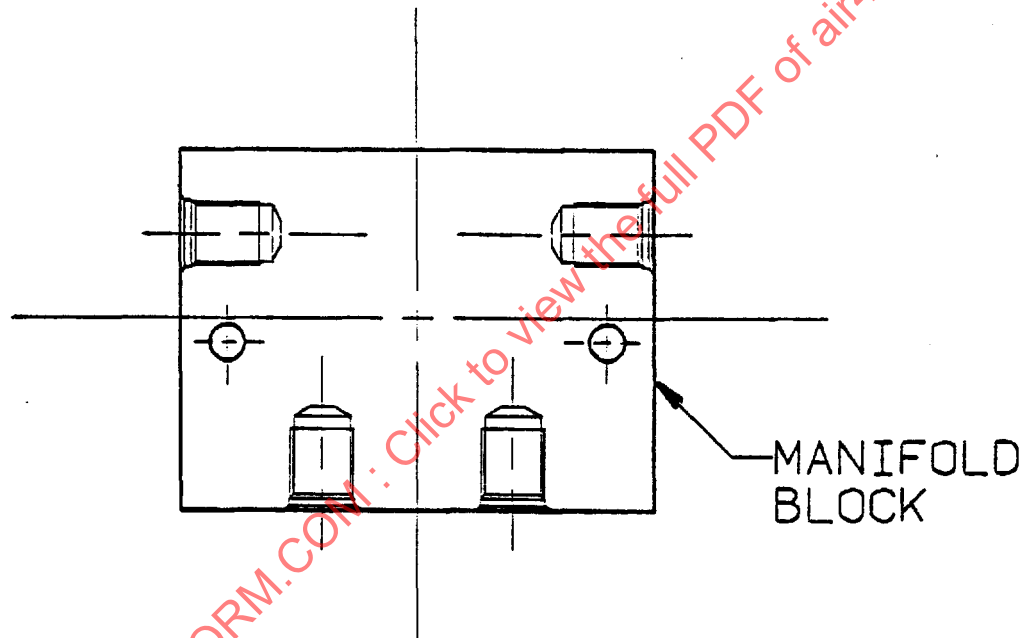
**PROBLEM:** AILERON FAILED TO OPERATE

**SOLUTION:** Although the manifold had passed inspection it was decided to replace it. Afterwards the aileron worked.

Never take for granted that any part is per the drawing.

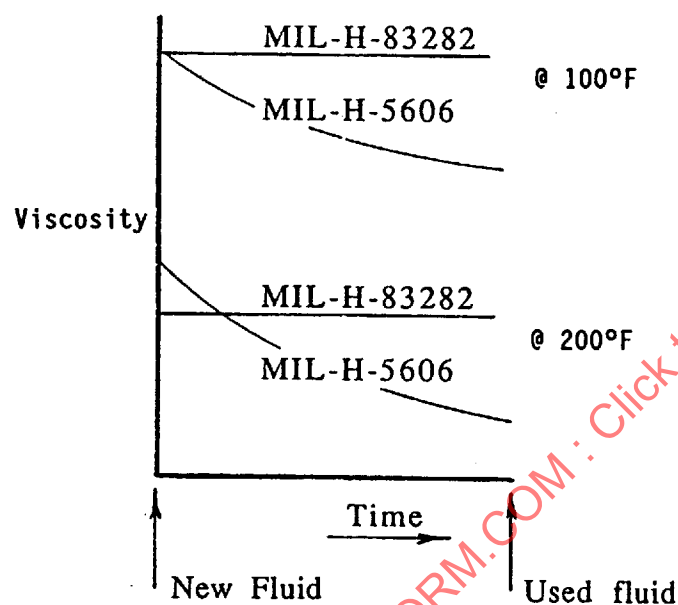
A low leakage requirement may test acceptably with a high viscosity, new, fluid and unacceptably with a low viscosity, used, fluid.

SOLUTION: Specify that test benches be operated for 8 h through orifices to shear fluid prior to conducting critical leakage acceptance tests.

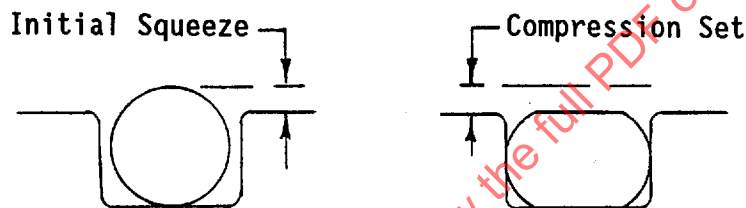
ILLUSTRATION 1

**ISSUE:** Small cross-section static seals, typically 0.070 in diameter, per MS28775 or MIL-P-83461 (nitrile) are prone to leakage failures. A contributing factor may be local "necking down" caused by uneven installation stretch forces for large sizes. However, the primary problem is due to compression set of the elastomer, which is critical for small cross-sections. High temperature operation for a few hours results in a permanent loss of squeeze with leakage pronounced at normal as well as colder temperatures and low pressures (see Illustration 1).

- SOLUTION:**
1. Where external seepage would result, avoid small cross-section seals, especially for sizes above a 2 in diameter. Where they must be used, the elastomer compound should be changed:
    - a. Fluorocarbon per MIL-R-83485 has been successful in solving problems where the temporary loss of squeeze below  $-40^{\circ}\text{F}$  due to the coefficient of shrinkage can be accepted, i.e., slight seepage at low temperature.
    - b. Phosphonitrilic fluoroelastomer (PNF) per MIL-P-87175 has been successful solving problems where squeeze must be maintained down to  $-65^{\circ}\text{F}$ .
    - c. Fluorosilicone per MIL-R-25988 may prove to be an acceptable lower cost alternate to PNF in certain applications such as face seals.
