# AEROSPACE INFORMATION REPORT

**SAE** AIR4543

## Aerospace Hydraulics and Actuation Lessons Learned

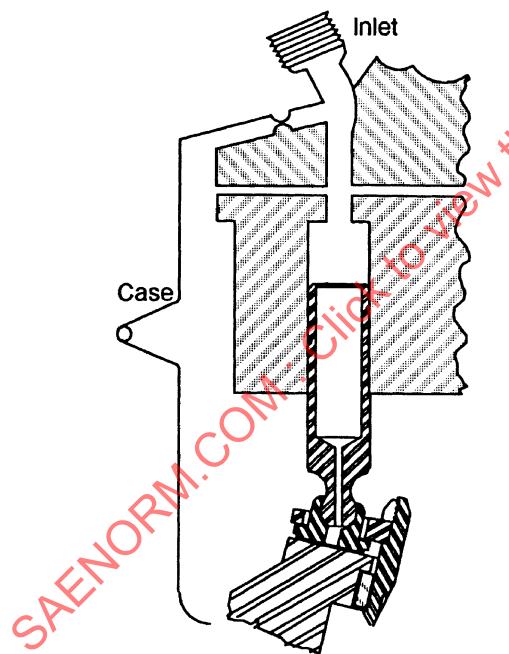
FIGURE 3.1.3 - Pump Overheat and Rapid Wear

PROBLEM: PUMP OVERHEAT AND RAPID WEAR

- ISSUE:
1. Pump case drain line too small
  2. Creates high back pressure (case)
  3. Creates high discharge pressure (flow)
  4. Overheat (pump)
  5. Excessive pump shoe wear

- SOLUTION:
1. Increase line size (case drain)
  2. Use bypass type filters
  3. Reroute line to reduce pressure drop
  4. Internally drain (to inlet) if minimum system demand available

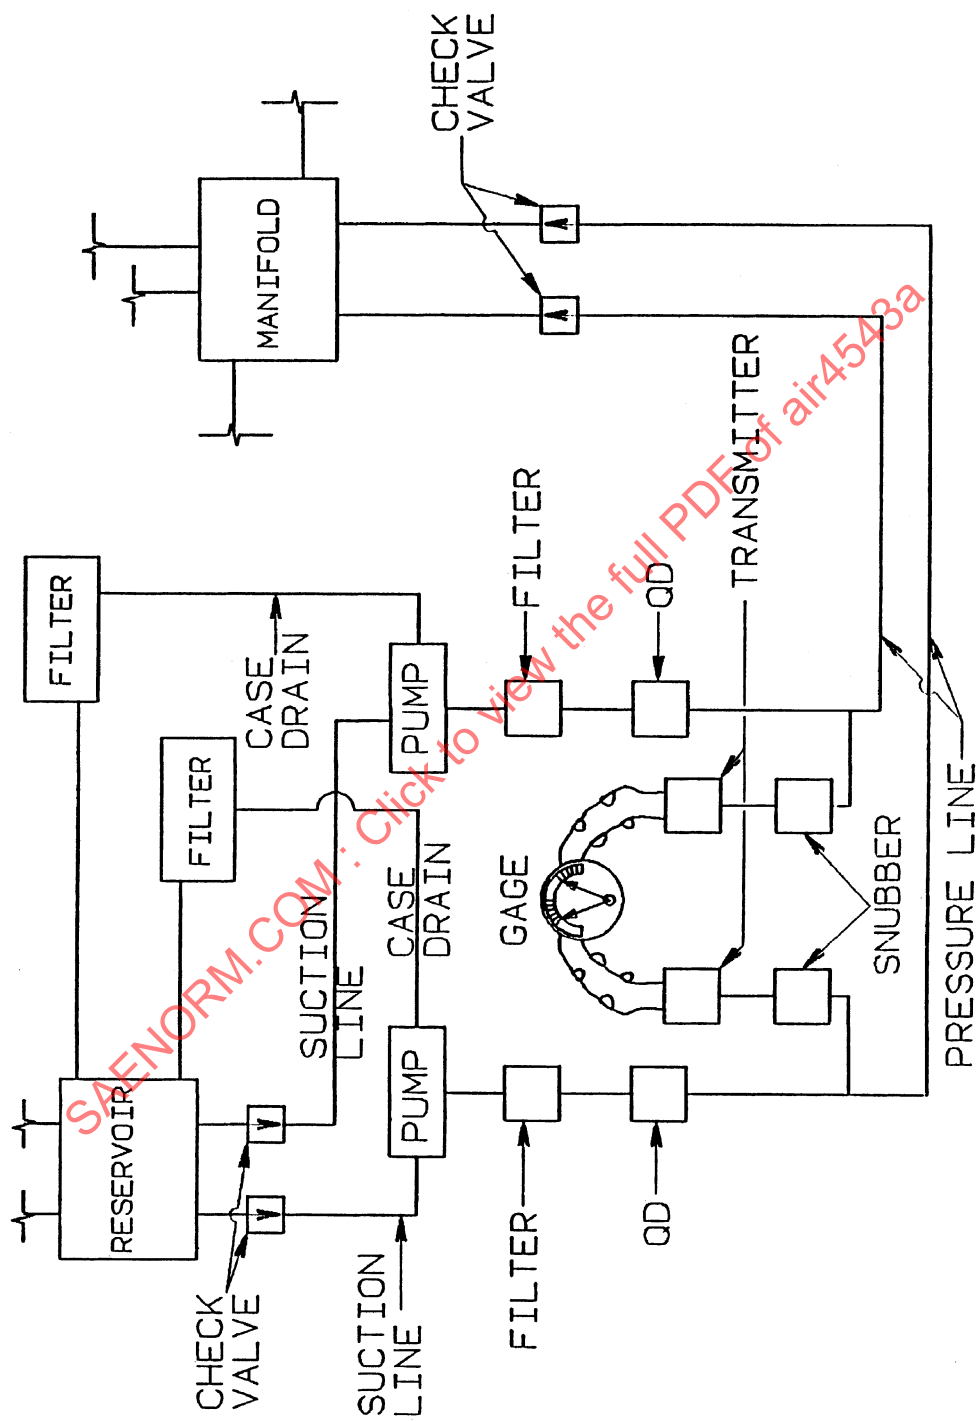
FIGURE 3.1.7 - Pump Suction Line Bursting

- ISSUE:**
1. On the initial engine run of a twin engine aircraft the R/H pump suction line burst.
  2. The line was replaced and the R/H engine started - no problem.
  3. The L/H engine was started and the R/H suction line burst.
  4. The line was replaced and the L/H engine started - no problem.
  5. The R/H engine was then started and the R/H suction line burst.

- SOLUTION:**
1. The R/H pump compensator was found to have a slightly lower pressure setting than required.
  2. A failed pump outlet check valve created a reverse pumping situation on the R/H side.
  3. Pump and check valve were replaced.

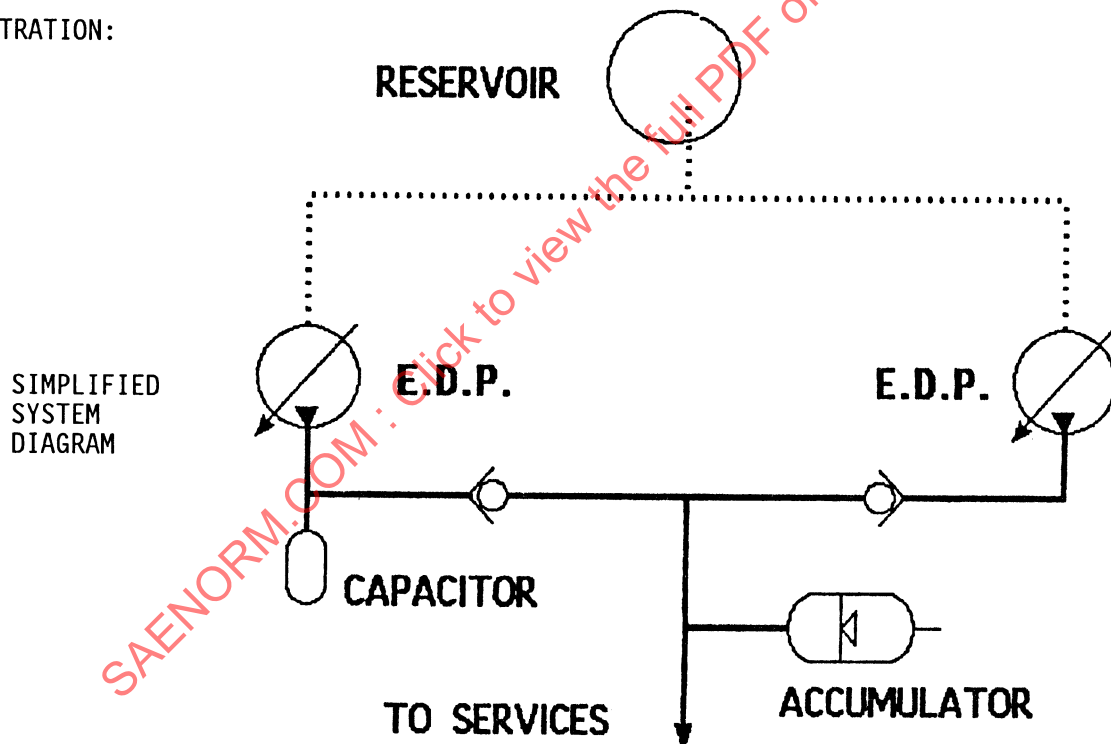
FIGURE 3.1.8 - Hydraulic System Noise

PROBLEM: HYDRAULIC SYSTEM NOISE

- ISSUE:
1. With a twin engine driven pump (E.D.P.) hydraulic system, there were complaints of noise, although not encountered with:
    - a. Earlier production aircraft;
    - b. When system is pressurized by ground rigs.
  2. Resonance condition occurred in the shortest line downstream of E.D.P. due to the reduced volume of the high pressure part of the hydraulic system.

- SOLUTION:
1. Initially increase the accumulator size to that previously fitted.
  2. Finally, revert to a smaller accumulator and add a "capacitor" (a small pressure vessel (22 in<sup>3</sup>) to the system).

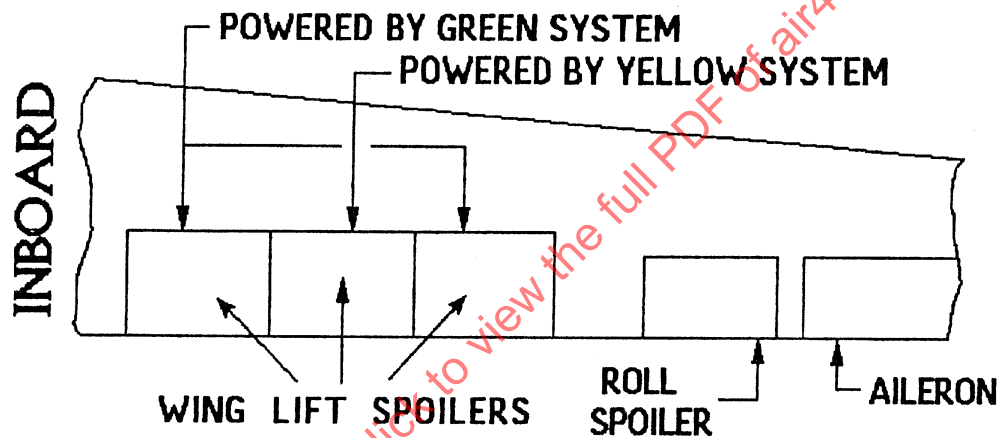
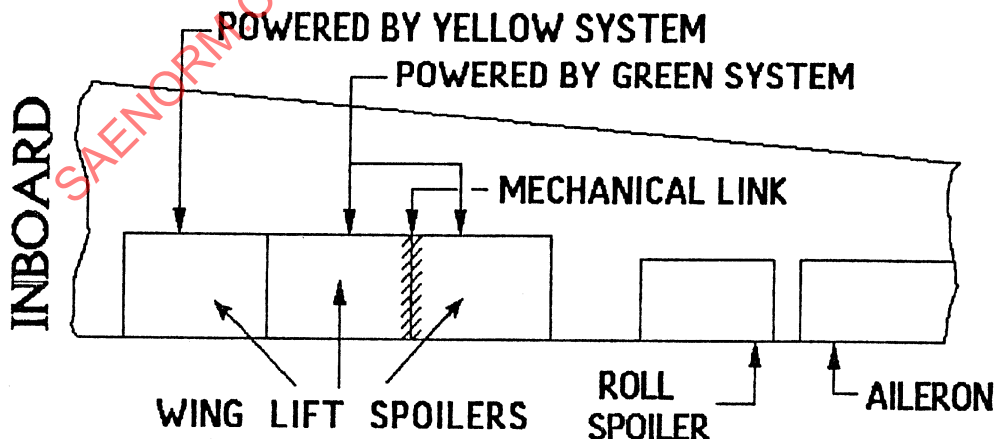
FIGURE 3.1.9 - Effect of JAR/FAR Requirement on Flight Control Surface Operation

- ISSUE:**
1. Noncompliance with JAR/FAR 25.671:
  2. A single failure of a flight control surface attachment point could cause a catastrophic event.
  3. The center or outboard ground lift spoiler panel could deploy following the failure of the eye end attachment point, for example, such that an inadvertent rolling moment could not be controlled.

- SOLUTION:**
1. Reroute hydraulic supplies to the lift spoilers and link the center and outboard panels.

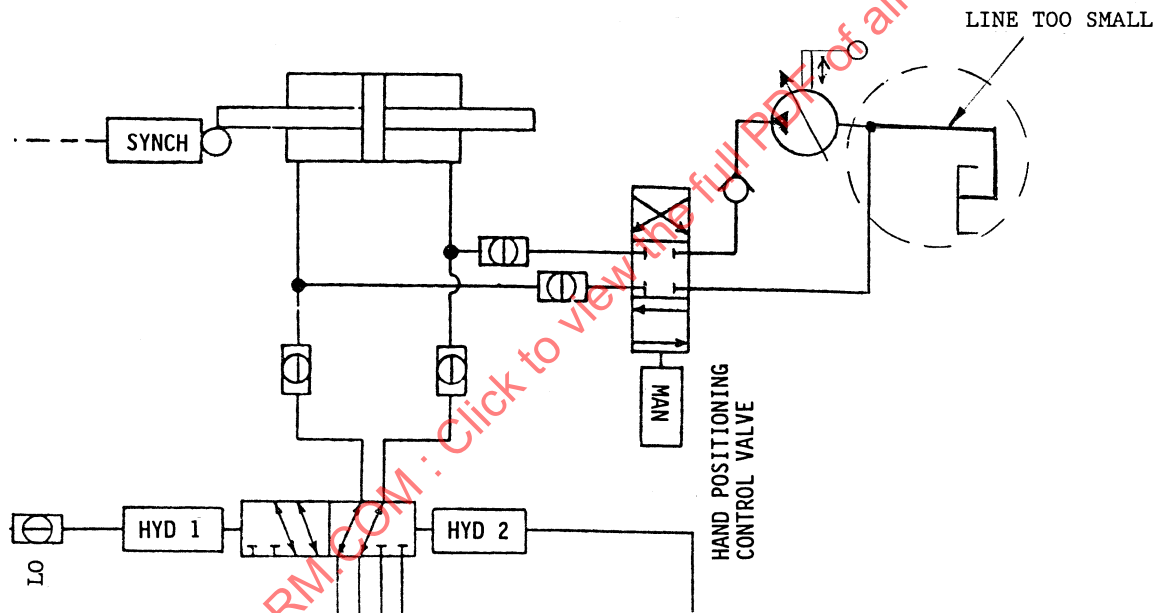
FIGURE 3.1.13 - Inadequately Sized Hand Pump Suction Line

PROBLEM: INADEQUATELY SIZED HAND PUMP SUCTION LINE

SOLUTION: The variable displacement hand pump discharges fluid as the pump handle is stroked in each direction. However, analysis indicated that the pump takes suction only when the pump is stroked in one direction. As a result, considerable flow is required from the unpressurized reservoir during the suction stroke even though the cylinder is balanced (equal volume for each direction of travel). The diameter of the make-up line from the reservoir to the pump suction had been sized for minimal flow and had to be increased to obtain rated pump capacity.

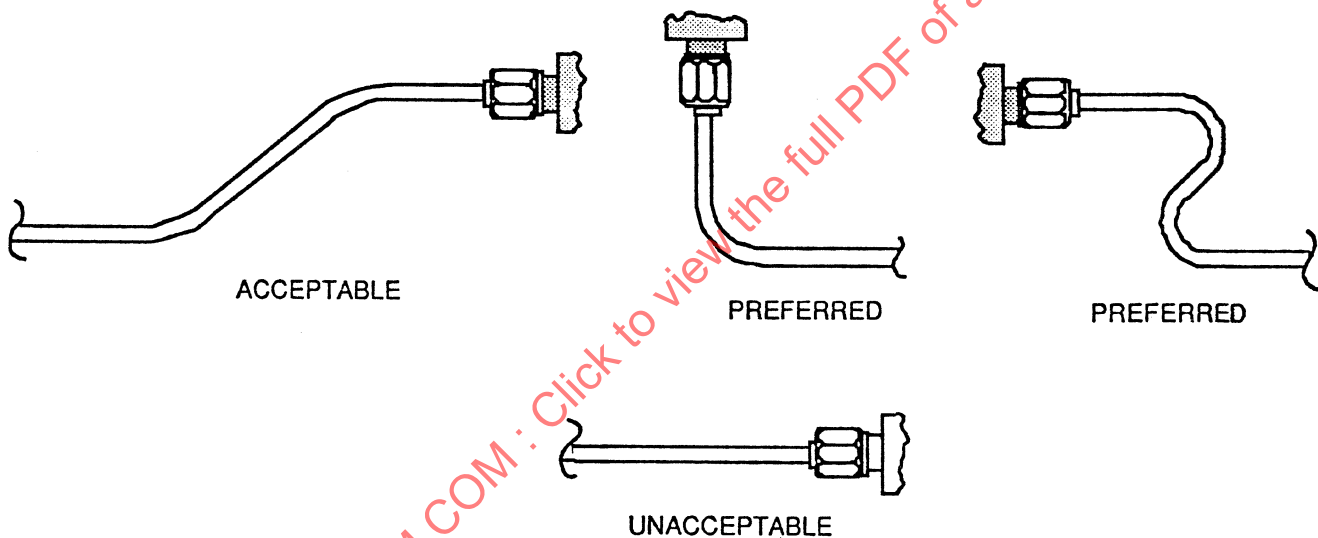
- ISSUE:
1. During initial installations, tubes without flexibility cannot be sufficiently extended for fit.
  2. Tubes without flexibility sustain damage from pressure surges and vibration.

SOLUTION: Incorporate bend(s) in the hydraulic tubing to increase the tolerances and dissipate surges.

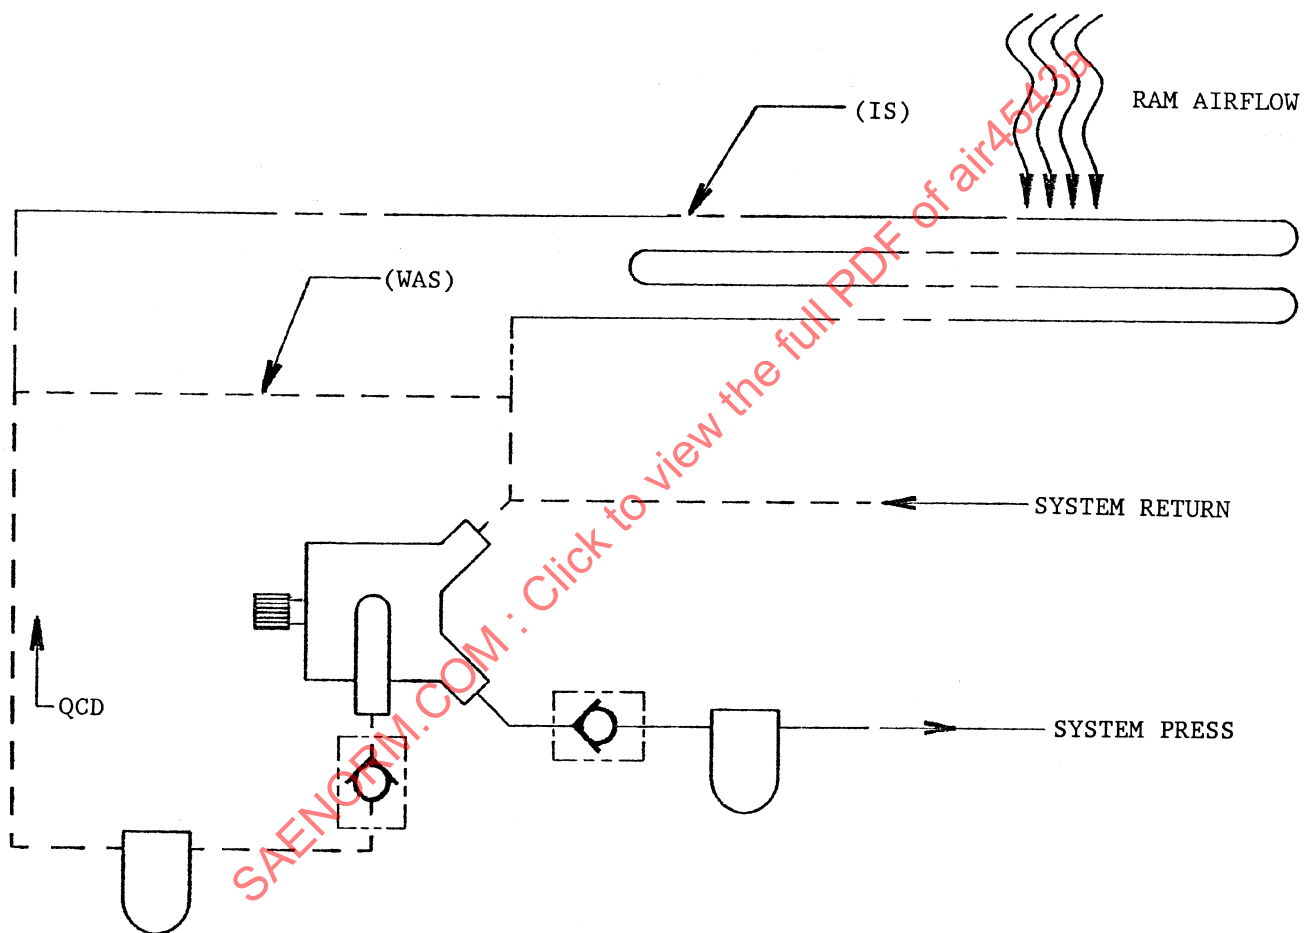
FIGURE 3.1.16 - System Overheat Caused by Inefficient Pump and Lack of Heat Exchanger

PROBLEM: SYSTEM OVERHEAT CAUSED BY INEFFICIENT PUMP AND LACK OF HEAT EXCHANGER

- SOLUTION:
1. Revise the specifications to buy the pump with guaranteed efficiency and case drain flow over the life of the pump.
  2. Increase the case drain line diameter and the filter housing size.
  3. Reroute the case drain line to increase surface area and also expose to area with ram air.

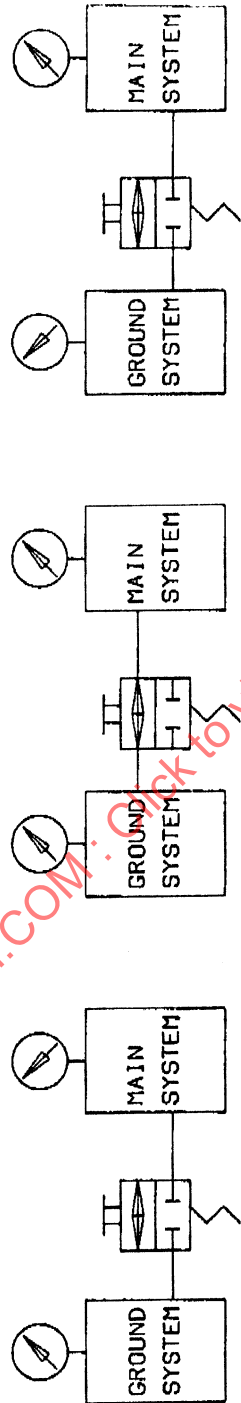
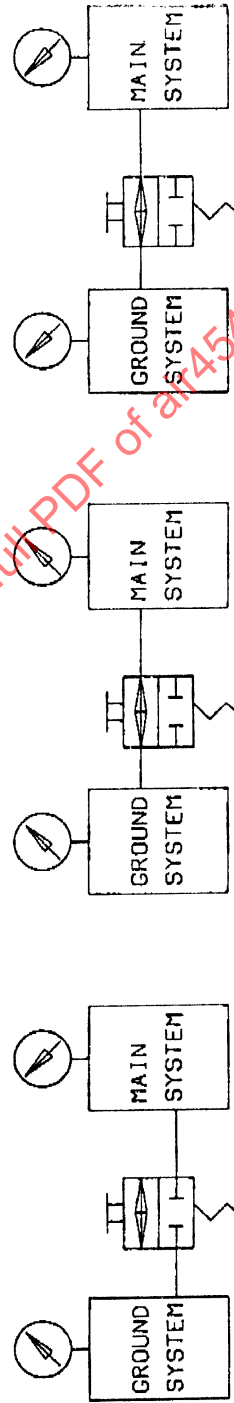
FIGURE 3.1.23 - Intrasystem Fluid Transfer

**Issue:** Ground/utility checkout transfers "compression" fluid to main system

**SOLUTION:** Decompress main system as final checkout action.

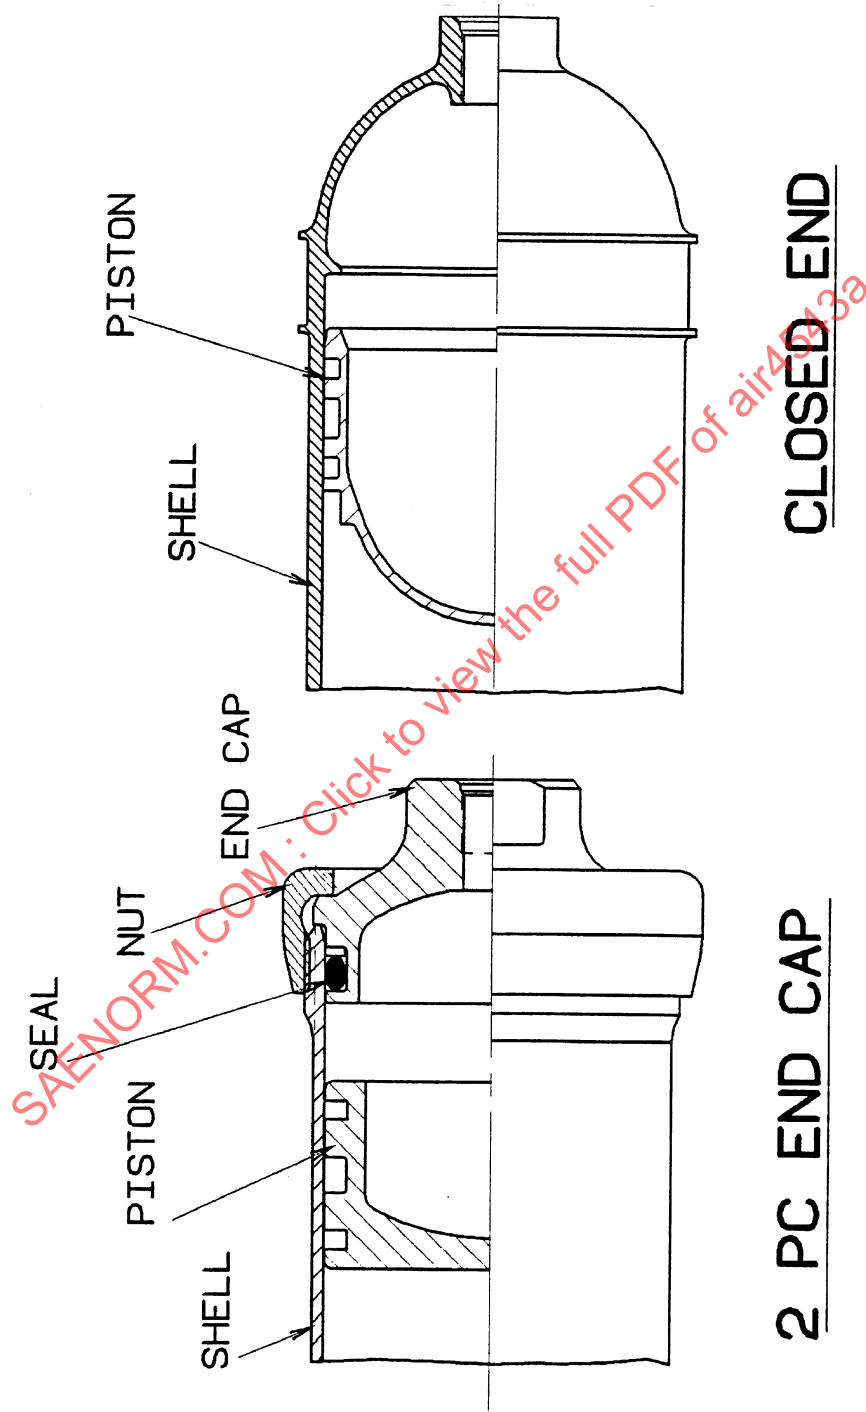
FIGURE 3.2.1.1 - Excessive or Premature Leakage Across Accumulator Seals

**PROBLEM:** EXCESSIVE OR PREMATURE LEAKAGE ACROSS ACCUMULATOR SEALS

**ISSUE:** Gas leaking into the system can cause a loss of aircraft or system.

- SOLUTION:**
1. Ensure that the chrome plate is controlled to minimize cracking (cracks inherent in chrome plating process).
  2. Ensure that the seal compound meets all temperature, pressure, and pressure discharge requirements. Minimize the compression set and explosive decompression.
  3. Use the closed end cap on gas side (eliminate static seal).
  4. Improve the seal concept to improve sealing capability (multiple seals, metal bellows, etc.).

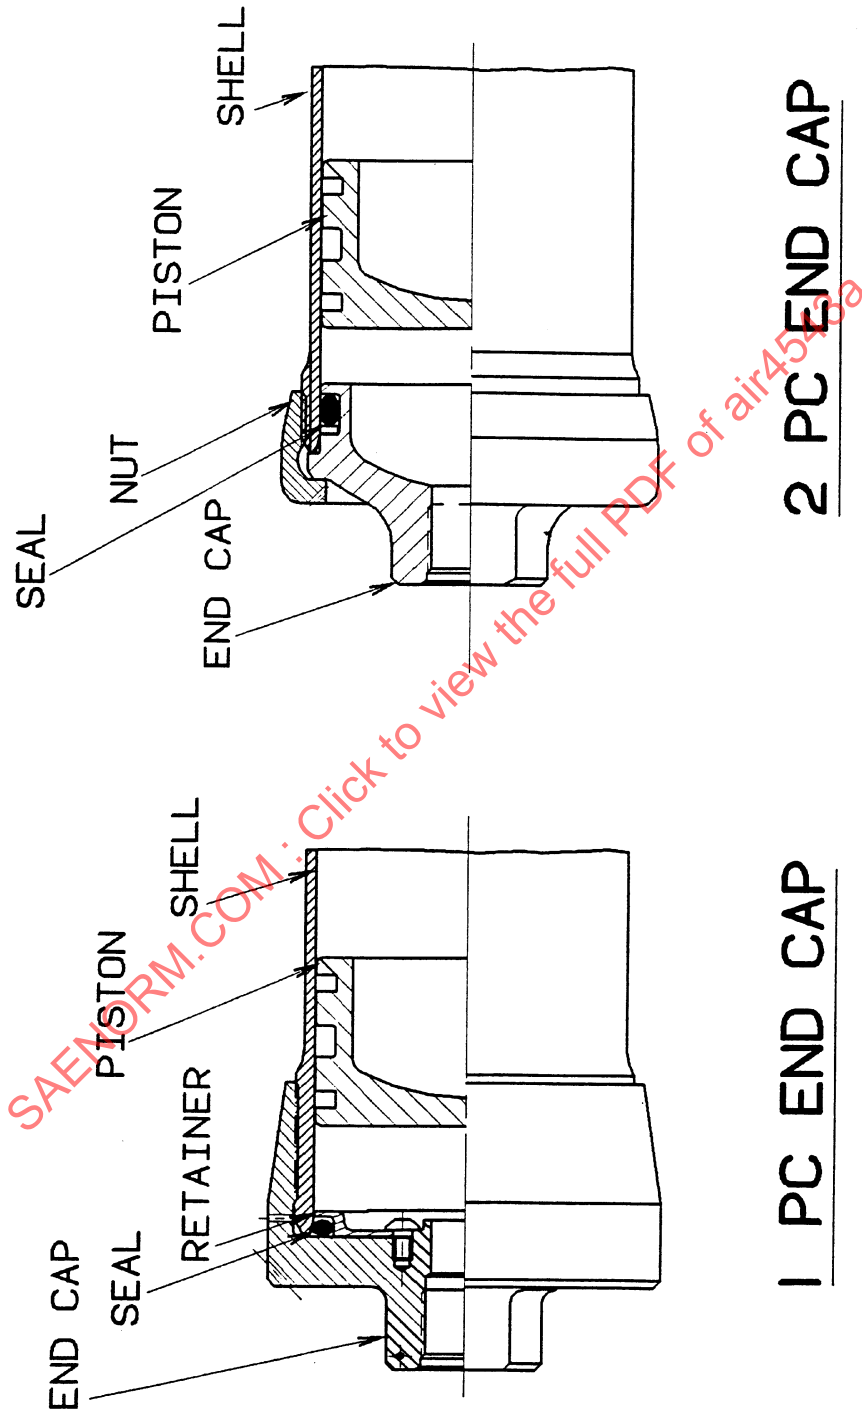
FIGURE 3.2.1.2 - Premature Failure of Accumulator End Caps

**PROBLEM:** PREMATURE FAILURE OF ACCUMULATOR END CAPS

**ISSUE:** Failed accumulators are an extreme hazard to aircraft.

- SOLUTION:**
1. Replace aluminum with steel or equivalent.
  2. Ensure that equipment is used at design pressure.
  3. Use two piece end cap design to distribute stresses (steel nut and aluminum gland).
  4. Use the closed end cap on gas side.
  5. Use materials with good fracture toughness - slow crack propagation.
  6. Provide adequate corrosion protection.

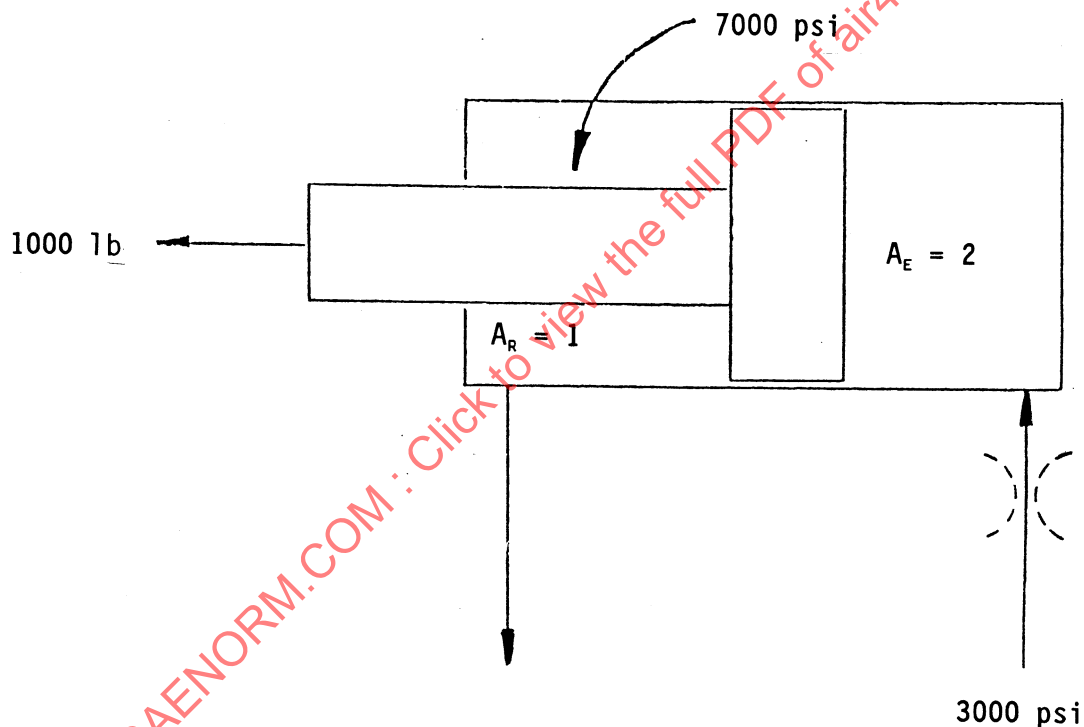
ISSUE: There have been many cases where designers failed to recognize the high pressure that can occur on the retract side of a cylinder due to pressure intensification and/or an aiding load.

SOLUTION: Include a restrictor in the extend line so that the extend pressure is reduced to an acceptable level.

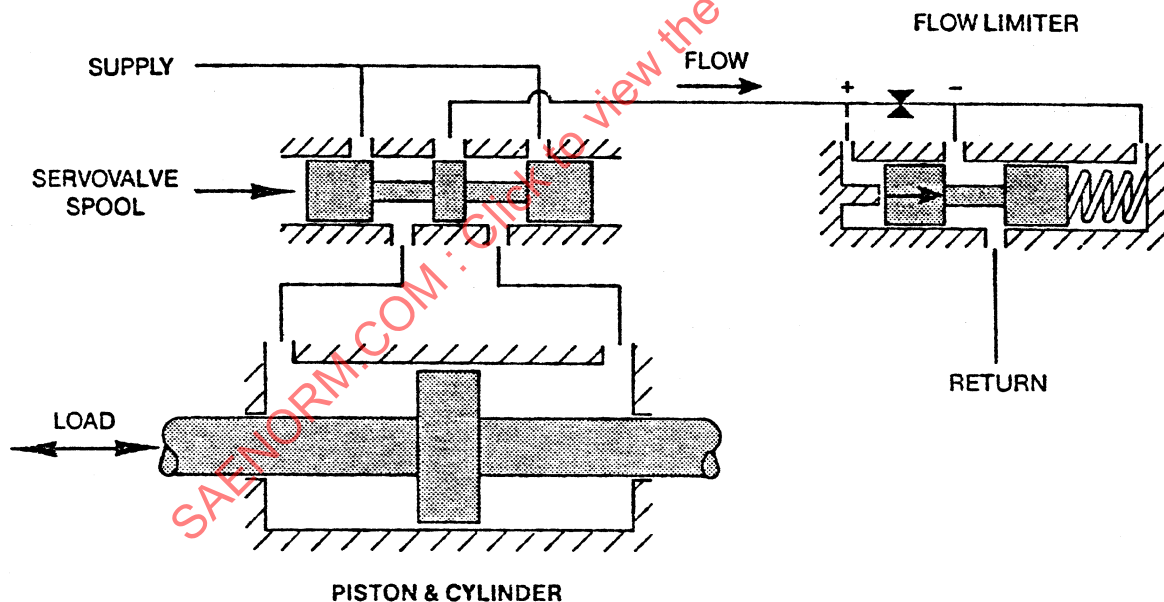
- ISSUE:**
1. During the countdown for the initial launch of the Gemini two-man space vehicle, the primary servovalve of the dual redundant thrust vector control actuator blew off the manifold.
  2. The actuator flow limiter used to restrict excessive thrust vector control rate caused high back pressure during engine start transient.
  3. The high impulse loads can create transient back pressure on the servovalve. Alternate configurations for limiting actuator velocity should be considered if impulse loads cannot be suppressed.

- SOLUTION:**
1. A quick fix was to beef-up the servovalve body and mounting.
  2. A long-term solution has been to add cylinder bypass (pressure relief) valves to dissipate energy of hard engine/rocket motor starts.

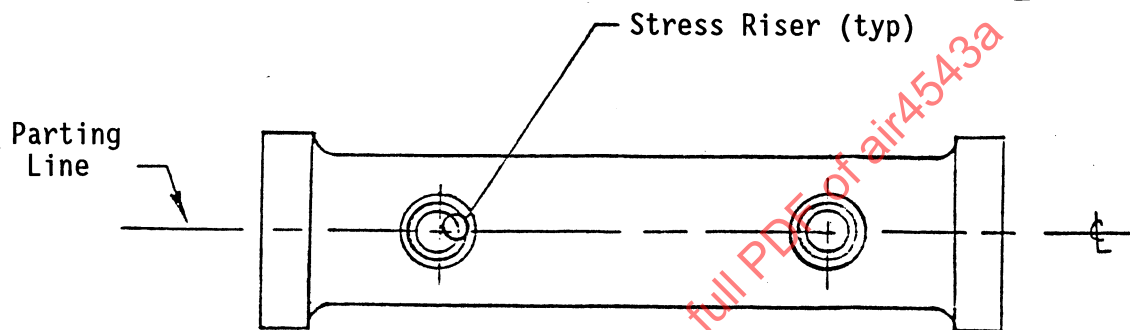
ILLUSTRATION 1

**PROBLEM:** FATIGUE FAILURES IN CYLINDERS WITH PARTING LINE THROUGH PORTS

**ISSUE:** The parting line placement on the cylinder centerline for "shallow draw" forging creates stress risers at the ports and at the thinnest section of the cylinder. This can result in fatigue failures or shortened life (see Illustration 1).

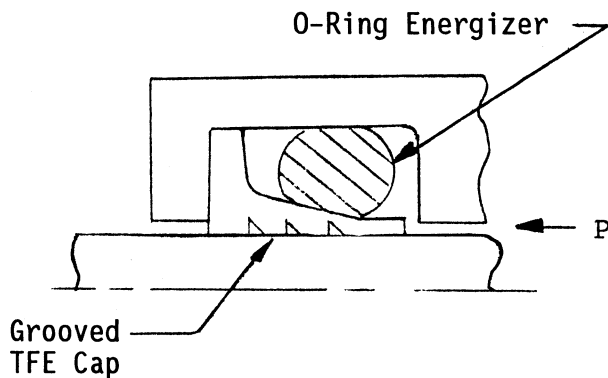
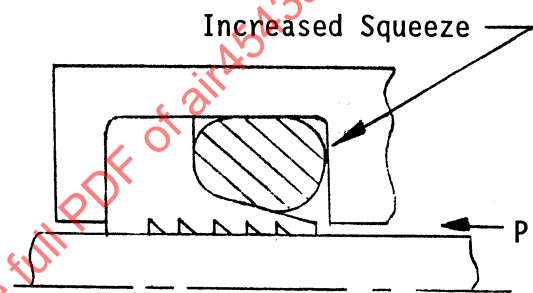
FIGURE 3.2.2.5 - Rejection of Low Friction Actuators for Dynamic Leakage

**PROBLEM:** REJECTION OF LOW FRICTION ACTUATORS FOR DYNAMIC LEAKAGE

**ISSUE:** Actuators designed and qualified for low friction (manual reversion) applications sometimes fail leakage tests for no apparent reason. TFE capped rod seals, such as shown in Illustration 1, are usually employed to meet low friction.

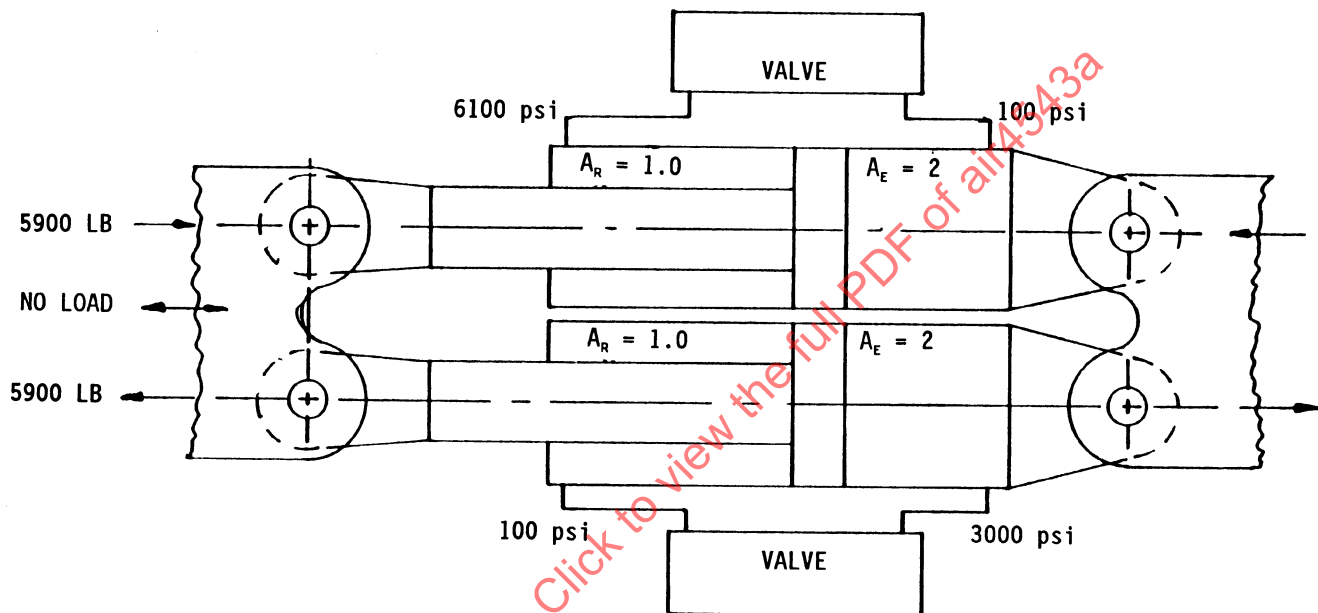
PROBLEM: FATIGUE DAMAGE TO LOADED STRUCTURE AND CYLINDERS

- SOLUTION:
1. Use a single tandem valve for control pressure matching.
  2. Mechanically couple separate valves for control pressure matching.
  3. Use pressure transducers and electronic equalization to match control pressures.
  4. Use underlapped separate servovalves to match control pressures at null (may still have a dynamic force fight problem).

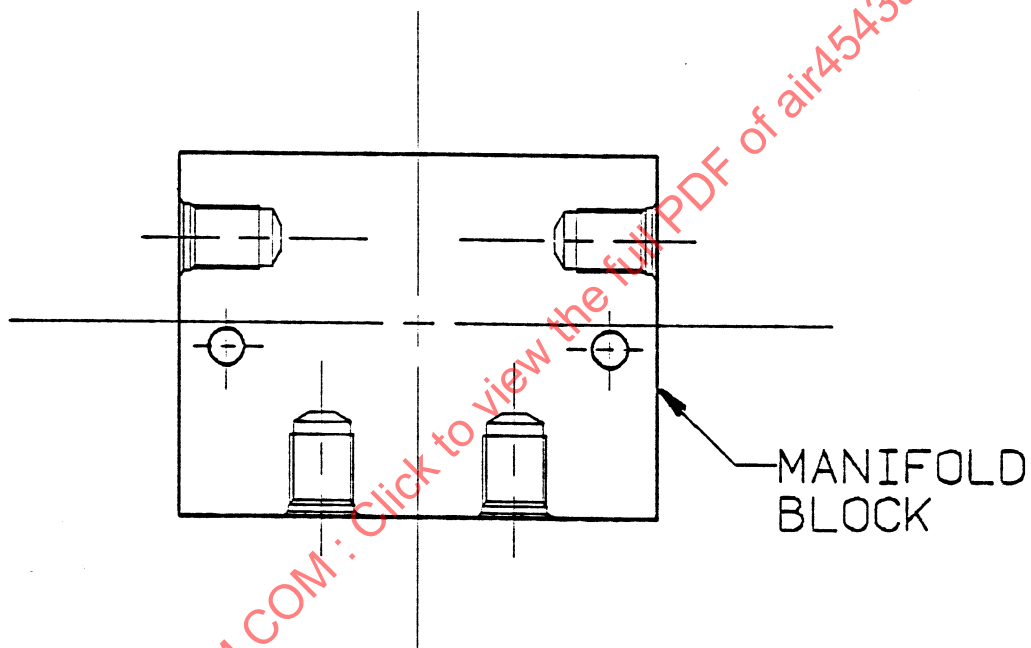
PROBLEM: AILERON FAILED TO OPERATE

SOLUTION: Although the manifold had passed inspection it was decided to replace it. Afterwards the aileron worked.

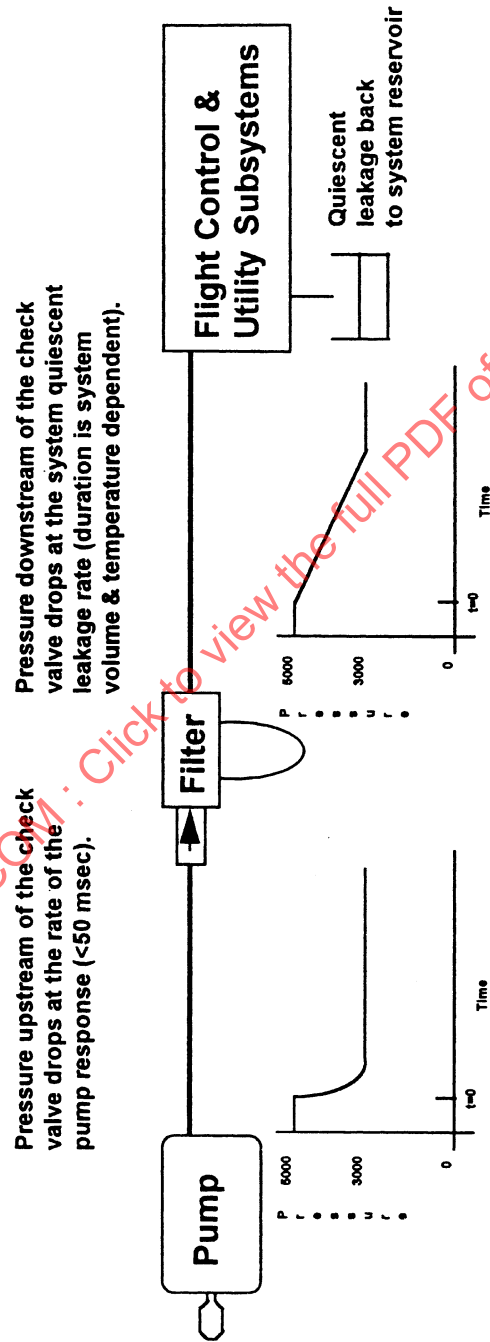
**ISSUE:** Switching from high pressure to low pressure causes the high pressure filter check valve to close resulting in inadequate system volume downstream of the dual pressure pump to maintain stability.

**SOLUTION:** Specify a dual pressure pump response rate, from high pressure to low pressure, that is slower than the system quiescent leakage rate.

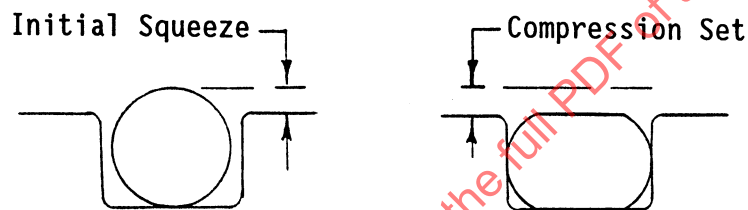
ILLUSTRATION 1

**ISSUE:** Small cross-section static seals, typically 0.070 in diameter, per MS28775 or MIL-P-83461 (nitrile) are prone to leakage failures. A contributing factor may be local "necking down" caused by uneven installation stretch forces for large sizes. However, the primary problem is due to compression set of the elastomer, which is critical for small cross-sections. High temperature operation for a few hours results in a permanent loss of squeeze with leakage pronounced at normal as well as colder temperatures and low pressures (see Illustration 1).

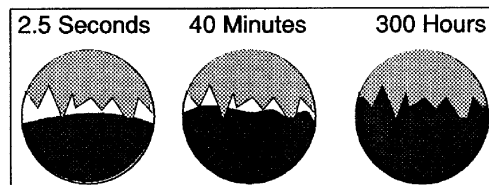
Hardcoat anodize and a large rubber footprint is an unfavorable combination. The rubber extrudes into the voids and crevices of the hardcoat. The degree of elastomer imbedding is time dependent but reaches a finite value  $\approx 100\%$ . The force required to shear is proportional to the amount of imbedded rubber and potentially can exceed the force available from the reservoir pressurization device.

**SOLUTION:** Be cognizant of the micro-surface, its relationship with seals and select seals and finishes appropriately. For this particular application, a new loss pressure seal with a small controlled rubber footprint was selected. This limited the amount of extruded rubber, therefore, reducing the shear force required to an acceptable level.

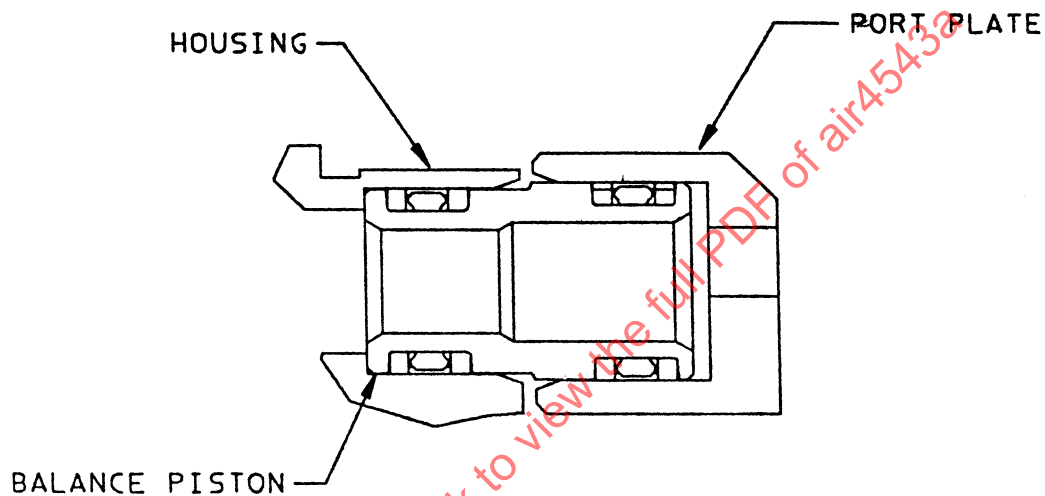
**ISSUE:** Cyclic/reversing pressures on floating port plate type units causes dithering wear on seals at high frequency. Can cause leakage and contamination debris.

**SOLUTION:** Unbalancing of transfer tube causes greater force in one direction and prevents dithering motion, thus reducing seal wear and leakage.
