**(R) Aerospace Hydraulics and Actuation Lessons Learned**

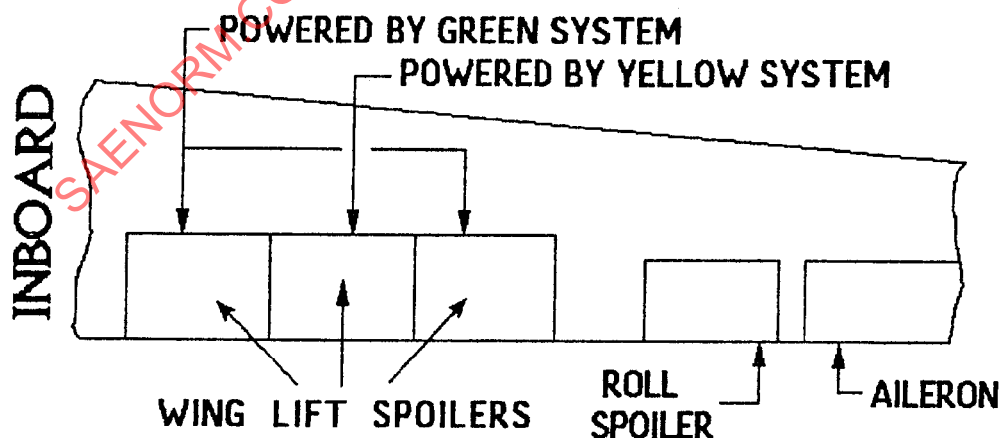
- b. A single failure of a flight control surface attachment point could cause a catastrophic event.
- c. The center or outboard ground lift spoiler panel could deploy, following the failure of the eye end attachment point for example, such that an inadvertent rolling moment could not be controlled.

SOLUTION: Reroute hydraulic supplies to the lift spoilers and link the center and outboard panels.

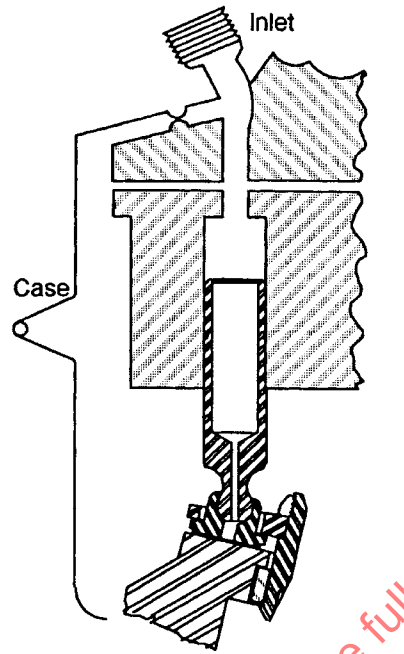
PROBLEM: Pump overheat and rapid wear installed in aircraft system.

- Pump case drain line too small
- Creates high back pressure (case)
- Creates high discharge pressure (flow)
- Overheat (pump)
- Excessive pump shoe wear

- a. Increase line size (case drain)
- b. Use bypass type filters
- c. Reroute line to reduce pressure drop
- d. Internally drain (to inlet) if minimum system demand available

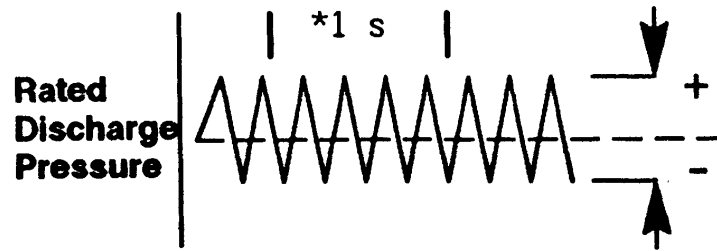
PROBLEM: Hydraulic system life and noise degraded by excessive pump pressure ripple.

- a. Line fatigue
- b. Excessive wear (moving parts)
- c. Vibration/noise

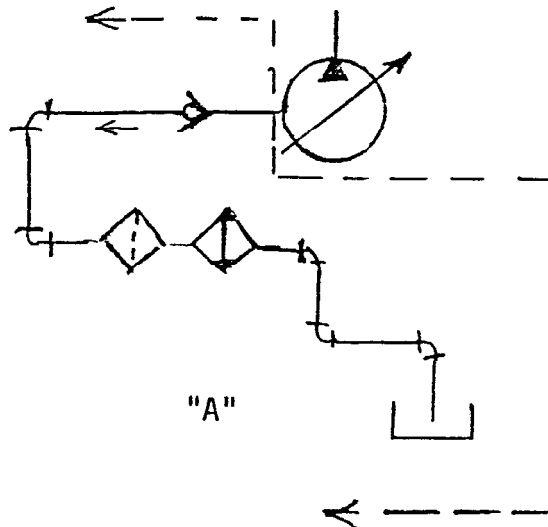
ISSUE: Restrictions in the hydraulic pump/motor case drain plumbing can cause high pressure and subsequent failure of the pump/motor case. Restrictions can be caused by too small diameter tubing, long tubing lengths, or improper component installations. The restrictions can result in high line pressure drop, resulting in high pressures in the pump or motor case. Pump and motor cases are generally designed to a 500 lbf/in<sup>2</sup> (3450 kPa) proof pressure or less.

- a. Analyze the installation and determine the pressure drop of the pump or motor case drain plumbing from the case to the reservoir. The analysis should include evaluations considering delta pressure of all possible case drain flow and fluid temperature combinations, case drain filter variables, transient flows, and component installation.

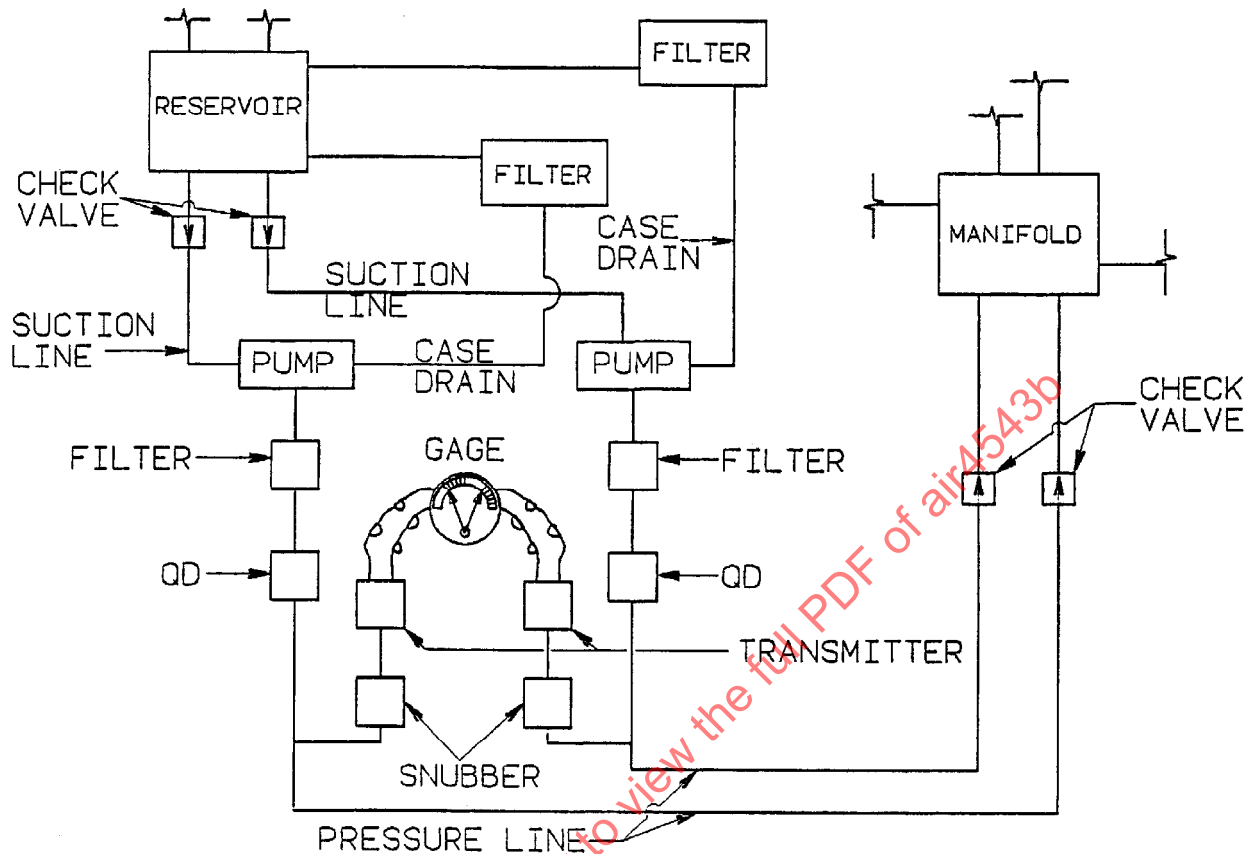
- a. On the initial engine run of a twin engine aircraft the R/H pump suction line burst.
- b. The line was replaced and the R/H engine started - no problem.
- c. The L/H engine was started and the R/H suction line burst.
- d. The line was replaced and the L/H engine started - no problem.
- e. The R/H engine was then started and the R/H suction line burst.

- The R/H pump compensator was found to have a slightly lower pressure setting than required.
- A failed pump outlet check valve created a reverse pumping situation on the R/H side.
- Pump and check valve were replaced.

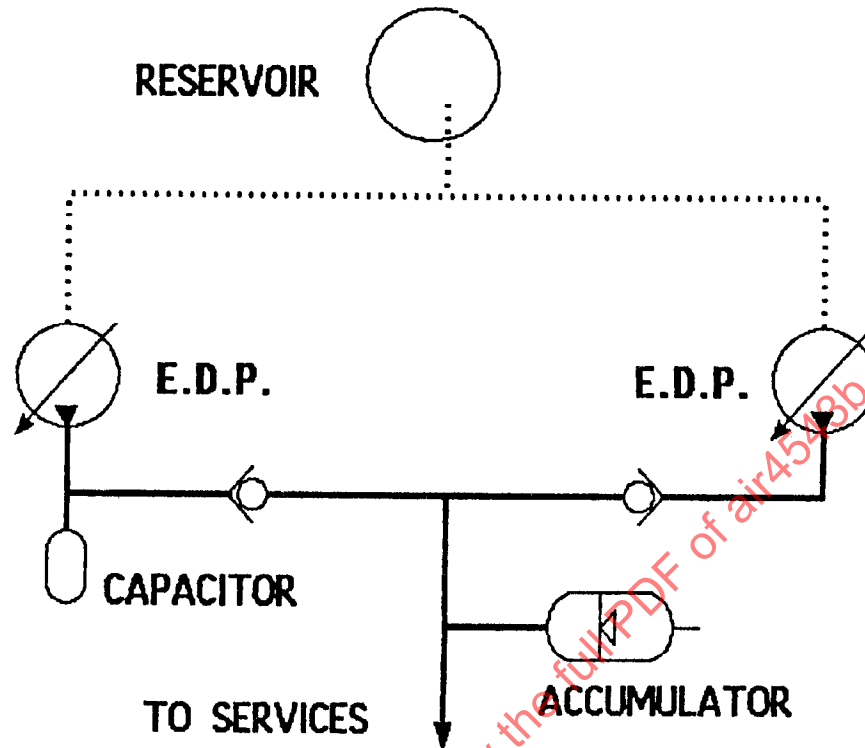
- With a twin engine driven pump (E.D.P.) hydraulic system, there were complaints of noise, although not encountered with:
  - Earlier production aircraft;
  - When system is pressurized by ground rigs.
- Resonance condition occurred in the shortest line downstream of E.D.P. due to the reduced volume of the high pressure part of the hydraulic system.

- Initially increase the accumulator size to that previously fitted.
- Finally, revert to a smaller accumulator and add a "capacitor" (a small pressure vessel (22 in<sup>3</sup>) (360 cm<sup>3</sup>) to the system).

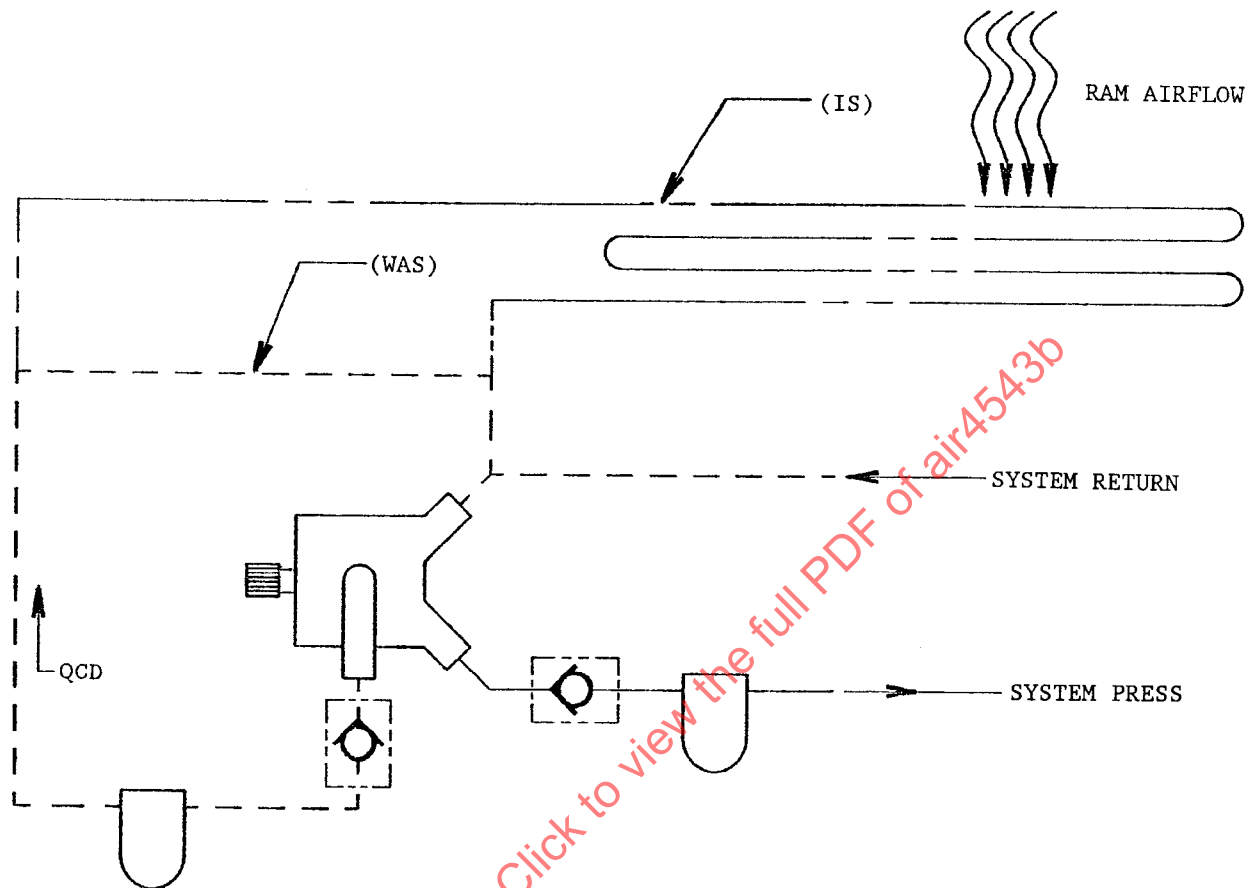
PROBLEM: System overheat caused by inefficient pump and lack of heat exchanger.

- Revise the specifications to buy the pump with guaranteed efficiency and case drain flow over the life of the pump.
- Increase the case drain line diameter and the filter housing size.
- Reroute the case drain line to increase surface area and also expose to area with ram air.

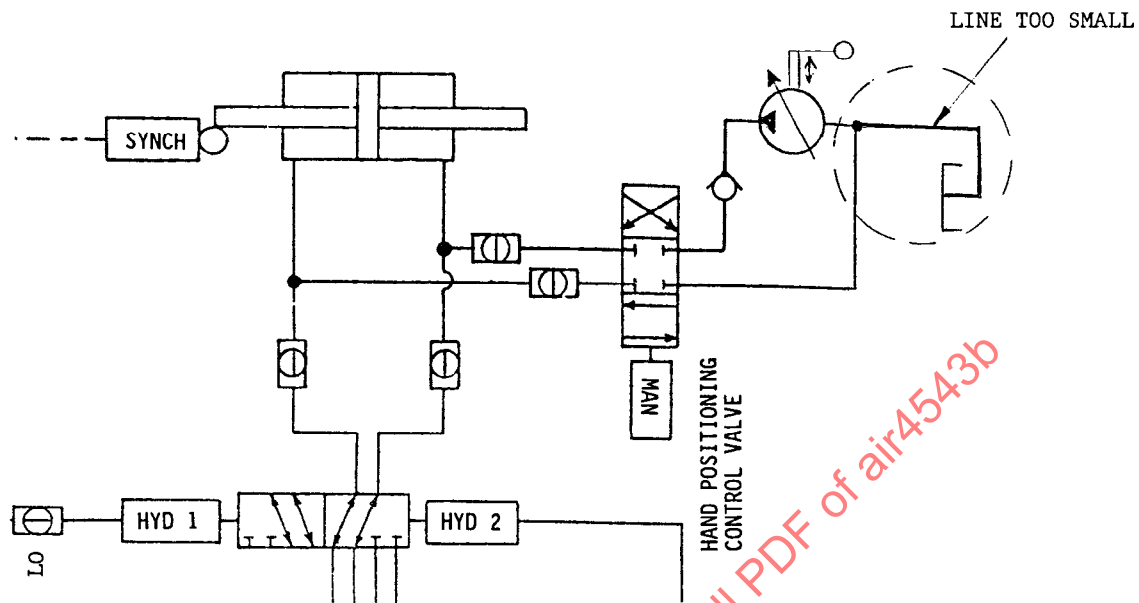
PROBLEM: Inadequately sized hand pump suction line causes unacceptable performance.

**SOLUTION:** The variable displacement hand pump discharges fluid as the pump handle is stroked in each direction. However, analysis indicated that the pump takes suction only when the pump is stroked in one direction. As a result, considerable flow is required from the unpressurized reservoir during the suction stroke even though the cylinder is balanced (equal volume for each direction of travel). The diameter of the make-up line from the reservoir to the pump suction had been sized for minimal flow and had to be increased to obtain rated pump capacity.

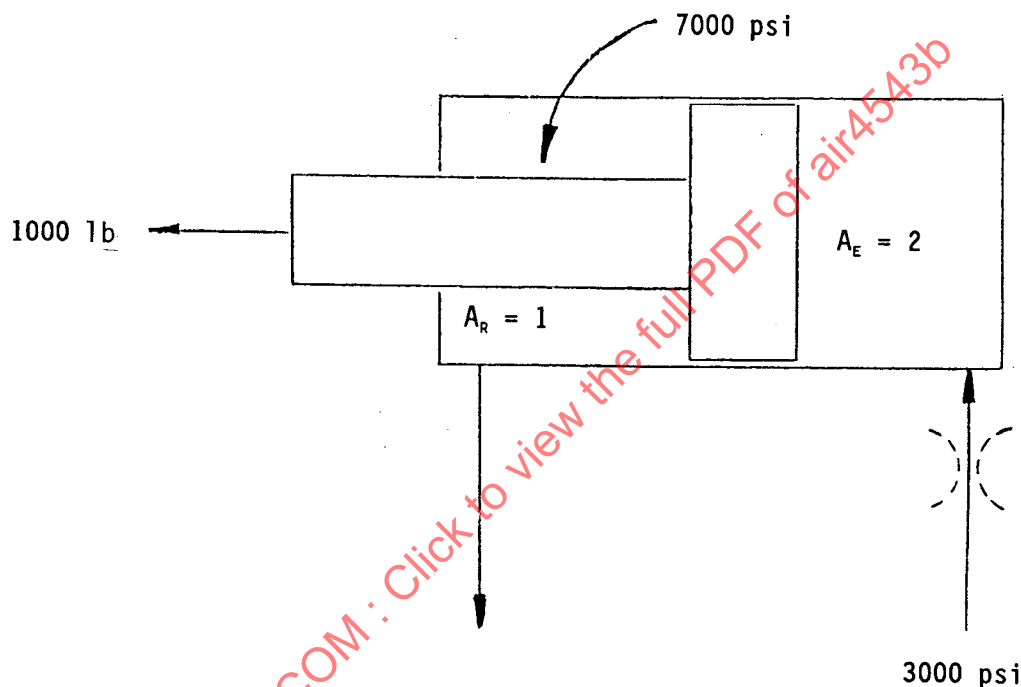
ISSUE: There have been many cases where designers failed to recognize the high pressure that can occur on the retract side of a cylinder due to pressure intensification and/or an aiding load.

SOLUTION: Include restrictor in the extend line so that the extend pressure is reduced to an acceptable level.

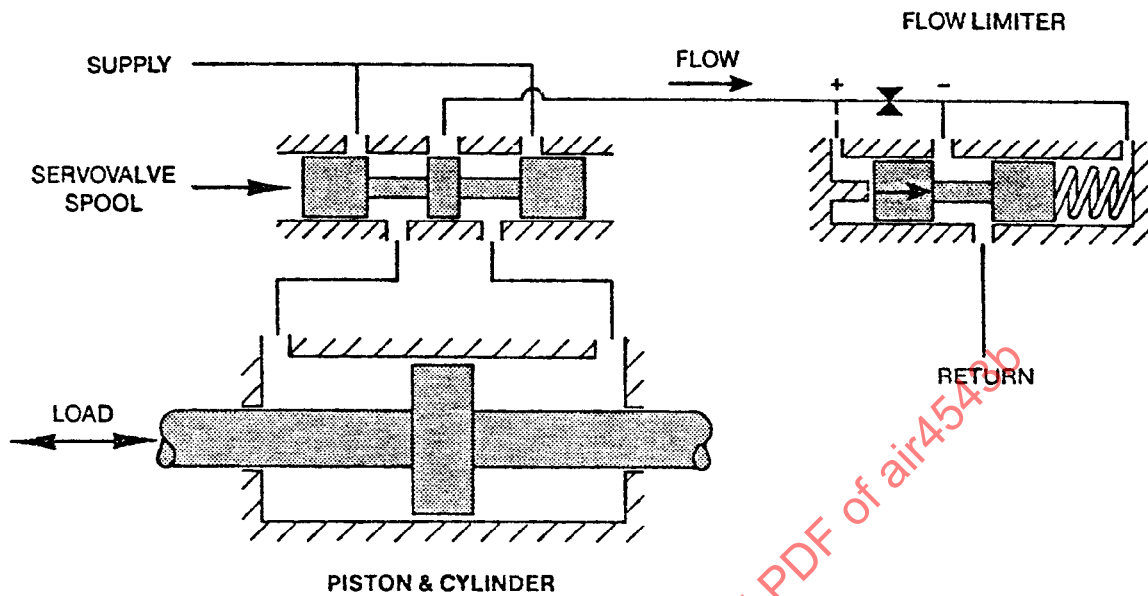
- During the countdown for the initial launch of the Gemini two-man space vehicle, the primary servo valve of the dual redundant thrust vector control actuator blew off the manifold.
- The actuator flow limiter used to restrict excessive thrust vector control rate caused high back pressure during engine start transient.
- The high impulse loads can create transient back pressure on the servo valve. Alternate configurations for limiting actuator velocity should be considered if impulse loads cannot be suppressed.

- A quick fix was to beef-up the servo valve body and mounting.
- A long-term solution has been to add cylinder bypass (pressure relief) valves to dissipate energy of hard engine/rocket motor starts.

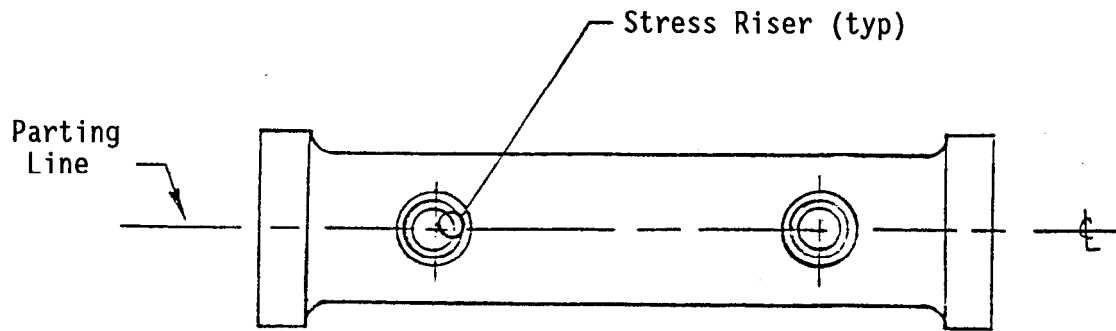
PROBLEM: Fatigue failures in cylinders with parting plane through ports.

ISSUE: The parting line placement on the cylinder centerline for "shallow draw" forging creates stress risers at the ports and at the thinnest section of the cylinder. This can result in fatigue failures or shortened life (see Illustration 1).

SOLUTION: Relocate the parting line off the cylinder centerline and completely off the ports (see Illustration 2).

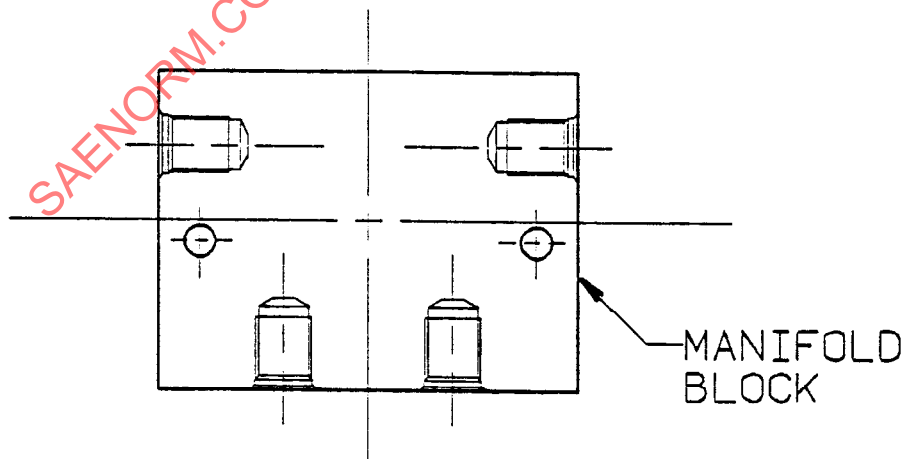
PROBLEM: Installed aileron actuator failed to operate.

ISSUE: No hydraulic oil was being delivered to the L/H aileron actuator. After extensive troubleshooting, it was found that a manifold block passage had not been drilled.

SOLUTION: Although the manifold had passed inspection it was decided to replace it. Afterwards the aileron worked.

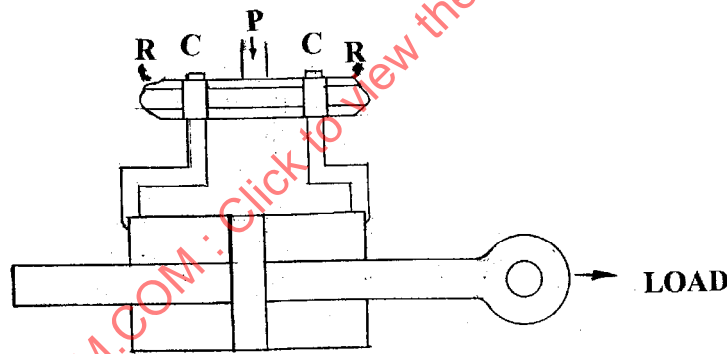
**PROBLEM:** Early pressure fatigue failures of fly by wire actuators.

**ISSUE:** Fly by wire servoactuator barrel and end closure pressure fatigue failures occurred in a very short period of use due to a combination of servovalve overlap conditions and continuous small movement command which kept the valve within the overlap region.

To meet low leakage requirements, the supplier provided valves with overlap - long overlap cylinder to return lands and shorter overlap pressure to cylinder lands, tending toward high "no load" null pressures. Combined with an aiding air load, the resisting cylinder pressure may reach a very high pressure value. For example: A constant 1500 lbf/in<sup>2</sup> (10 300 kPa) extend force pressure load could require the resisting cylinder chamber pressure to approach 4500 lbf/in<sup>2</sup> (31 000 kPa) in a 3000 lbf/in<sup>2</sup> (20 700 kPa) system when the valve is in the overlap region and the actuator is extending, depending on the ratio of the overlap lengths.

Combining this condition with small amplitude, low frequency computer generated commands while the aircraft is flying straight and level results in cylinder chamber pressure cycles in the resisting cylinder chamber approaching a 3000 lbf/in<sup>2</sup> (20 700 kPa) to 4500 lbf/in<sup>2</sup> (31 000 kPa) range while retracting and extending respectively. If the commands are continuous, even at low frequencies, a substantial number of high pressure cycles may be experienced in a short time even if there is virtually no load change.

- Minimize overlaps but specify overlap balance conditions if a low leakage is required.
- Insure, via very slow cycle looped cylinder pressure monitoring, that there is a good balance of pressure and return land overlaps if overlaps are substantial, i.e., that the cylinder pressure remains within an approximate  $(P + R)/2 \pm 500$  lbf/in<sup>2</sup> ( $\pm 3500$  kPa) range in the entire overlap region.
- It is important to know what the FCC is requiring the actuator to do.
- Minimize the frequency of small movement commands (system).

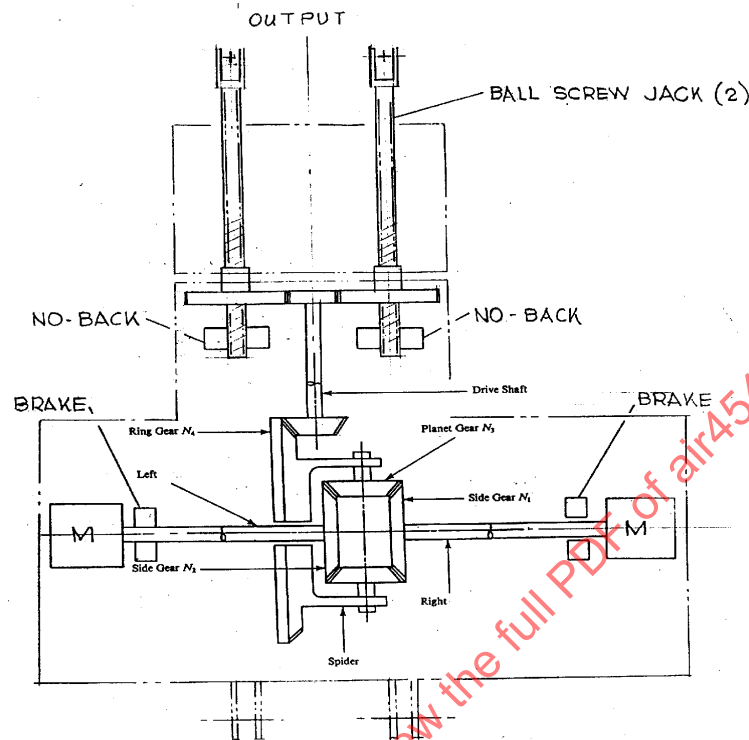
ISSUE: Redundancy is frequently employed in the attempt to meet safety and reliability requirements of flight control systems or components. In order to meet the safety requirements, latent failures are sometimes inadvertently incorporated into the design. The subsequent reliability analysis may not properly take into account the actual failure rate of the system or component. In the pitch trim actuator the failure of the mechanical no-backs was undetected because the electro-magnetic brakes at the motors prevented the output from being back driven even after failure of the no-backs. A subsequent failure (open) in the gear train caused the output to be back-driven (the ball screws are reversible) by the air loads at a high rate with no restraint except the inertia of the components.

**SOLUTION:** Carefully examine the component or system for latent failures. If found, the best solution is simply to alter the design and eliminate the latent failure mode. The next best approach is to properly take into account the exposure of the latent failure mode in determining the actual system failure rate. Hopefully the resultant net failure rate is acceptable for the application being considered. If not, a redesign is in order. Alternately, a reduction in the exposure time of the latent mode may be an option.
