# AEROSPACE RECOMMENDED PRACTICE

ARP6307™

## New and Newly Retreaded Tire Appearance

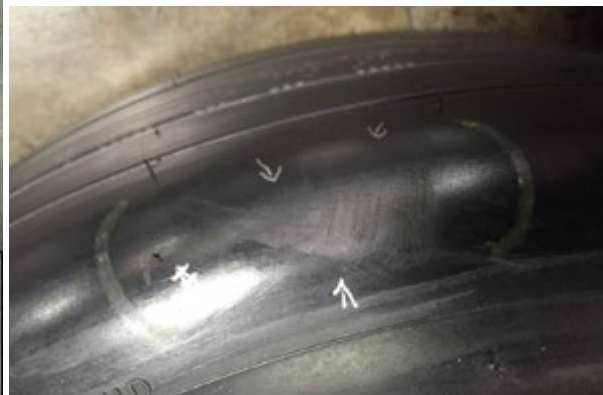
Abrasions on the tire can be attributed to tires rubbing against each other, the shipping container wall, or storage facilities floor/walls.

Abrasion examples - These tires are acceptable for use.

- Tire is acceptable for use provided fabric reinforcements are not visible and providing the required tire identification markings (load/speed ratings, part number, serial number, ply rating, (E)TSO-C62 marking, etc.) are still clearly legible.

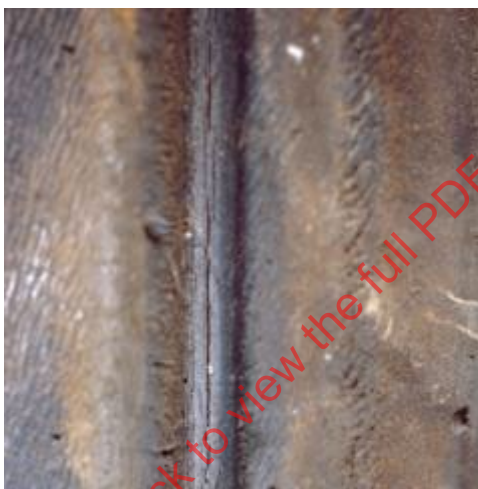
**Figure 10**

Cracks may be caused by the molding process and improper storage (ozone attack).

Crack example - This tire is acceptable for use (photo is of a used tire).

- Tire is acceptable for use unless the fabric reinforcements are exposed.

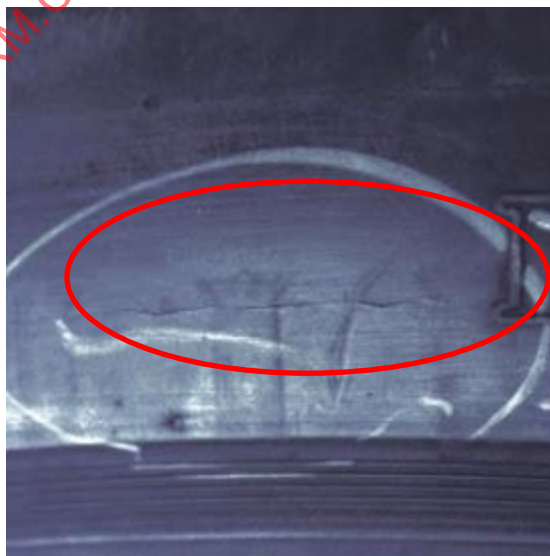
**Figure 11**

Crack example - This tire may be used.
