SERVICE DAMAGE LIMITS FOR AIRCRAFT HYDRAULIC TUBING

PREPARED BY  
SAE SUBCOMMITTEE G-3E,  
AEROSPACE TUBING INSTALLATIONS,  
OF SAE COMMITTEE G-3, AEROSPACE  
FITTINGS, HOSE & TUBING  
ASSEMBLIES

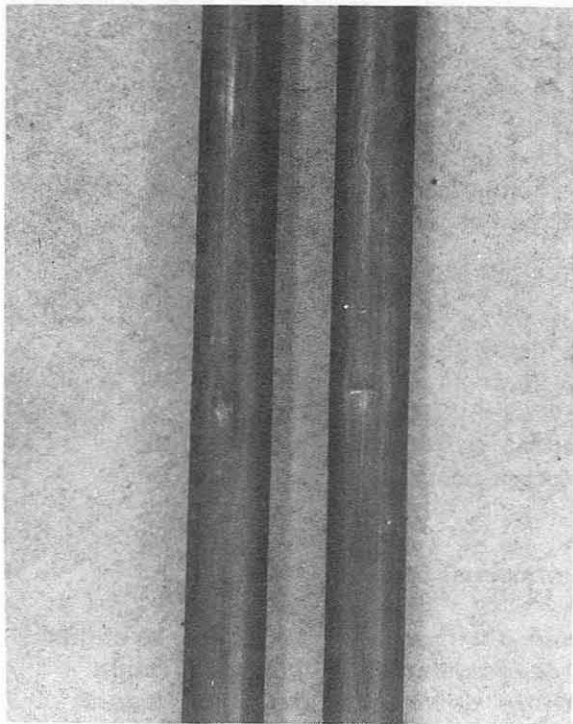
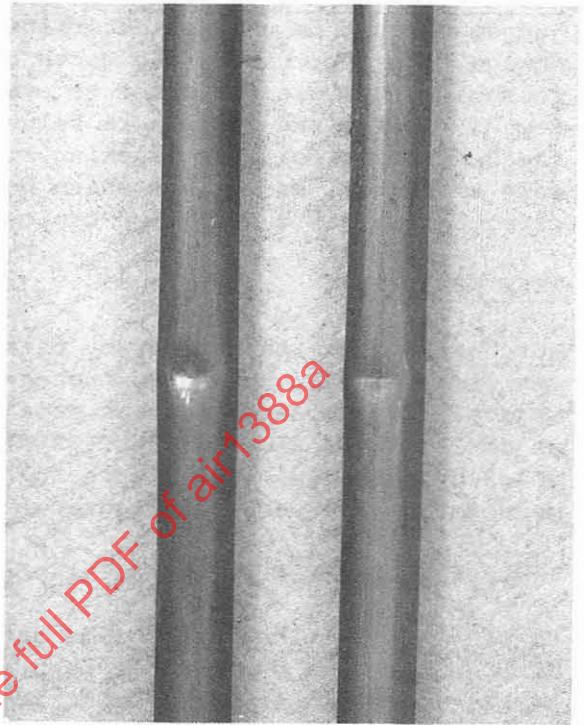
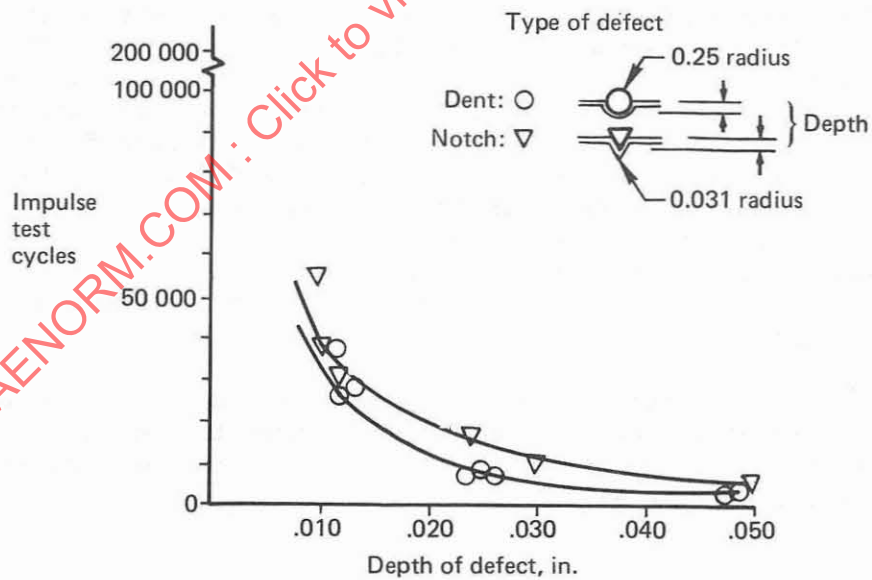
FIGURE 1. IMPULSE TEST PERFORMANCE OF 3/8 BY 0.018 3Al-2.5V CW TITANIUM TUBING WITH VARIOUS DEFECTS

Dent and Notch 0.010 In. Deep

Dent and Notch 0.050 In. Deep

Notches: It may be noteworthy that the round dent was found to be more detrimental than the sharp, notch-type dent, such as might be caused by a sharp object. This observation was made for MIL-T-7081 6061T6 aluminum tubing as well as for AMS 5561 21Cr-6Ni-9Mn (CRES), AMS 4944 3Al-2.5V (CW), and AMS 4943 3Al-2.5V annealed, (see Figure 13). Typical comparisons of impulse test performance are shown in Figures 1 and 2.

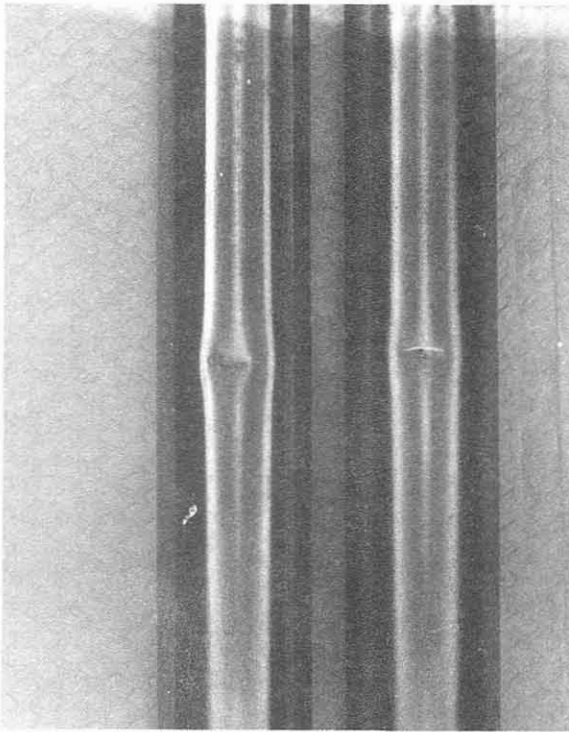
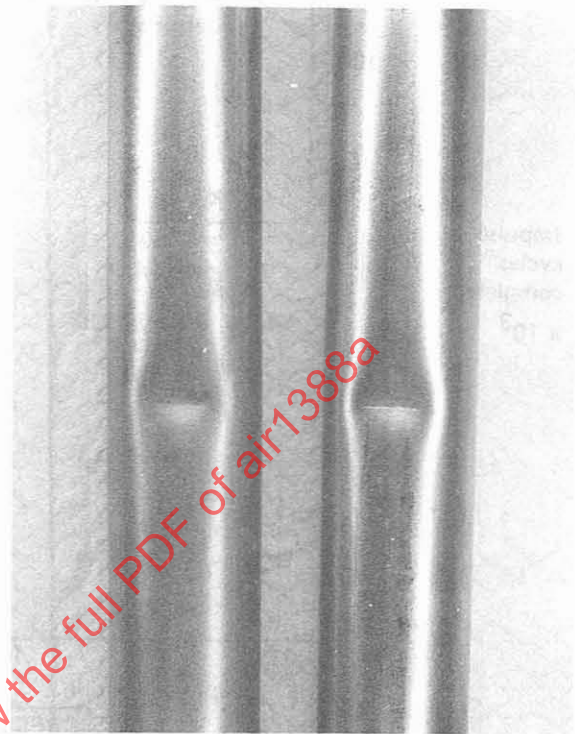
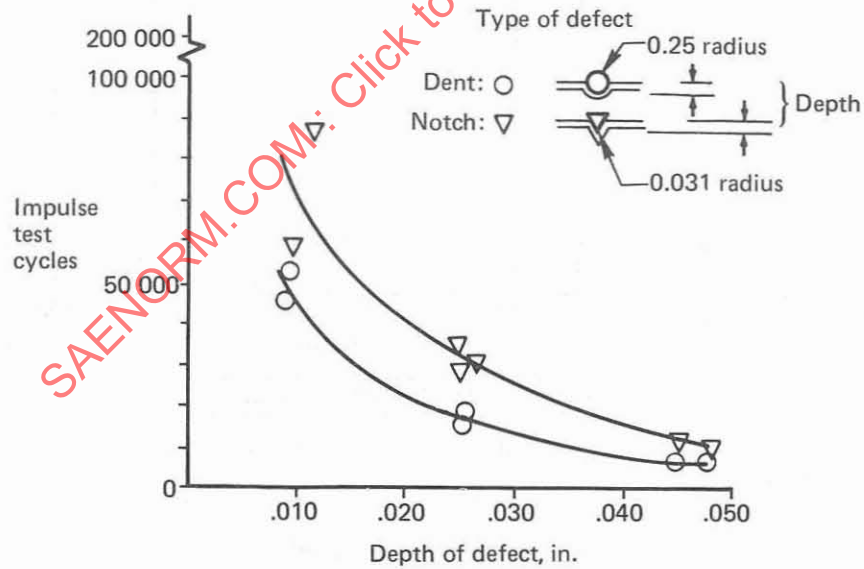
FIGURE 2. IMPULSE TEST PERFORMANCE OF 3/4 BY 0.039 3Al-2.5V CW TITANIUM TUBING WITH VARIOUS DEFECTS

Dent and Notch 0.025 In. Deep

Dent and Notch 0.050 In. Deep

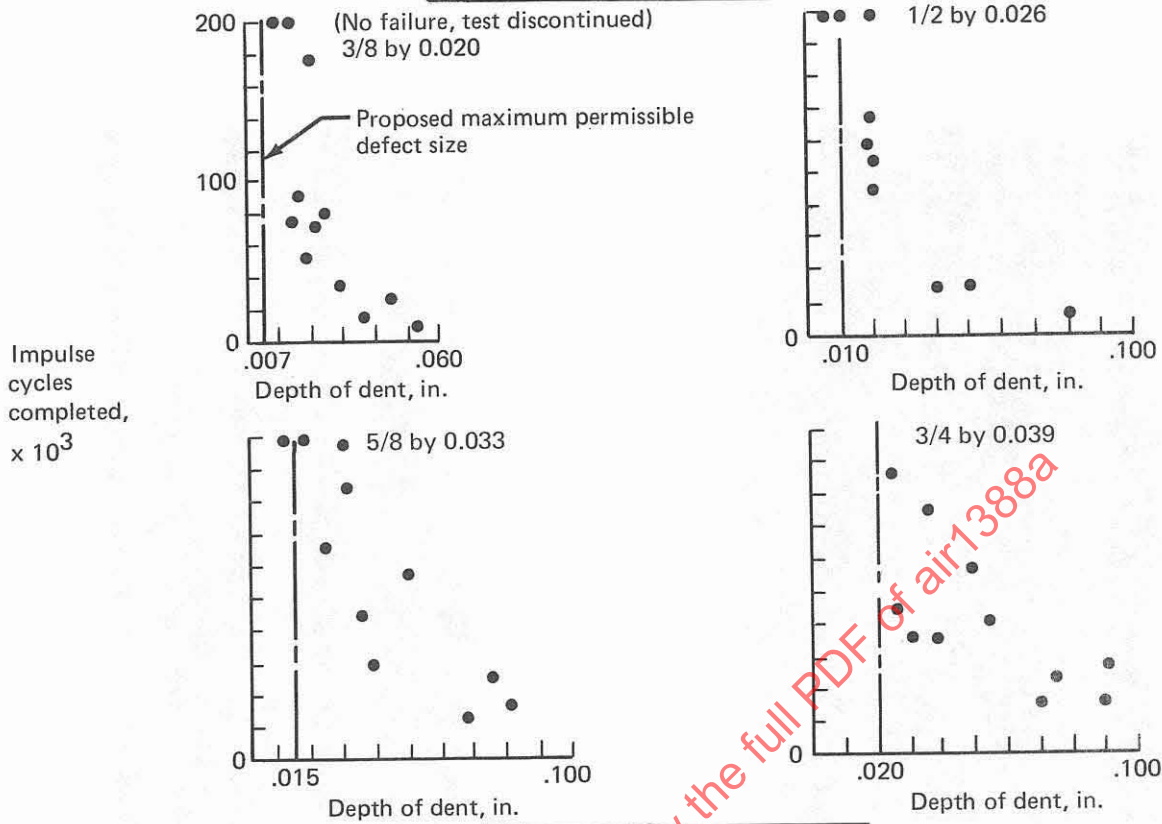
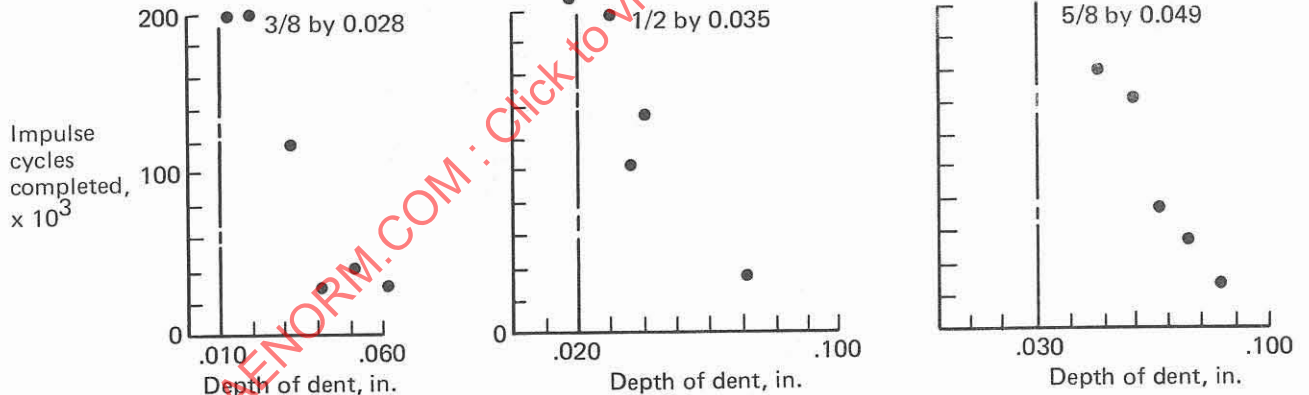
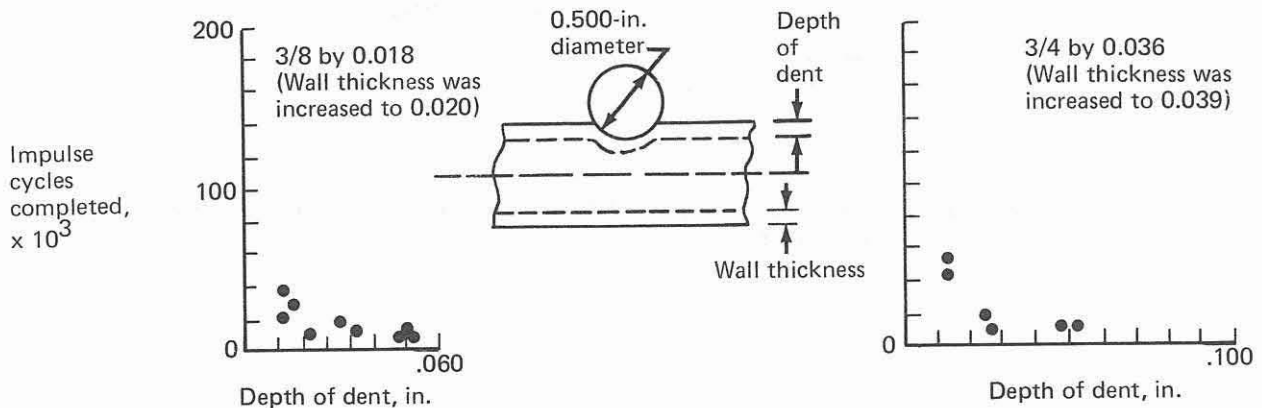
FIGURE 3. IMPULSE TEST DATA, DENTED TUBING, 3000-PSI SYSTEM

CRES 21Cr-6Ni-9Mn, AMS 5561 Type II

CRES 304 1/8 Hard, MIL-T-6845

Titanium 3Al-2.5V CW BMS 7-234

Chafing and Denting Depth: The data in Figures 3 through 15 indicate a sudden drop in the test performance when a critical defect depth is reached, thus permitting a conservative selection of acceptable defect levels. Figures 3 through 12 contain a compilation of impulse test data for 21Cr-6Ni-9Mn, 304 1/8 hard CRES, 3Al-2.5V CW 3000 psi, and 3Al-2.5V annealed 3000 psi tubing, having dents, notches, and chafes of varying depth. They illustrate the basis for the permissible limits recommended in Table 1, and for estimating the defect limits in tubing sizes that were not tested. Figures 13 and 14 indicate that dents and chafes severely reduce the impulse life of aluminum return line tubing in the larger sizes. Figures 11 and 12 contains the test results for chafing damage in 21-6-9 3000 psi hydraulic tubing. No burst tests for chafed 304 1/8H tubing were conducted; instead, the chafing limits are recommended for 21Cr-6Ni-9Mn were calculated to be more than safe for use with 304 1/8 hard tubing also. The effect of chafing and denting on 3Al-2.5V CW tubing was tested in all sizes used in 3000 psi systems. Figure 15 compares the effect of tube size and defect type on 3Al-2.5V titanium tubing.

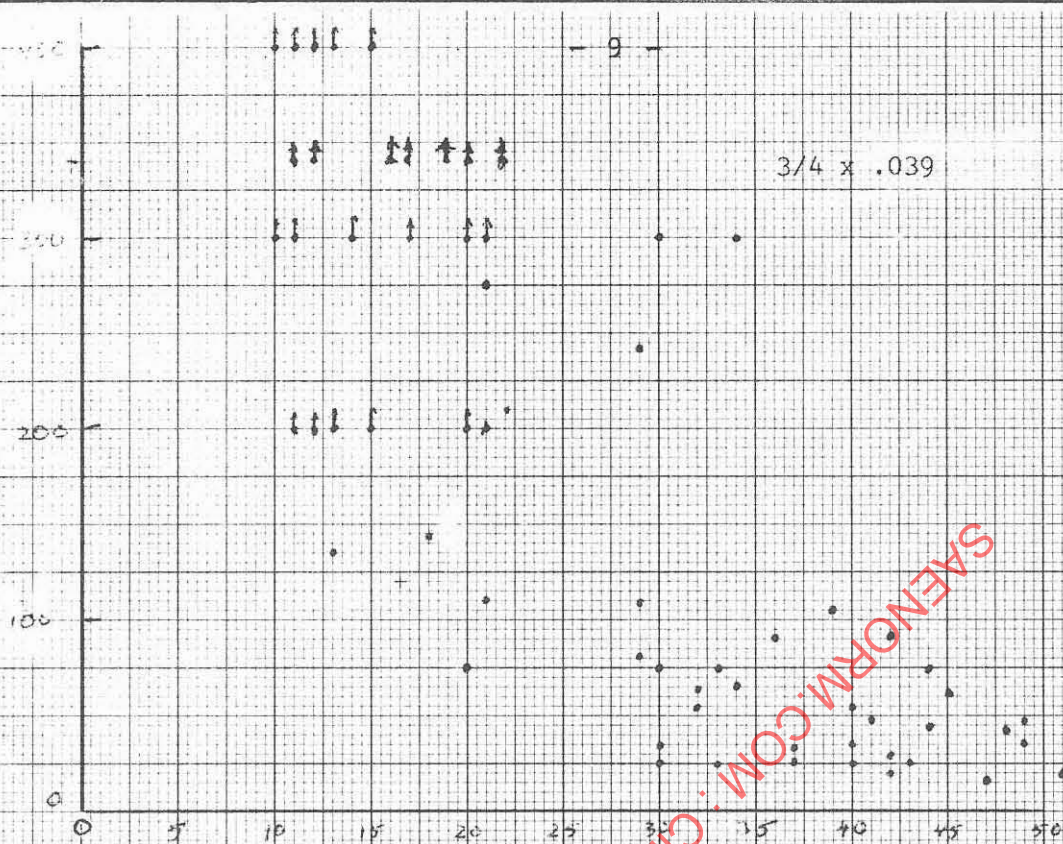
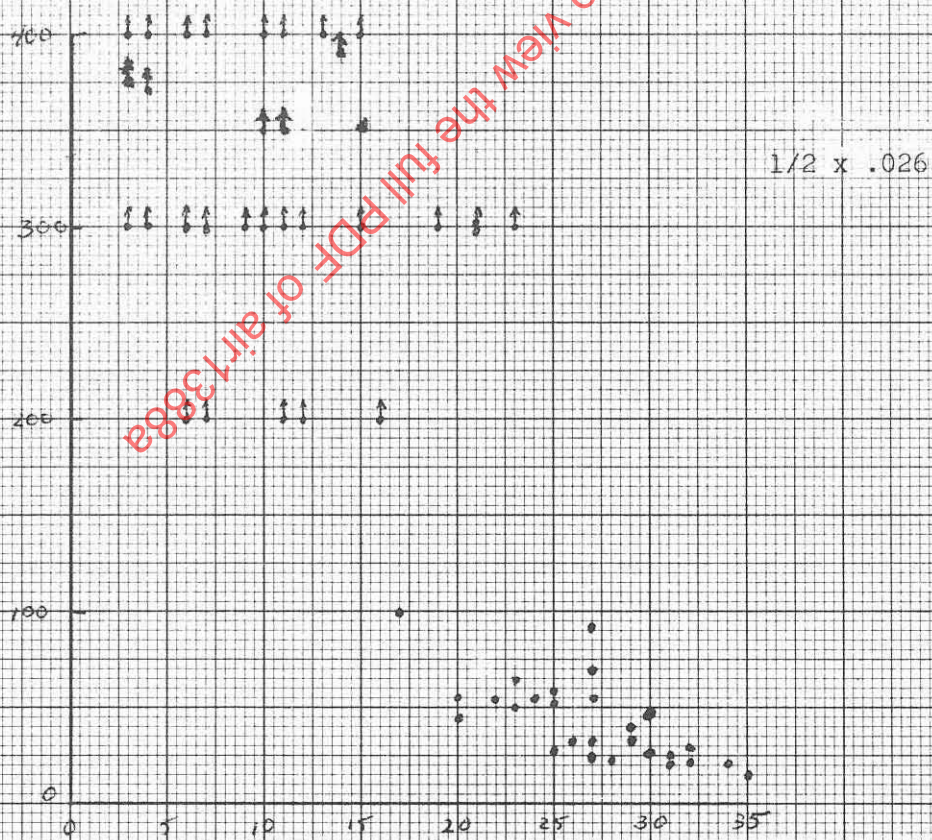
FIGURE 4 Impulse Test Data, Dented Tubing, Ti-3Al-2.5CW Tubing

IMPULSE CYCLES (X1000)

Depth of Dent (In x .001)
