# AEROSPACE RECOMMENDED PRACTICE

**ARP1658™****REV. C**

Hose Assemblies, Installed, Visual Inspection Guide for

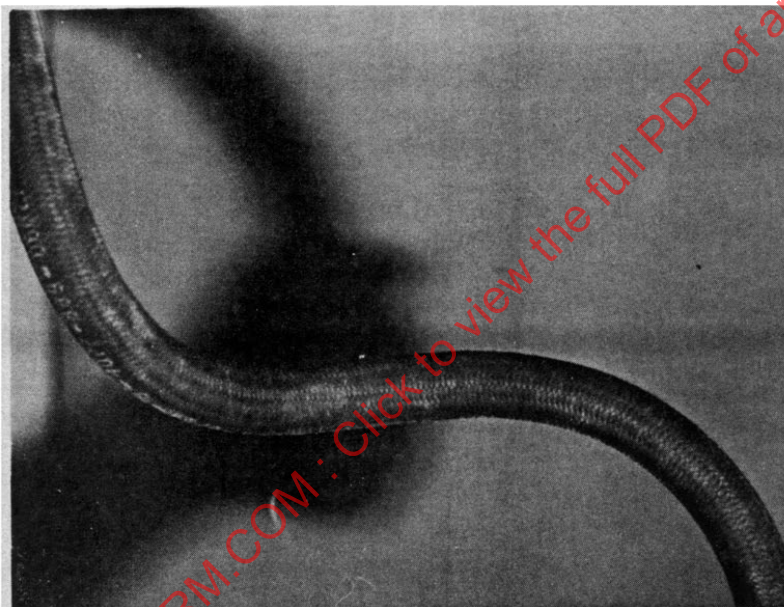
**Figure 24 - Twist - minor and major  
medium-pressure rubber hose with fabric cover  
(MIL-H-8794)**

Minor: On all spirally reinforced hose.

Major: If wires are broken or liner cannot be rounded out.
