# AEROSPACE RECOMMENDED PRACTICE

ARP6225

## Aircraft Tire Inspection - In-Service Removal Criteria

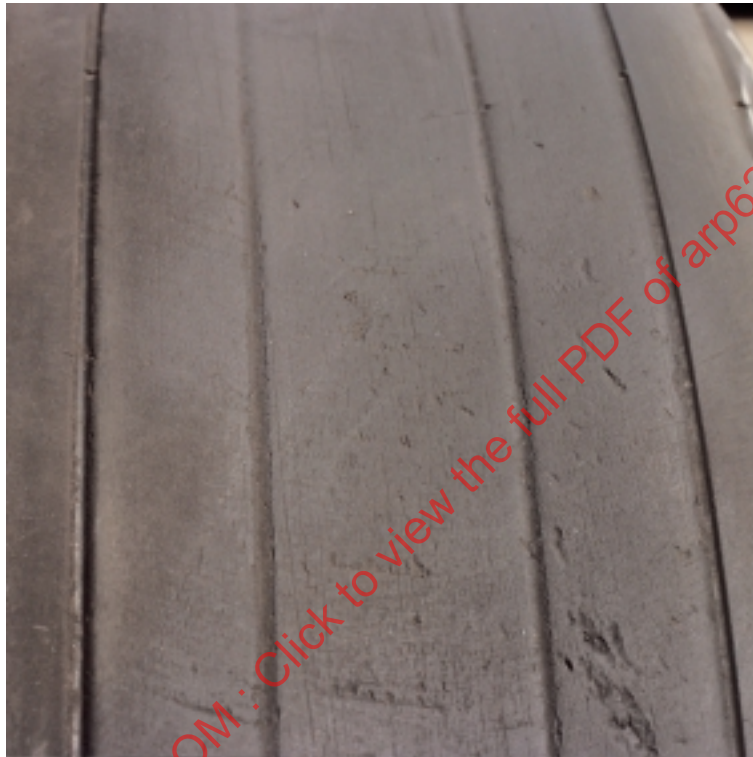
FIGURE 3 - NORMAL WEAR

An even tread wear indicates that the tire has been properly maintained during its service life.

**NORMAL REMOVAL WEAR LIMIT:** When the wear level reaches the bottom of any groove at one point or up to 1/8 of the circumference (Figure 3):

| <b><u>TREAD WEAR CRITERIA</u></b> | | |
|---|---|---|
| <b><u>Normal Wear</u></b> | An even tread wear indicates that the tire has been properly maintained during its service life. | NORMAL REMOVAL WEAR LIMIT: When the wear level reaches the bottom of any groove at one point or up to 1/8 of the circumference (Figures 3 and 4).<br>RETURN TO BASE WEAR LIMIT: If either the protector ply (radial) or the reinforcing ply (bias) is exposed at any location over the tread surface (Figure 5). |

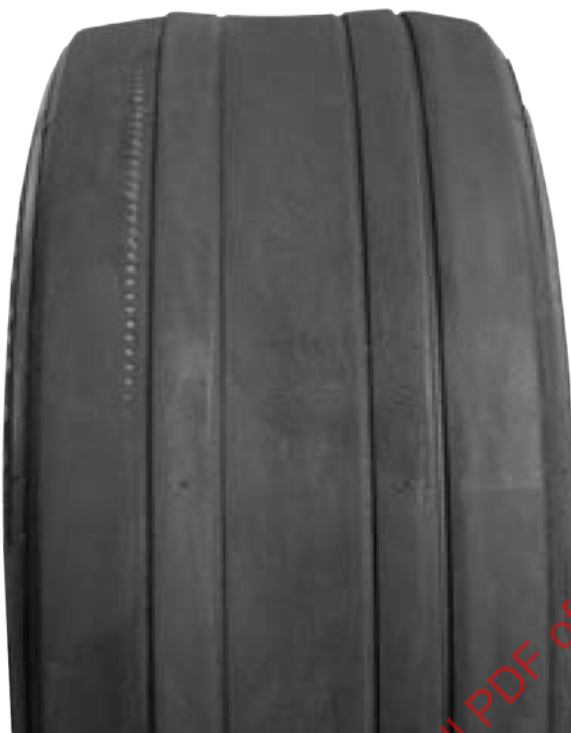
FIGURE 4 - SHOULDER WEAR

**RETURN TO BASE WEAR LIMIT:** If either the protector ply (radial) or the reinforcing ply (bias) is exposed at any location over the tread surface (Figure 4 or 5).

Under-inflation can lead to excessive tread shoulder wear. It will lead to high tire deflection and subsequent heat build-up which may result in severe tire damage. The cause for operating underinflated should be investigated by the operator and corrective actions taken.

**REMOVAL LIMIT:** Tires with uneven wear should be removed from the aircraft if the wear limits (defined under normal wear) are reached.

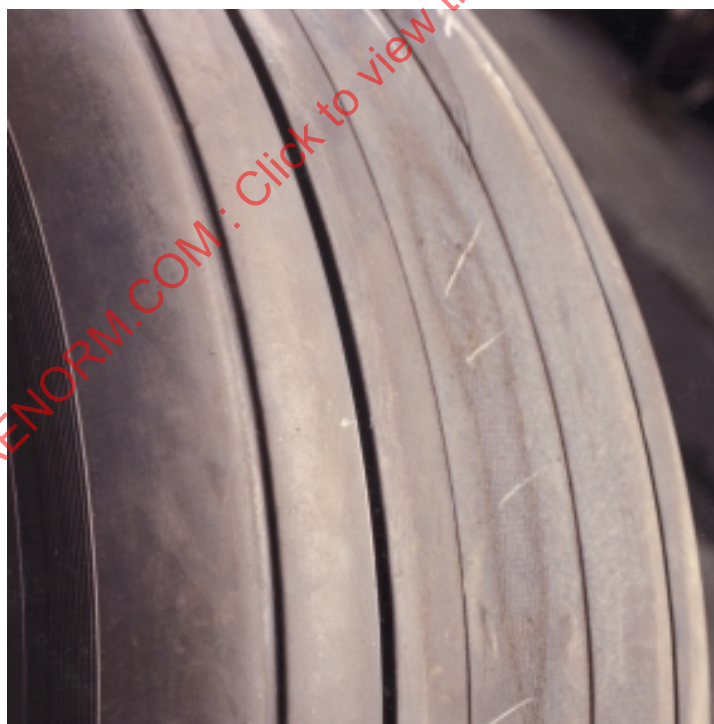
FIGURE 5 - CENTER WEAR

Over-inflation can accelerate the center tread wear, reduce tire traction, reduce the number of landings per tread and make the tire more susceptible to cutting and foreign object damage (FOD).

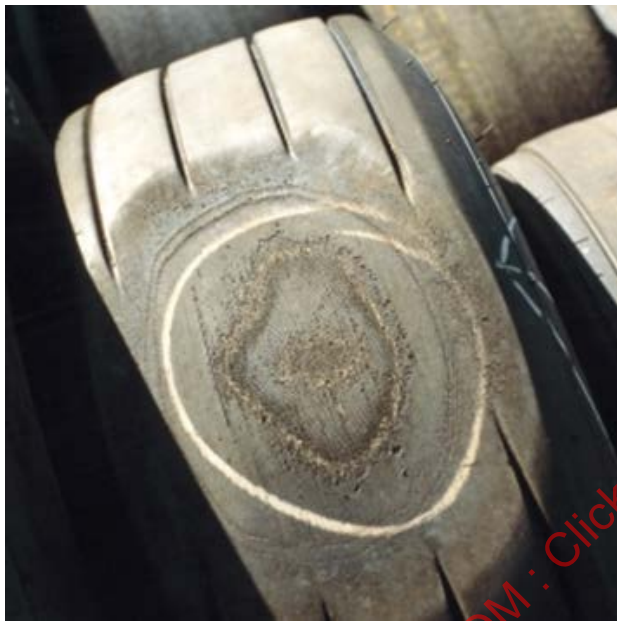
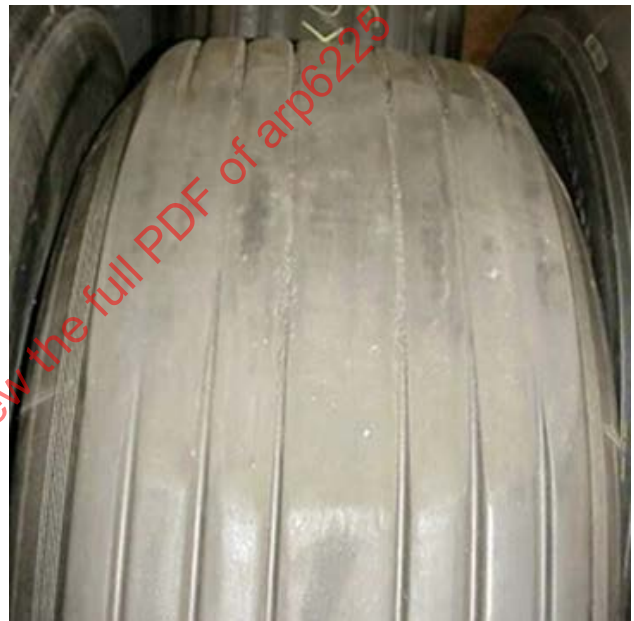
FIGURE 7 - FLAT SPOT

Tread flat spot or severe tread rubber abrasion results from steering maneuvers prior to aircraft rolling, or the locking of the wheel during braking or touchdown. Flat spotting due to cold temperature or prolonged parking is not a condition for tire removal.

1. the flat spot damage exceeds the wear removal criteria of 5.1; or
2. the flat spot contributes to an unacceptable vibration condition (Figure 7).

Locked wheel tire flat spot

Typical tire flat spot

| <b><u>TREAD WEAR CRITERIA</u></b> | | |
|---|---|---|
| <b><u>Flat Spots</u></b> | Tread flat spot or severe tread rubber abrasion results from steering maneuvers prior to aircraft rolling, or the locking of the wheel during braking or touchdown. Flat spotting due to cold temperature or prolonged parking is not a condition for tire removal. | The tire should be removed from the aircraft when:<br>1) the flat spot damage exceeds the wear removal criteria of 5.1; or<br>2) the flat spot contributes to an unacceptable vibration condition (Figure 7). |

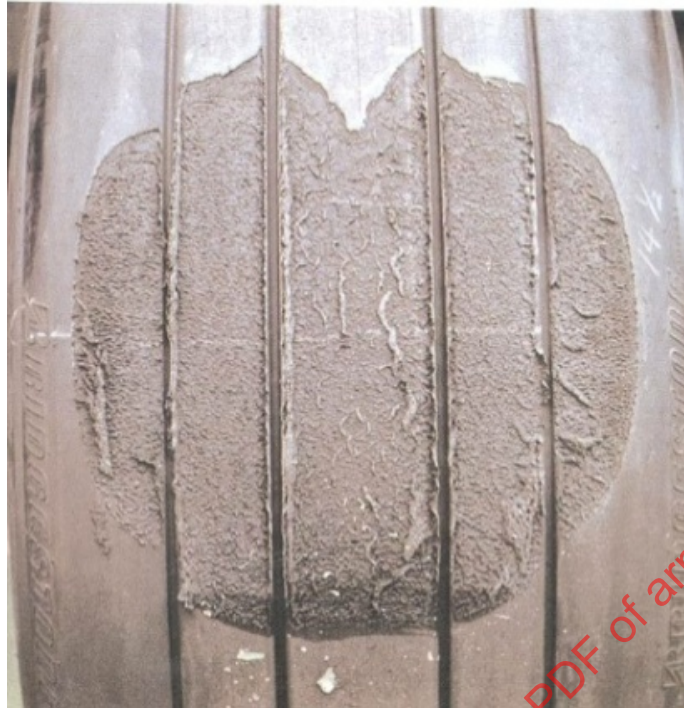
FIGURE 8 - TREAD RUBBER REVERSION

Tread rubber reversion is generally caused by wheel locking on wet or ice covered runways. The affected area is similar in shape to a flat spot (oval), but the rubber appears to be melted (Figure 8).

1. the reversion flat spot damage exceeds the wear removal criteria of 5.1; or
2. an unacceptable vibration condition is experienced.

| <b><u>TREAD WEAR CRITERIA</u></b> | | |
|---|---|---|
| <b><u>Tread Rubber Reversion</u></b> | Tread rubber reversion is generally caused by wheel locking on wet or ice covered runways. The affected area is similar in shape to a flat spot (oval), but the rubber appears to be melted (Figure 8). | The tire should be removed from the aircraft when:<br>1) the reversion flat spot damage exceeds the wear removal criteria of 5.1; or<br>2) an unacceptable vibration condition is experienced. |

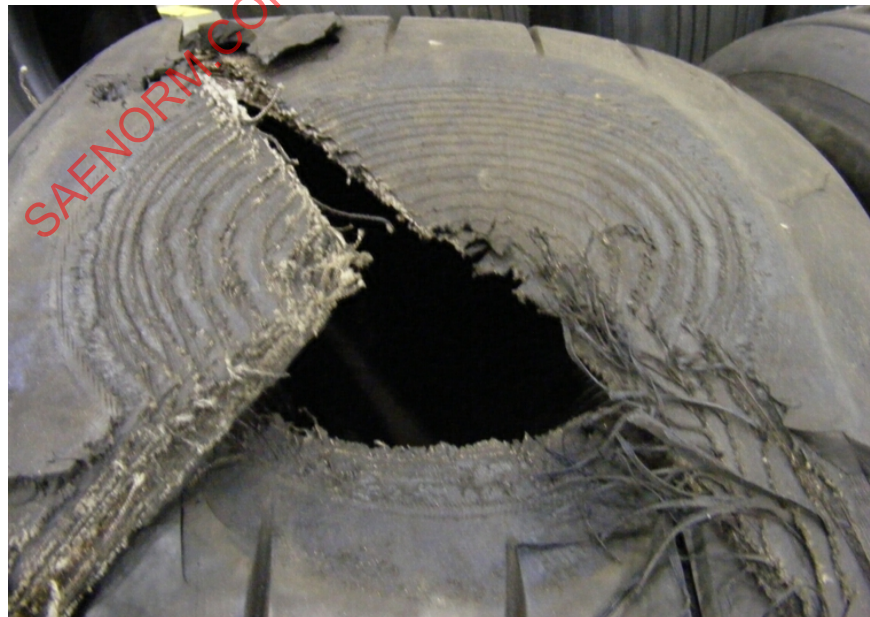
FIGURE 9 - SKID THROUGH

Skid-through burst results from the locking of the wheel. In this case, the tire experiences either a loss of inflation pressure or an explosive blowout (Figure 9).

REMOVAL LIMIT: Both the failed tire and axle mate tire should be removed from the aircraft, the burst tire marked as "scrap" and the axle mate tire marked with the removal reason ("Mate to Flat"). The skid through tire can be scrapped locally but the mate to flat tire should be returned to the tire manufacturer or retreader.

| <b><u>TREAD WEAR CRITERIA</u></b> | | |
|---|---|---|
| <b><u>Skid-Through Burst</u></b> | Skid-through burst results from the locking of the wheel. In this case, the tire experiences either a loss of inflation pressure or an explosive blowout. (Figure 9). | Both the failed tire and axle mate tire should be removed from the aircraft, the burst tire marked as "scrap" and the axle mate tire marked with the removal reason ("Mate to Flat"). The skid through tire can be scrapped locally but the mate to flat tire should be returned to the tire manufacturer or retreader. |

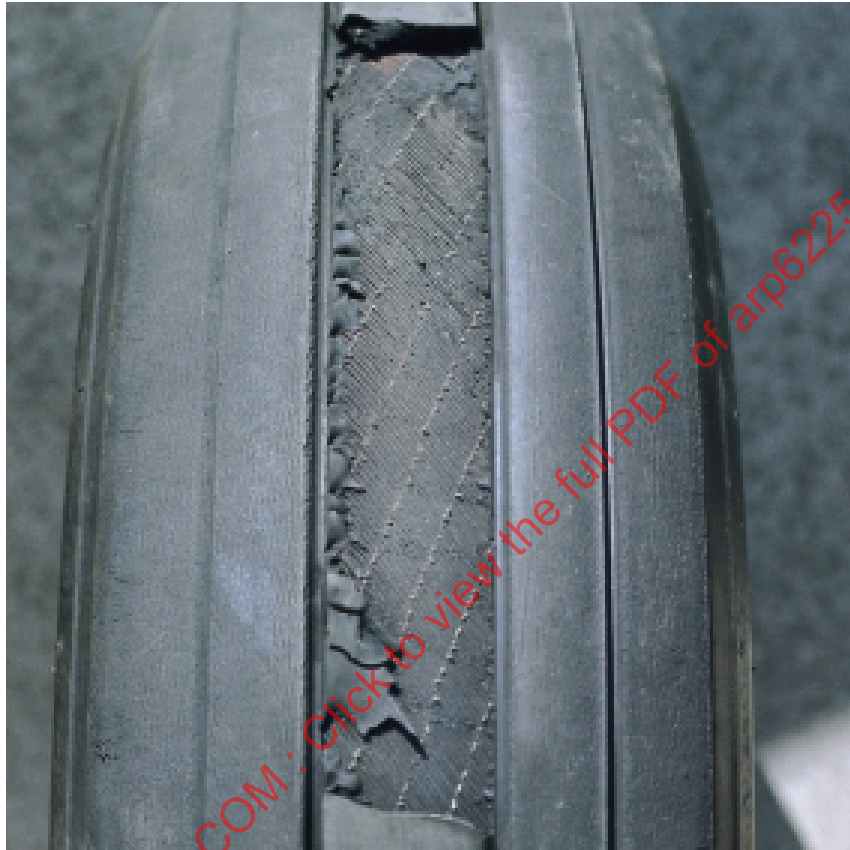
FIGURE 10 - PEELED RIB

A peeled rib usually starts with a cut or damage in the tread and results in a circumferential delamination of the tread rib away from the tire casing, typically with no loss of reinforcing plies (Figure 10) or tire pressure.

**REMOVAL LIMIT:** The tire should be removed immediately from service when the peeled section, regardless of length, is exposing fabric or has fully detached. Pieces from the tread should be requested from airport authorities and returned to the home base for potential analysis by the tire supplier.

| <b><u>Peeled Rib</u></b> | A peeled rib usually starts with a cut or damage in the tread and results in a circumferential delamination of the tread rib away from the tire casing, typically with no loss of reinforcing plies (Figure 10) or tire pressure. | The tire should be removed immediately from service when the peeled section, regardless of length, is exposing fabric or has fully detached. Pieces from the tread should be requested from airport authorities and returned to the home base for potential analysis by the tire supplier. |

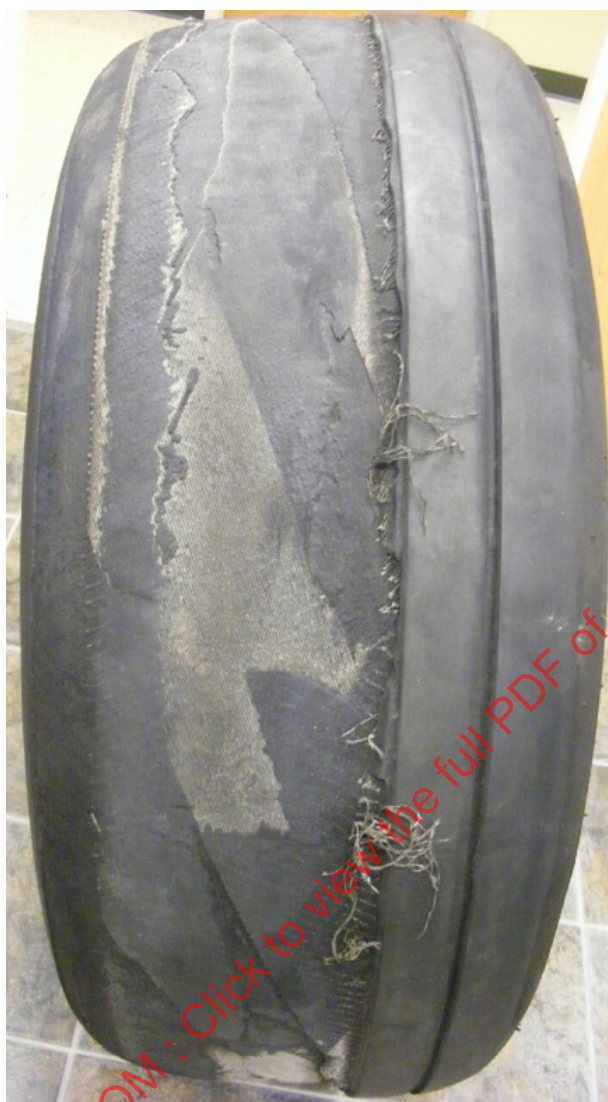
FIGURE 11 - THROWN TREAD

**REMOVAL LIMIT:** The tire should be removed immediately from service. Pieces from the tread should be requested from airport authorities and returned to the home base for potential analysis by the tire supplier. If the damaged tire is not inflated due to a loss of inflation pressure, then the axle mate should be removed also.

| <b><u>Thrown Tread</u></b> | A thrown tread on an inflated tire is a partial or complete loss of the tread down to the casing plies or tread reinforcing plies/protector ply (Figure 11). | The tire should be removed immediately from service. Pieces from the tread should be requested from airport authorities and returned to the home base for potential analysis by the tire supplier. If the damaged tire is not inflated due to a loss of inflation pressure, then the axle mate should be removed also. If the tire is still inflated after the aircraft is parked, record the tire pressure after it has cooled down (allow 3 hours). |

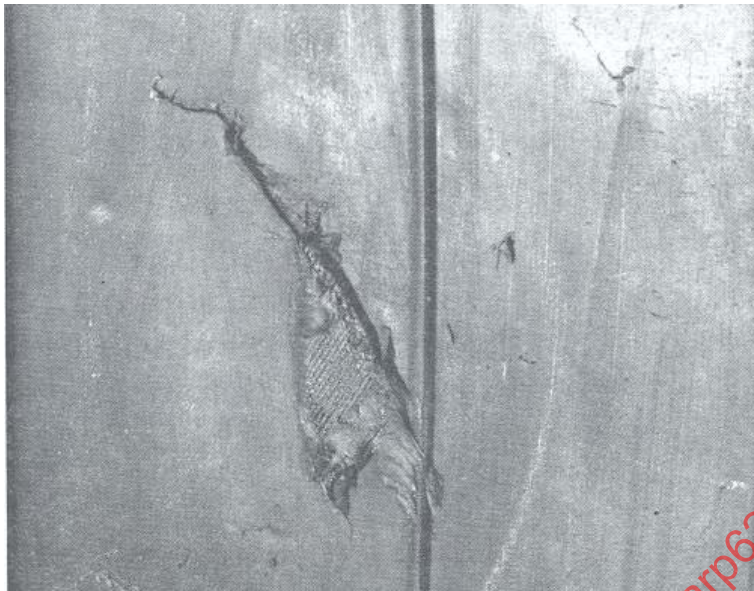
FIGURE 12 - TREAD CUT

Foreign objects that are present on runways, taxiways and parking areas can cause cuts to the tires (Figure 12).

- the cut exposes or penetrates reinforcing ply (bias tire) or protector ply (radial tire), or
- the cut or damage severs or extends across a tread rib, or
- undercutting occurs at the base of any tread rib cut

| <b><u>Tread Cuts</u></b> | Foreign objects that are present on runways, taxiways and parking areas can cause cuts to the tires (Figure 12). | Tire should be removed immediately from the aircraft if: <ul style="list-style-type: none"> <li>the cut exposes or penetrates reinforcing ply (bias tire) or protector ply (radial tire), or</li> <li>the cut or damage severs or extends across a tread rib, or</li> <li>undercutting occurs at the base of any tread rib cut</li> </ul> |

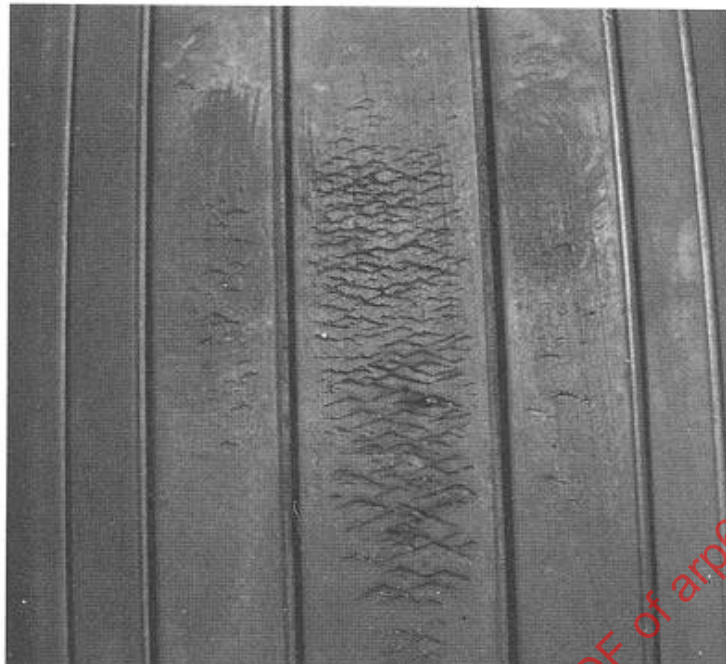
FIGURE 13 - CHEVRON CUTTING

Chevron cutting is tread damage (small z-, s- or v-shaped tears) caused by touchdown, running and/or braking on cross-grooved runways (Figure 13). Chevron cutting is a condition of the tread rubber only.

- The tread cut criteria are reached, or
- The tread reinforcing ply (bias tire) or protector ply (radial tire) is exposed for more than 1.0 square inch (6.45 cm<sup>2</sup>), or
- The cutting involves the full width of any one of the tread ribs

| <b><u>Chevron Cutting</u></b> | Chevron cutting is tread damage (small z-, s- or v-shaped tears) caused by touchdown, running and/or braking on cross-grooved runways (Figure 13). Chevron cutting is a condition of the tread rubber only. | Tire should be removed from aircraft if: <ul style="list-style-type: none"> <li>The tread cut criteria are reached, or</li> <li>The tread reinforcing ply (bias tire) or protector ply (radial tire) is exposed for more than 1.0 square inch (6.45 cm<sup>2</sup>), or</li> <li>The cutting involves the full width of any one of the tread ribs</li> </ul> |

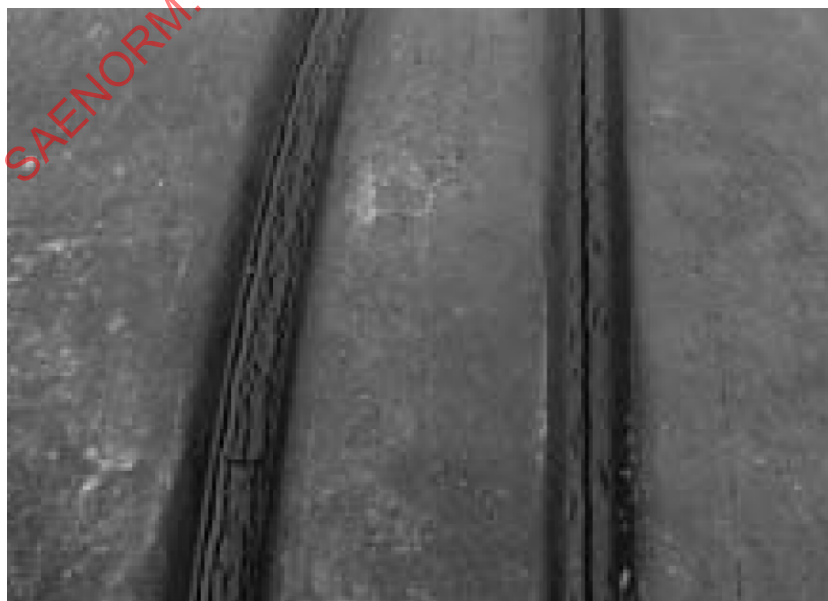
FIGURE 14 - GROOVE CRACKING

Groove cracking may result from ozone attack of the rubber or excessive flexing of the groove bottoms as a result of insufficient inflation of the tire. These cracks occur along the bottom of tread grooves (Figure 14).

- groove cracking exposes the reinforcing ply (bias tire) or the protector ply (radial tire) for more than 0.25 inch (6.35 mm) circumferentially in length.
- groove cracking has led to undercutting of the adjacent rib by more than 0.25 inch (6.35 mm).

| <b><u>Groove Cracking</u></b> | Groove cracking may result from ozone attack of the rubber or excessive flexing of the groove bottoms as a result of insufficient inflation of the tire. These cracks occur along the bottom of tread grooves (Figure 14). | The tire should be removed immediately from the aircraft if: <ul style="list-style-type: none"> <li>groove cracking exposes the reinforcing ply (bias tire) or the protector ply (radial tire) for more than 0.25 inch (6.35 mm) circumferentially in length.</li> <li>groove cracking has led to undercutting of the adjacent rib by more than 0.25 inch (6.35 mm).</li> </ul> |

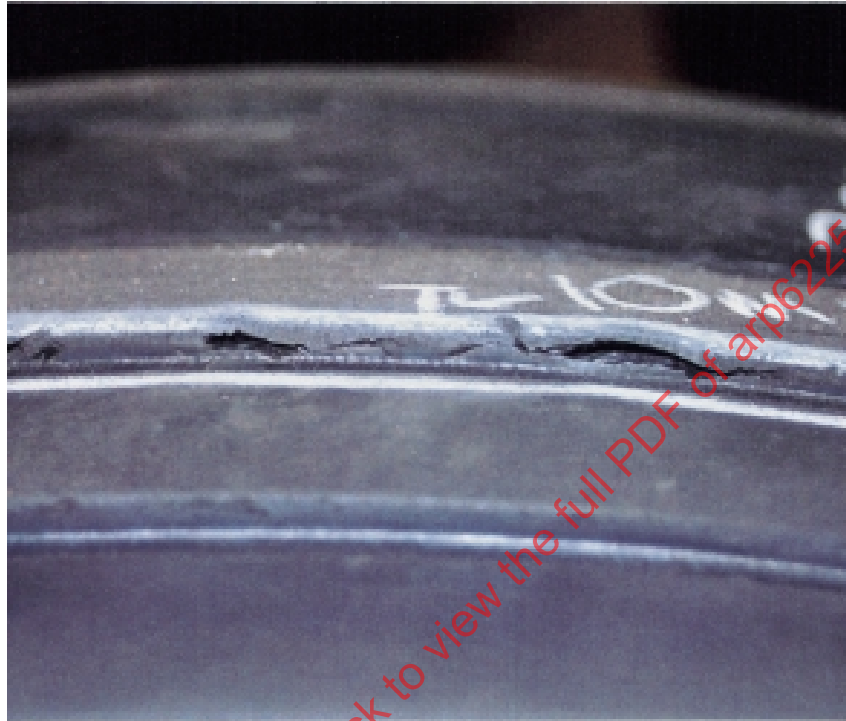
FIGURE 15 - RIB UNDERCUTTING

Rib undercutting can be an extension of groove cracking progressing under a tread rib or develop as a break in the groove wall extending under the rib. This can lead to tread chunking, peeled rib, or thrown tread (Figure 15).

**REMOVAL LIMIT:** The tire should be removed immediately from the aircraft if undercutting extends more than 0.25 inch (6.35 mm) under the tread rib.

| <b><u>Rib Undercutting</u></b> | Rib undercutting can be an extension of groove cracking progressing under a tread rib or develop as a break in the groove wall extending under the rib. This can lead to tread chunking, peeled rib, or thrown tread (Figure 15). | The tire should be removed immediately from the aircraft if undercutting extends more than 0.25 inch (6.35 mm) under the tread rib. |

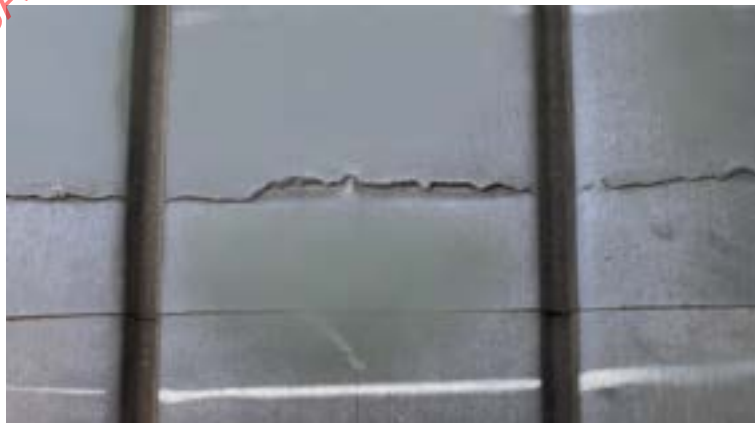
FIGURE 16 - OPEN TREAD SPLICE

An open tread splice is a crack in the tread rubber where the manufacturing joint or splice separates in a radial direction across the tread ribs (Figure 16).

**REMOVAL LIMIT:** The tire having this defect should be removed immediately from the aircraft.

| <b><u>Open Tread Splice</u></b> | An open tread splice is a crack in the tread rubber where the manufacturing joint or splice separates in a radial direction across the tread ribs (Figure 16). | The tire having this defect should be removed immediately from the aircraft. |
