# AEROSPACE INFORMATION REPORT

**AIR4092™****REV. B**

Investigation of PTFE "Melt" Phenomenon for High Pressure Hoses

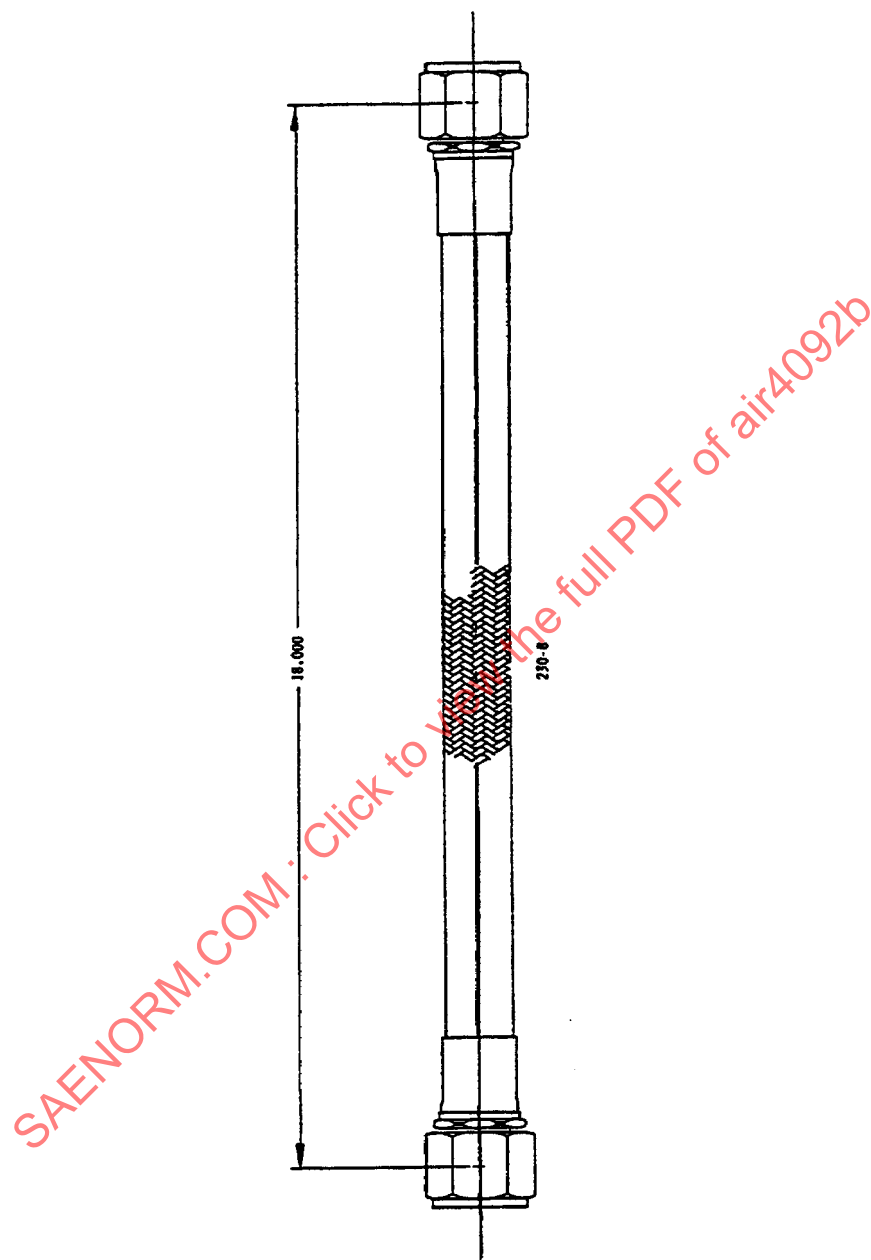
FIGURE 1

1. 18 in long, "230" Series, -8 size assemblies using straight to straight flared fittings. This is the lightweight, high pressure hose (see Figure 1). Conforms to AS1339 and AS115 (bare hose) and MIL-H-38360.
2. 18 in long assembly is identical to sample 1, except it has an integral silicone firesleeve (see Figure 2). Conforms to AS1339 and AS115 (integral firesleeve) 15 min and MIL-H-38360.
3. 18 in long assembly, "660" Series, -8 size assemblies using straight to straight flared fitting. This is the heavy duty spiral-wrapped, high pressure hose (see Figure 3). Conforms to AS 604 and AS 621 (bare hose) and MIL-H-38360.
