# AEROSPACE INFORMATION REPORT

**SAE AIR4543**

## AEROSPACE HYDRAULICS AND ACTUATION LESSONS LEARNED

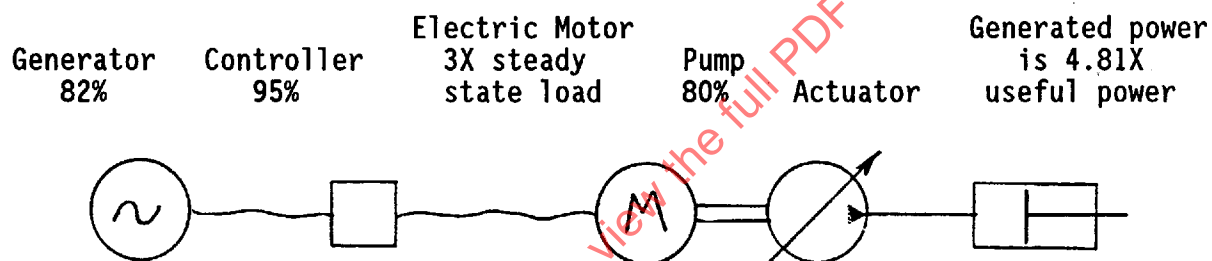
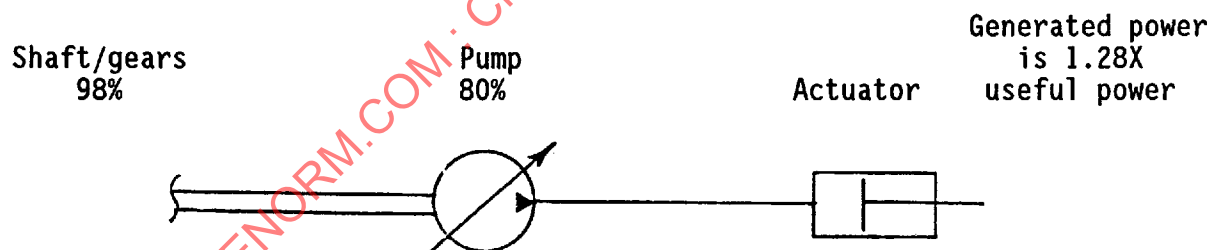
FIGURE 3.1.1 - Power Conversion Efficiency

Hydraulic power from an all-electric engine

Hydraulic power from the engine shaft

SOLUTION: Minimize the number of energy conversions between source and use.

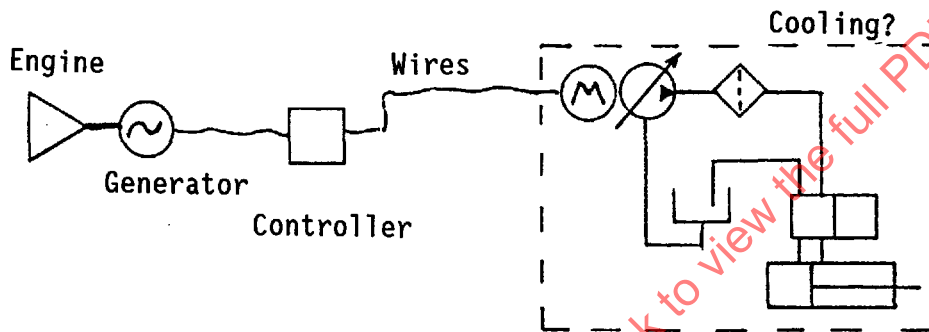
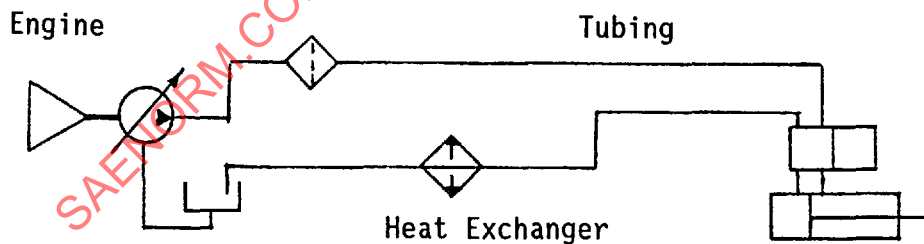
FIGURE 3.1.2 - Biased Trade Studies

ISSUE: Trade studies often fail to assess all influences on the air vehicle.

Frequently in such trade studies the following issues are not compared:

Cooling  
Power transmission  
Power conversion

SOLUTION: Conduct the trade study from the point of original power generation (usually the engine) to the point of final utilization.

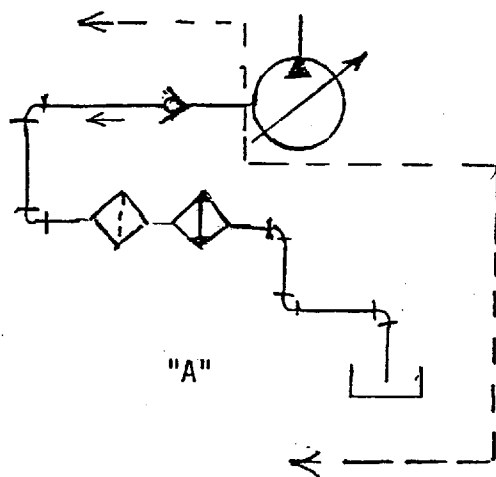
**ISSUE:** Restrictions in the hydraulic pump/motor case drain plumbing can cause high pressure and subsequent failure of the pump/motor case. Restrictions can be caused by too small diameter tubing, long tubing lengths, or improper component installation. The restrictions can result in high line pressure drop, resulting in high pressures in the pump or motor case. Pump and motor cases are generally designed to a 500 psi proof pressure or less.

Design pressure (pump/motor case) must be higher than any combination of A:

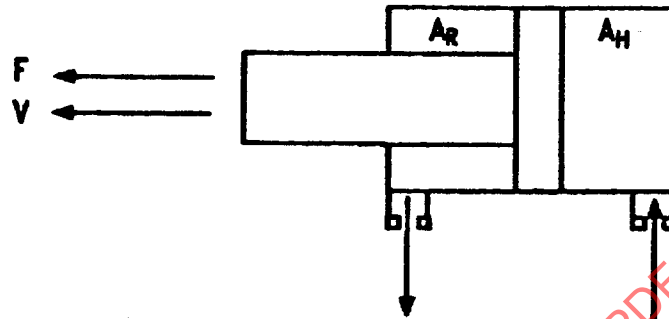
ISSUE: Velocity control restrictors must be sized to prevent overpressure and cavitation.

SOLUTION:

$$F = \left[ P_R + \frac{A_R^2 V^2 C_1^2}{C_R^2} \right] A_H - \left[ P_S - \frac{A_H^2 V^2 C_1^2}{C_H^2} \right] A_H$$

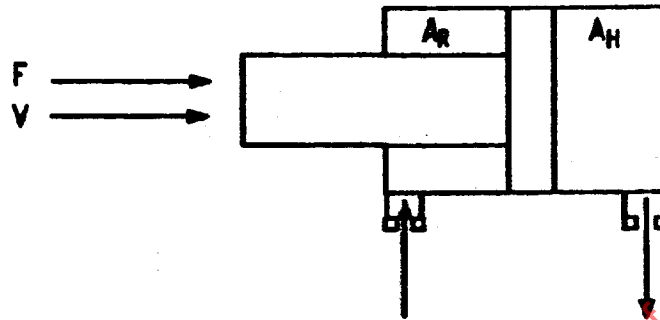
ISSUE: Velocity control restrictors must be sized to prevent overpressure and cavitation.

SOLUTION:

$$F = \left[ P_R + \frac{A_H^2 V^2 C_1^2}{C_H^2} \right] A_H - \left[ P_S - \frac{A_R^2 V^2 C_1^2}{C_R^2} \right] A_R$$
