# AEROSPACE INFORMATION REPORT

**SAE** AIR4543

## Aerospace Hydraulics and Actuation Lessons Learned

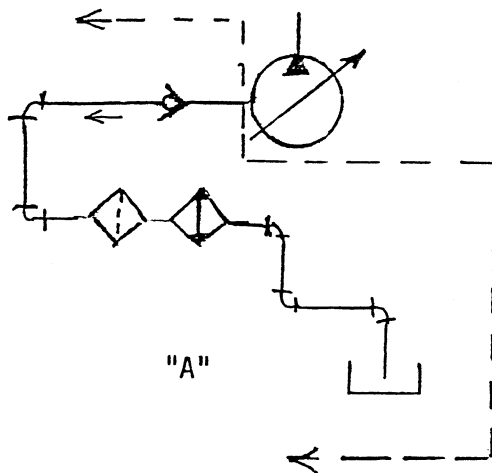
FIGURE 3.1.5 - Pump or Motor Case Drain Line Design

**ISSUE:** Restrictions in the hydraulic pump/motor case drain plumbing can cause high pressure and subsequent failure of the pump/motor case. Restrictions can be caused by too small diameter tubing, long tubing lengths, or improper component installation. The restrictions can result in high line pressure drop, resulting in high pressures in the pump or motor case. Pump and motor cases are generally designed to a 500 psi proof pressure or less.

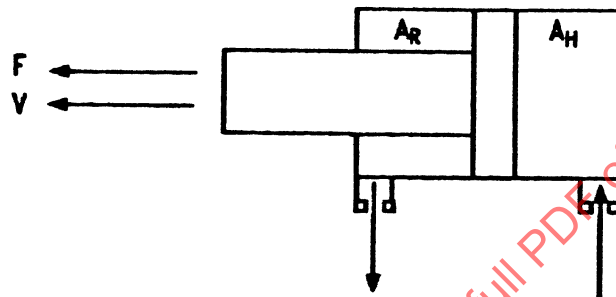
ISSUE: Velocity control restrictors must be sized to prevent overpressure and cavitation.

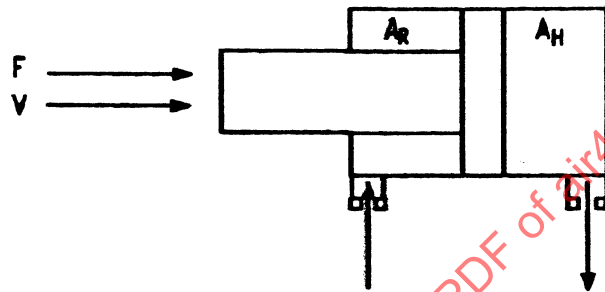
PROBLEM: VELOCITY CONTROL OF RETRACTING ACTUATOR  
 ISSUE: Velocity control restrictors must be sized to prevent overpressure and cavitation.

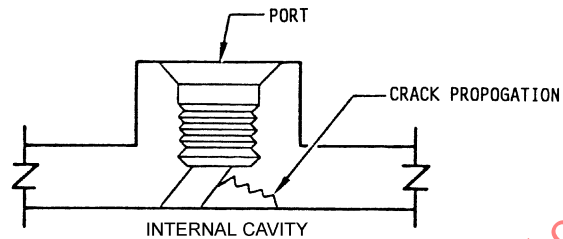
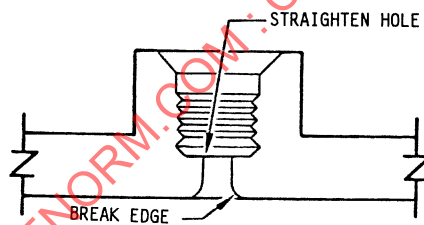
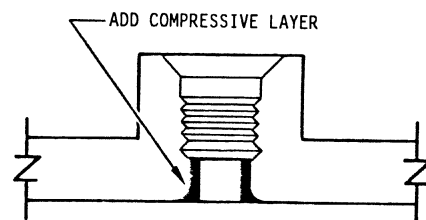
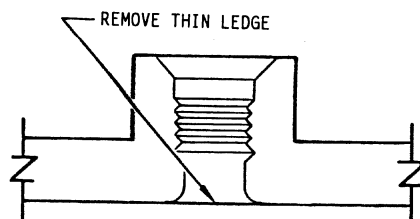
FIGURE 3.2.2.13 - Aluminum Manifold Fatigue

**ISSUE:** Early fatigue failures due to notch effect of hole intersections.

- SOLUTION:**
1. Keep hole intersection angles as near 90° as possible (Illustration 1)
  2. Break edges at hole intersections (Illustration 1)
  3. Add a localized compressive stress layer if feasible (various methods) (Illustration 2)
  4. Design to avoid - remove discontinuities where possible (Illustration 3)

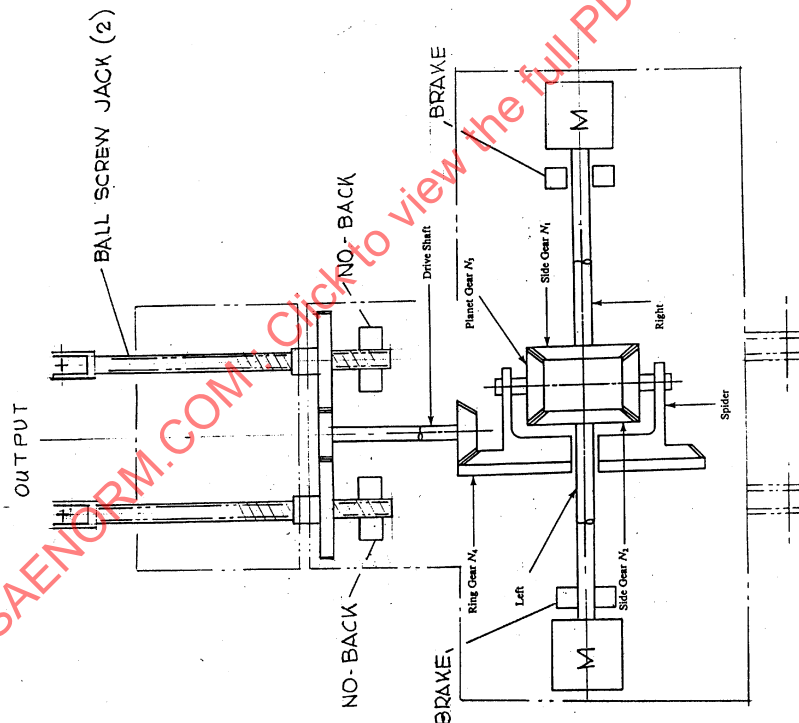
FIGURE 3.2.2.20 - Latent Failures in the Design of Flight Control Components

**ISSUE:** Redundancy is frequently employed in the attempt to meet safety and reliability requirements of flight control systems or components. In order to meet the safety requirements, latent failures are sometimes inadvertently incorporated into the design. The subsequent reliability analysis may not properly take into account the actual failure rate of the system or component. In the pitch trim actuator the failure of the mechanical no-backs was undetected because the electro-magnetic brakes at the motors prevented the output from being back driven even after failure of the no-backs. A subsequent failure (open) in the gear train caused the output to be back-driven (the ball screws are reversible) by the air loads at a high rate with no restraint except the inertia of the components.

**SOLUTION:** Carefully examine the component or system for latent failures. If found, the best solution is simply to alter the design and eliminate the latent failure mode. The next best approach is to properly take into account the exposure of the latent failure mode in determining the actual system failure rate. Hopefully the resultant net failure rate is acceptable for the application being considered. If not, a redesign is in order. Alternately, a reduction in the exposure time of the latent mode may be an option.

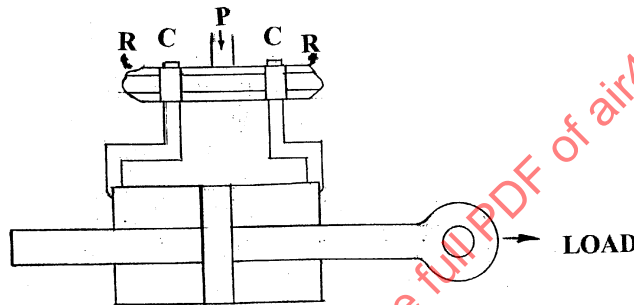
**ISSUE:** Fly by wire servoactuator barrel and end closure pressure fatigue failures occurred in a very short period of use due to a combination of servo valve overlap conditions and continuous small movement commands which kept the valve within the overlap region.

To meet low valve leakage requirements, the supplier provided valves with overlap - long overlap cylinder to return lands and shorter overlap pressure to cylinder lands, tending toward high "no load" null pressures. Combined with an aiding air load, the resisting cylinder pressure may reach a very high pressure value. For example: A constant 1500 psi extend force pressure load could require the resisting cylinder chamber pressure to approach 4500 psi in a 3000 psi system when the valve is in the overlap region and the actuator is extending, depending on the ratio of the overlap lengths.

Combining this condition with small amplitude, low frequency computer generated commands while the aircraft is flying straight and level results in cylinder chamber pressure cycles in the resisting cylinder chamber approaching a 3000 psi to 4500 psi range while retracting and extending respectively. If the commands are continuous, even at low frequencies, a substantial number of high pressure cycles may be experienced in a short time even if there is virtually no load change.

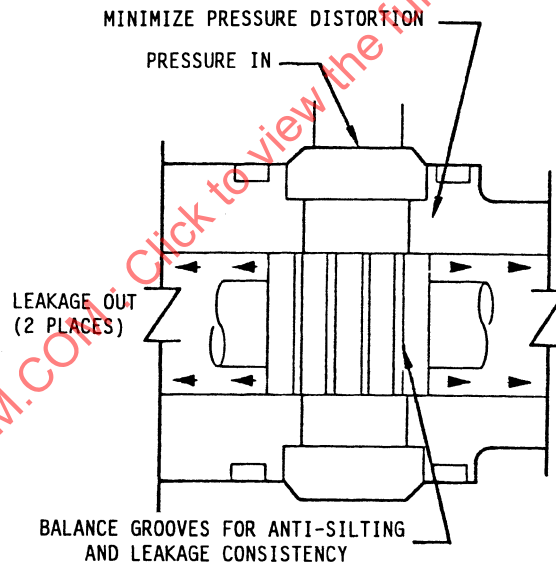
FIGURE 3.2.3.1 - Valve Rejections Due to Supplier/Contractor Fluid Filtration Variances

- ISSUE:
1. Applies more to lap assembly valves than poppet-seat valves.
  2. Finer filtration may result in significant increased leakage.
    - a. Particularly if the valve is designed with a relatively thin sleeve and the designer is counting on hydraulic damming or silting to diminish leakage as a function of time.
    - b. Low leakage lap assembly type valves are particularly subject to leakage increase when using finer filtered test fluid.

- SOLUTION:
1. Use better design practices.
    - a. More rigid sleeve/spool/structure/balance grooves
    - b. Balance grooves to minimize variances and prevent silting
  2. Test per requirements (supplier and contractor); use the same level of filtration.

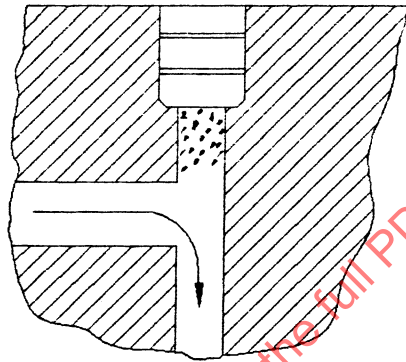
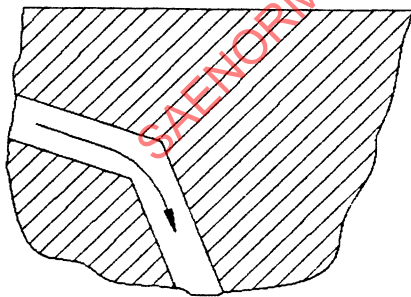
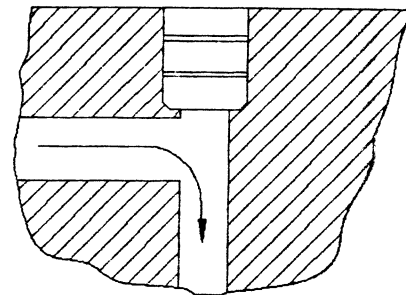
FIGURE 3.2.3.4 - Entrapped Contamination

ISSUE: Dead end passages collect the contaminant.

- SOLUTION:
1. Reroute the flow passage to eliminate potential traps where flow will flush the contaminant through the valve.
  2. Reduce the trap size.

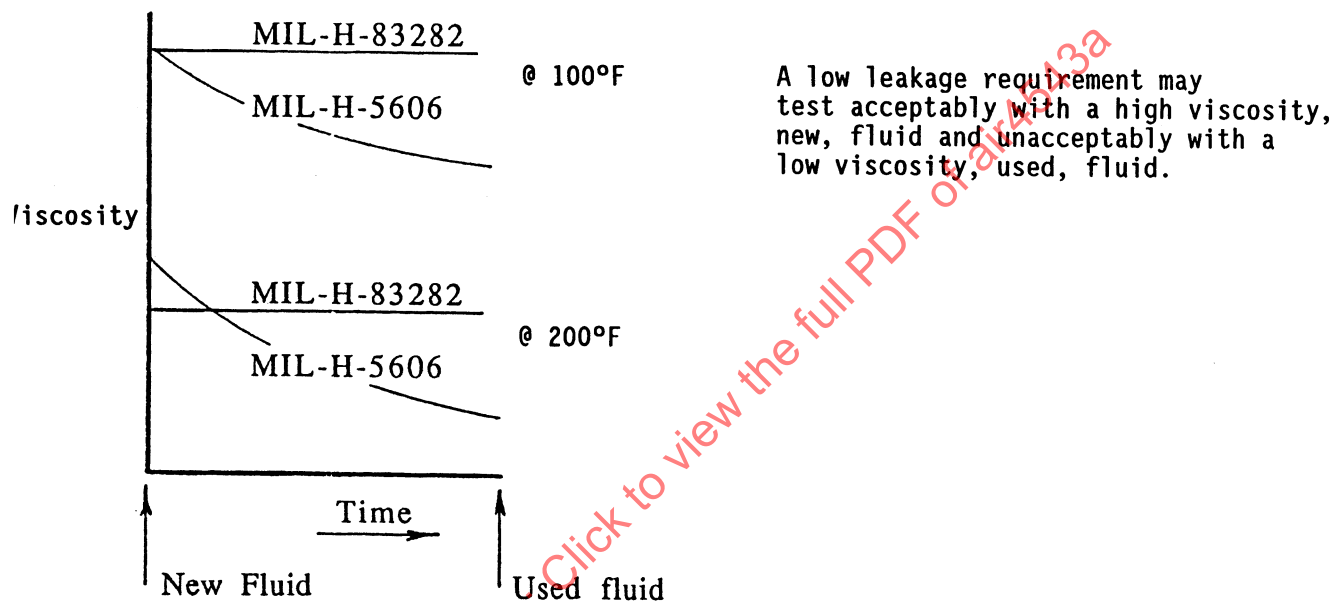
FIGURE 3.2.3.5 - Viscosity Effects on Performance

PROBLEM: VISCOSITY EFFECTS ON PERFORMANCE

ISSUE: Acceptance tests with new fluid are unacceptable with used fluid.

SOLUTION: Specify that test benches be operated for 8 h through orifices to shear fluid prior to conducting critical leakage acceptance tests.

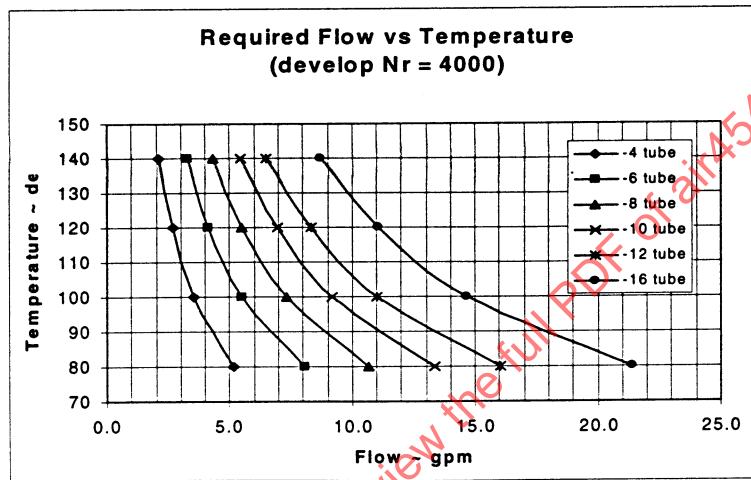
FIGURE 3.2.3.17 - Flushing System to Class 6

**ISSUE:** It was reported that a section of hydraulic plumbing would not clean up to a NAS1638 Class 6 with flushing.

**SOLUTION:** It was determined that the flow rate and fluid temperature being used were not per written guidelines. System cleanup is fast and repeatable when flushing flow rate creates a Reynolds number  $\Rightarrow 4000$  and fluid temperature is 120 to 130 °F.

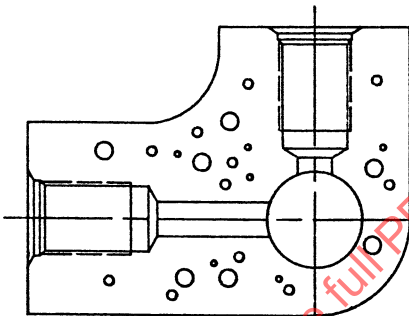
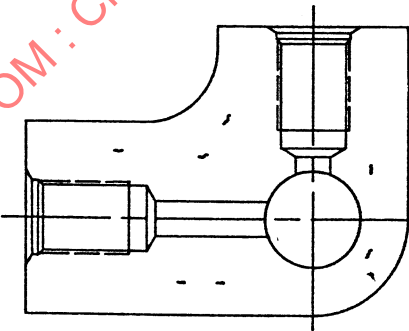
FIGURE 3.2.4.1 - Casting Fatigue

ISSUE: Casting "porosity" caused short fatigue life.

SOLUTION: Hot isostatic press (HIP) casting to reduce internal porosity size.

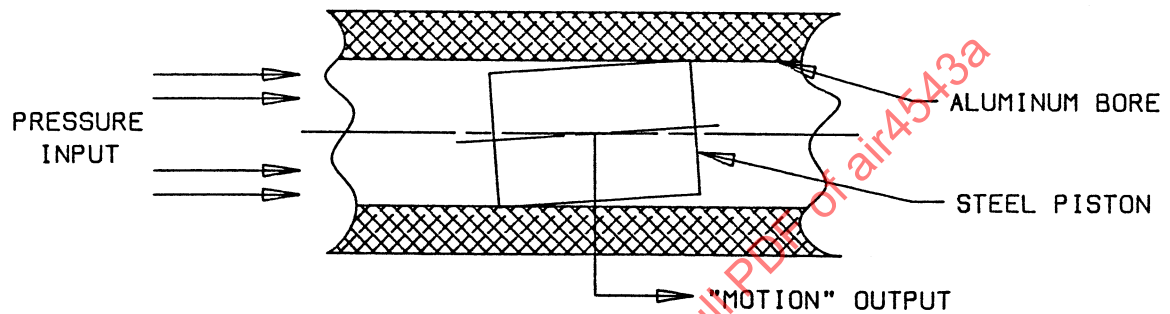
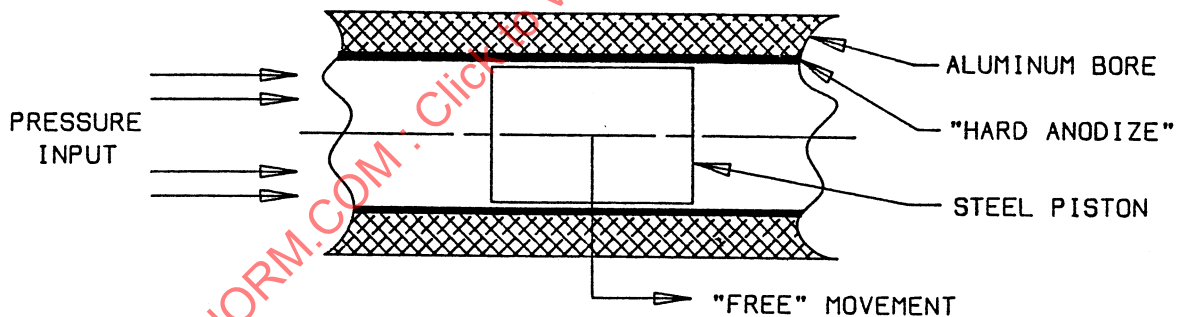
FIGURE 3.2.4.2 - Sliding Piston "Sticking" in Bore

PROBLEM: SLIDING PISTON "STICKING" IN BORE

ISSUE: Steel piston "sticking" in aluminum bore.

SOLUTION: Use PTFE impregnated "hard anodize" bore.

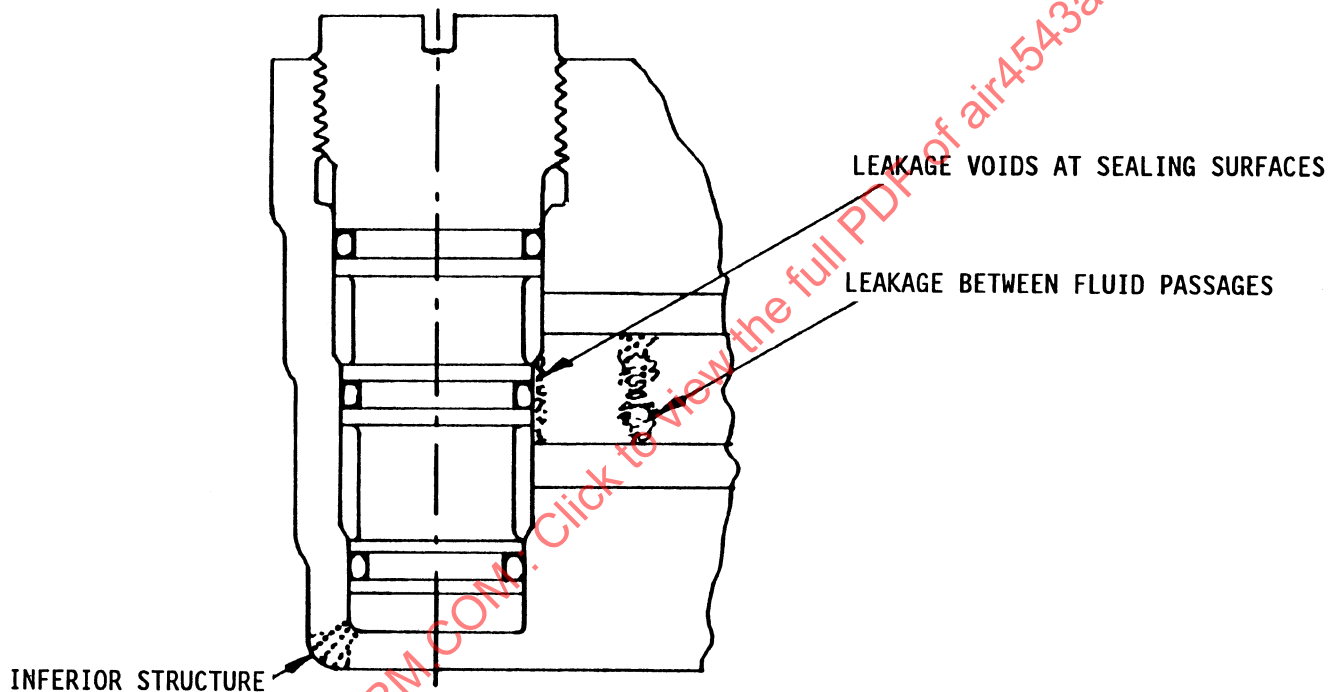
FIGURE 3.2.4.7 - Leakage and Inferior Structural Integrity Associated With Porosity in Cast Manifolds

ISSUE: Trapped gases and/or inadequate gates and risers result in shrinkage voids and porosity in manifold castings.

- SOLUTION:
1. Improve the casting gates, risers, and vents.
  2. Use the vacuum casting process to reduce trapped gases.
  3. Use hipping of the castings to reduce internal porosity.
  4. Impregnate the castings to improve sealing.
  5. Weld repair the larger defects and voids.

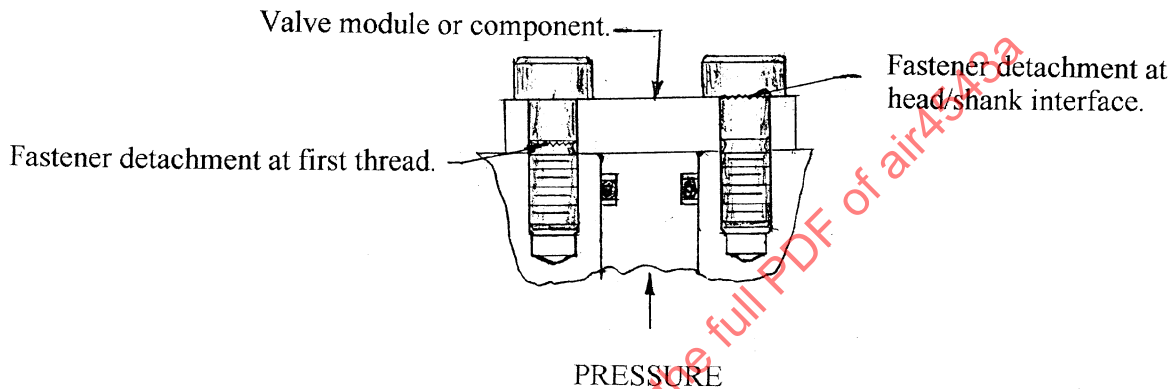
**ISSUE:** Early "in-service" failures of fasteners due to the process of hydrogen embrittlement.

Hydrogen embrittlement may occur when atomic hydrogen is present in a metal under load and diffuses over time to the higher stressed areas, promoting crack growth until failure. It is usually associated with high strength steel materials and electroplating, i.e., a process that involves hydrogen and a material that is susceptible to the process.

1. There have been several incidents wherein all four heads of a four screw or bolt pattern have "popped off" and the hydraulic system was lost.
2. Numerous incidents have occurred wherein heads "popped off", while installed on a unit and sitting on the shelf, due simply to initial, proper preloading plus the presence of diffused hydrogen induced during the fastener manufacturing process.
3. Proper processing primarily involves timely baking after plating for a proven time period and insuring that all fasteners in the baking lot are properly processed.

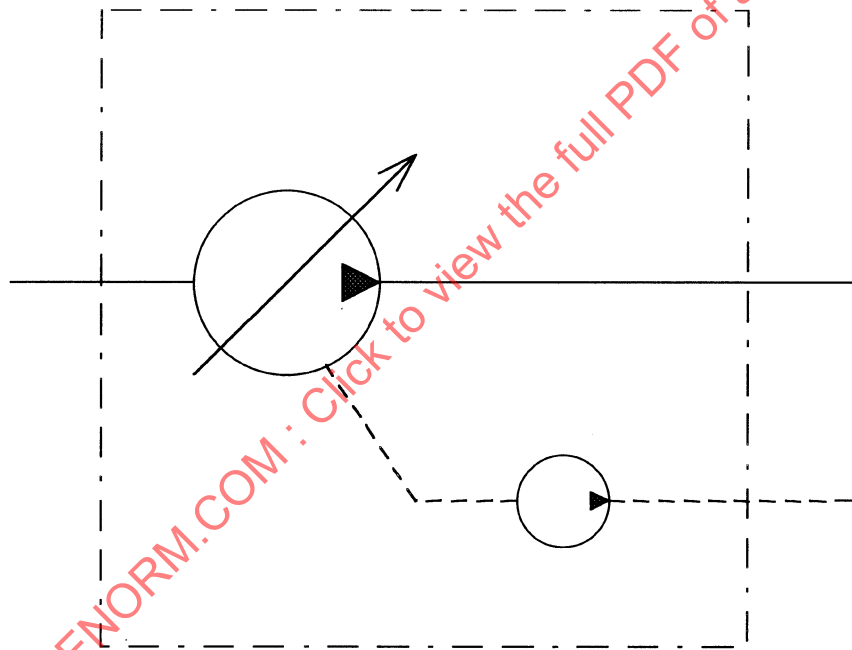
**ISSUE:** High pump case back pressures occur due to case drain line routing, contaminated filters, flow surges and restrictions. This results in pump overheating due to reduced case flow, deterioration of wear surfaces due to high internal pressure loading, fatigue of pump cases due to pressure spikes, high discharge pressures, and excessive heat rejection caused by higher discharge pressures, pump deterioration, pressure loading, and high fluid temperature.

**SOLUTION:** Incorporate case scavenge device to provide positive case drain flow.

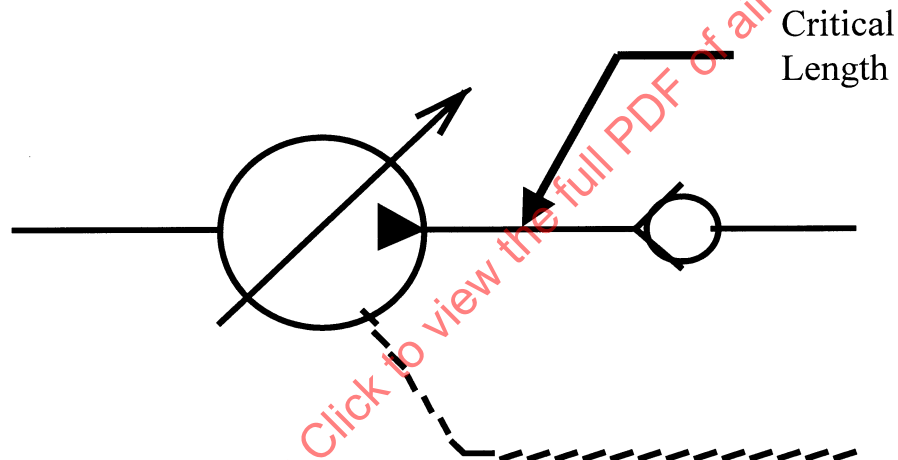
FIGURE 3.2.5.12 - Pump Instability Caused by Check Valve

**ISSUE:** Pump instability due to close proximity of outlet check valve to pump. Location of the check valve in the pump outlet line can have a great impact on pump stability. Locating check valve too close to pump requires additional design considerations. Additional leakage may also be required to improve stability which results in reduced efficiency and increased power loss.

- SOLUTION:**
1. Locate check valve as far away from pump outlet as possible.
    - a. Improves stability
    - b. Allows for lower internal leakage
    - c. Improves performance
    - d. Increases life
  2. If check valve must be located close to pump, then special design considerations are required.
    - a. Yoke over stroke angle
    - b. Compensator spool clearances
    - c. Compensator spool overlap
    - d. Compensator spring rate
  3. Check valve location and associated system volumes must be known early in pump design process to prevent problems and delays later in the program.

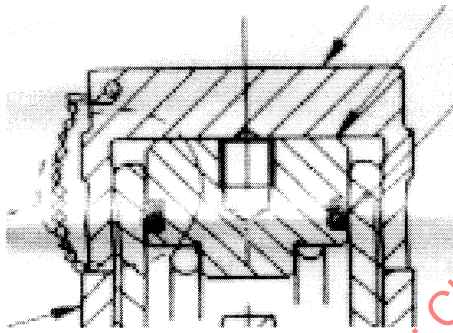
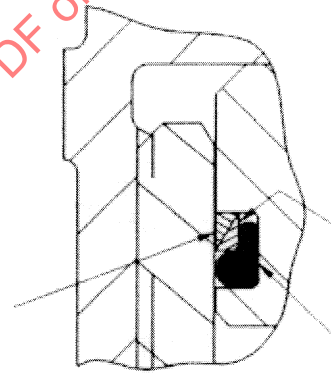
Options considered were special fire resistant coatings, stainless steel shielding, thermal blanket insulating blanket and special seal design.

**SOLUTION:** Incorporate special seal design with metal backups. This approach offers the advantages of:

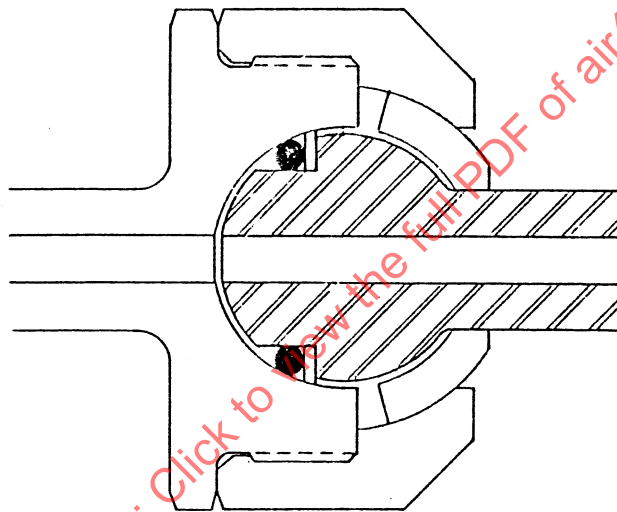
FIGURE 3.2.6.1 - Spherical Ball Swivel Leakage

ISSUE: Many spherical ball swivels tend to leak when initially pressurized. This is caused by the ball moving, within the clearance space, away from the seal.

- SOLUTION:
1. Use coiled tube rather than spherical swivels, if possible.
  2. Increase seal squeeze, and reduce ball to housing clearance as much as possible in the design of the swivel.

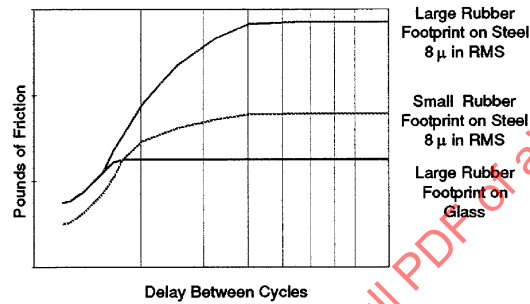
**ISSUE:** During start-up, with a day or more of system idle time, an aircraft experienced pump cavitation because of the loss of reservoir pressurization.

Loss of pressurization was traced to the sticking of the reservoir piston rubber O-ring seal on the reservoir housing.

The reservoir housing material is aluminum with hardcoat (Type 3) anodize. The hardcoat finish on the micro level looks like a dried lake bed. A crusty surface with voids and crevices.

The dynamic seal used was a design with a large rubber footprint.

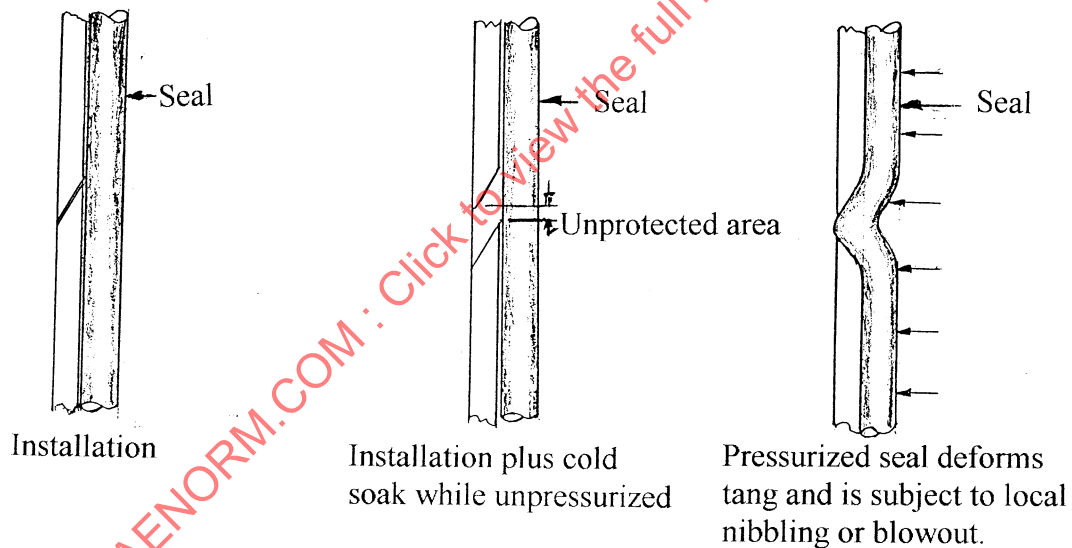
FIGURE 3.2.6.22 - Seal Nibbling Caused by Large Scarf Cut Backup Ring

**ISSUE:** When subjected to low temperatures with zero or very low pressure applied, Teflon backup rings will shrink. On large size static seals (approximately 4 in bores and larger sizes), 0.052/0.045 in thickness MS28774 scarf cut backups will gap beyond the scarf cut length with conditions of an initial room temperature followed by a cold soak at approximately -40 °F and with zero or very low pressure applied. Subsequent high pressure application, while in the shrunken condition, will drive the elastomer into the gap and subject it to possible blowout or nibbling failures.

- SOLUTION:**
1. Use uncut Teflon backups for larger bore sizes. Do not use MS28774 which are not designed for current gland standards.
  2. An applied axial seal pressure of approximately 100 psi or greater will prevent shrinkage at low temperatures. (Considers elastic modulus of Teflon, coefficient of friction of Teflon on a smooth metal surface and the projected axial force on the backup due to pressure); however, this is not a situation that one would live with.

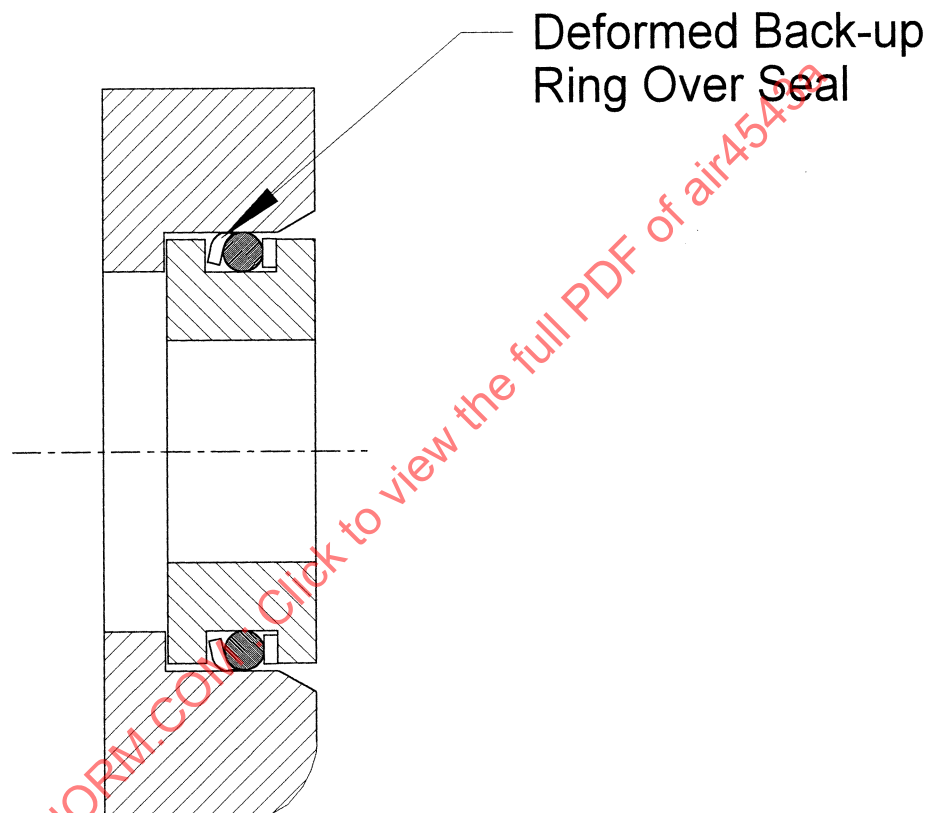
FIGURE 3.2.6.24 - Damaged Backup Ring

**ISSUE:** Installation of O-ring seal with two backups resulted in first backup deforming over O-ring.

**Use Only One Back-up Ring**

**SOLUTION:** Change design to eliminate upstream backup, i.e., single backup design which has short insertion of backup ring.

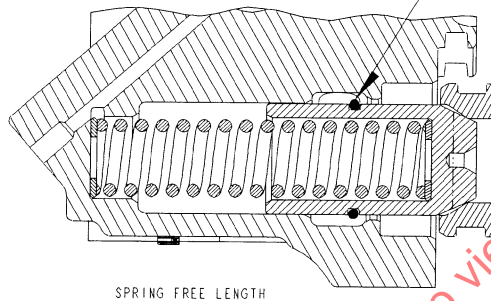
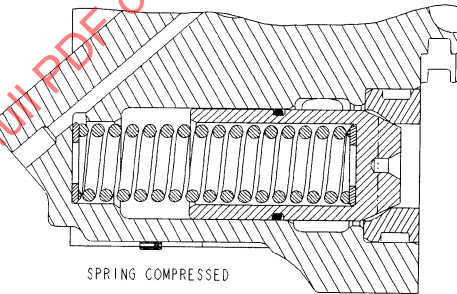
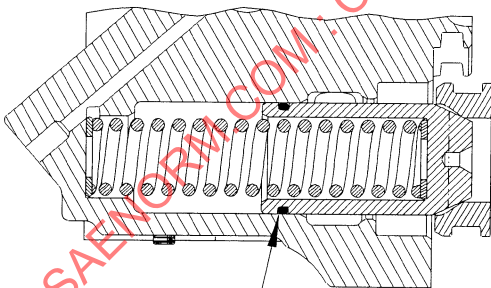
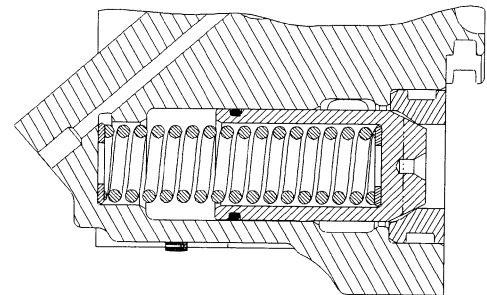
**PROBLEM:** PISTON SEAL INSTALLATION AND ALIGNMENT IS DIFFICULT AND RESULTS IN DAMAGE

**ISSUE:** Seals are damaged and leak on pistons which are used to preload springs in components. Seals do not engage bores before springs begin to compress.

Seal Not Engaged  
Prior To Blind Assembly

Engagement of Seals Should Occur Prior to Assembly

**SOLUTION:** Design components so that seals engage bores prior to assembly of mating components, i.e., compressing springs. Assembly is simplified and avoids damage to seals.

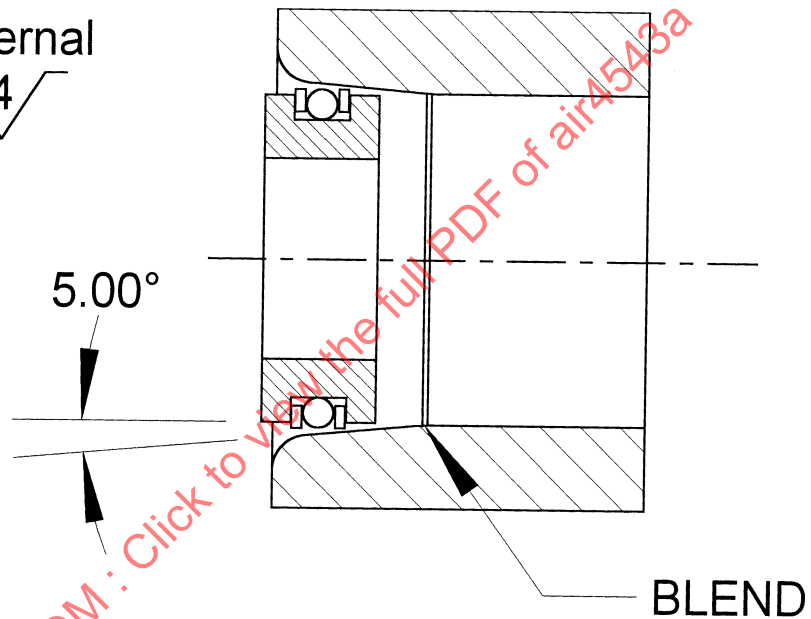
FIGURE 3.2.6.26 - Compressing Solid Backup Rings

PROBLEM: DAMAGE OCCURRING TO BACKUP RINGS DURING INSTALLATION

ISSUE: Upon installation of solid backup rings and O-rings of a piston seal into a bore, damage to backup rings occurred.

Finish All Internal  
Surfaces

SOLUTION: Use a compression type assembly tool to size backup rings prior to assembly into bores.

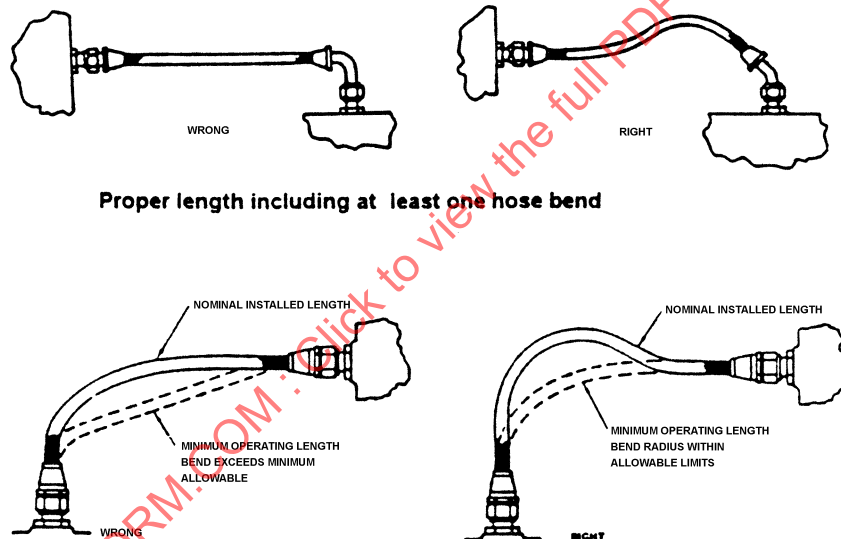
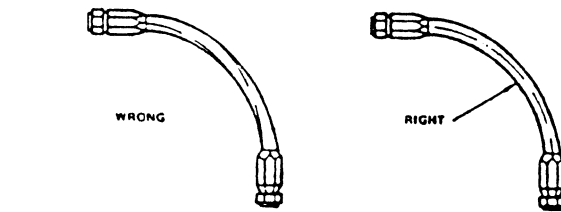
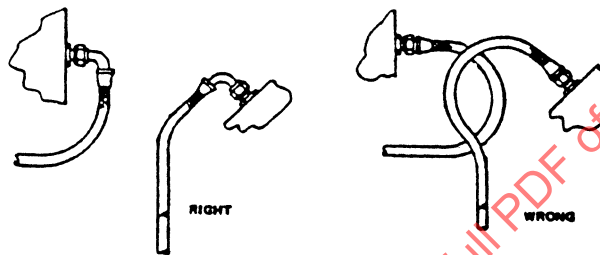
FIGURE 3.2.7.9 - Hose Installation Practices

**ISSUE:** Hose assemblies must be routed and installed properly to obtain the expected full service of the product.

- Proper length including at least one hose bend should be used to accommodate worst case of tolerance stackup.
- Proper routing to withstand motions/deflections.
- Proper installation to eliminate twisting.
- Proper use of elbows to provide most direct routing and minimize opportunity for abrasion.

**Proper length including at least one hose bend**

**Proper routing to withstand motions/deflections**

Proper installation to eliminate twisting

Proper use of elbows to provide most direct routing
