**(R) Aerospace Hydraulics and Actuation Lessons Learned**

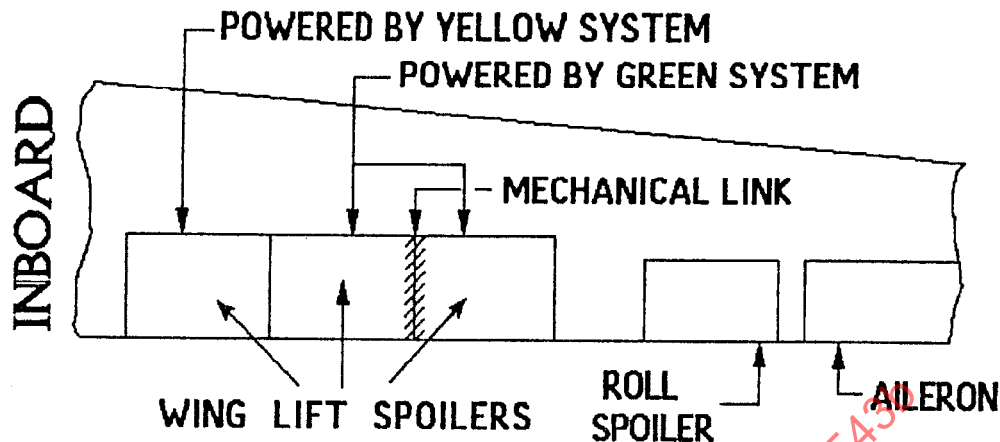
- b. A single failure of a flight control surface attachment point could cause a catastrophic event.
- c. The center or outboard ground lift spoiler panel could deploy, following the failure of the eye end attachment point for example, such that an inadvertent rolling moment could not be controlled.

SOLUTION: Reroute hydraulic supplies to the lift spoilers and link the center and outboard panels.

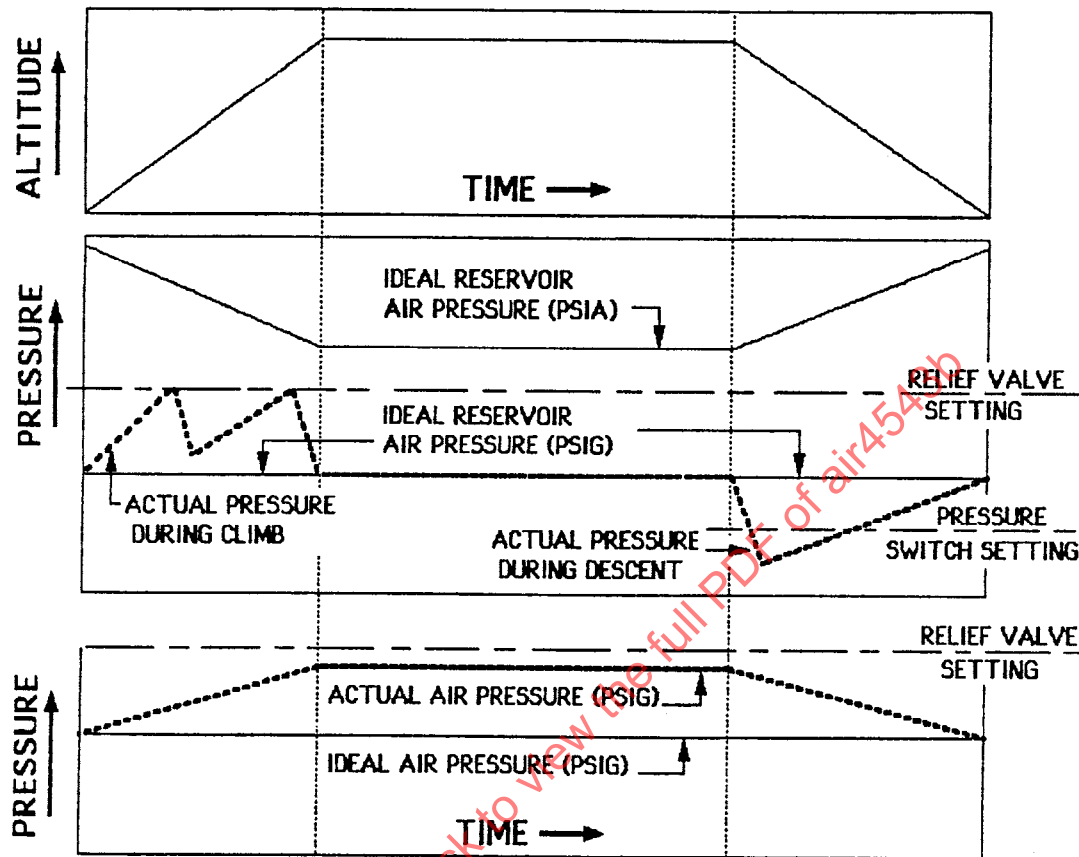
- During aircraft descent, hydraulic reservoir low air pressure warnings occurred although the reservoir pneumatic pressurization system was fully serviceable.
- The engine bleed air pressure with engines at flight idle was less than the pressure switch setting.

SOLUTION: Either reset the pressure switch to be less than the minimum bleed pressure or set the relief valve so that it does not operate during aircraft climb.

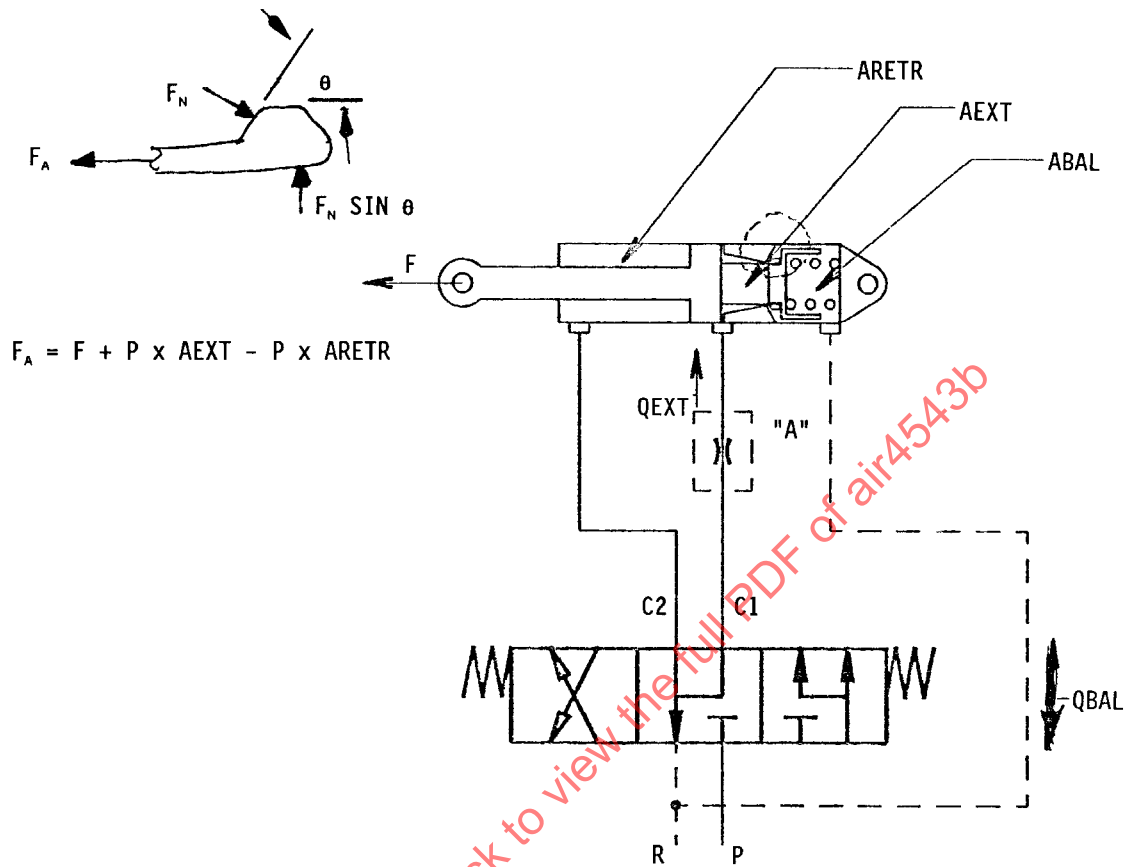
ISSUE: The contact area approaches zero at the point of lock release.

- Size port and line to ABAL for high transient flow.
- Relieve external  $F$  on fingers by application of retract pressure before application of extend pressure.
- Choke the inlet flow  $QEXT$  at "A" to reduce the rate of pressure rise to AEXT.
- Use one selector valve per actuator.
- Guide and lock piston hardness to be much higher than lock fingers.

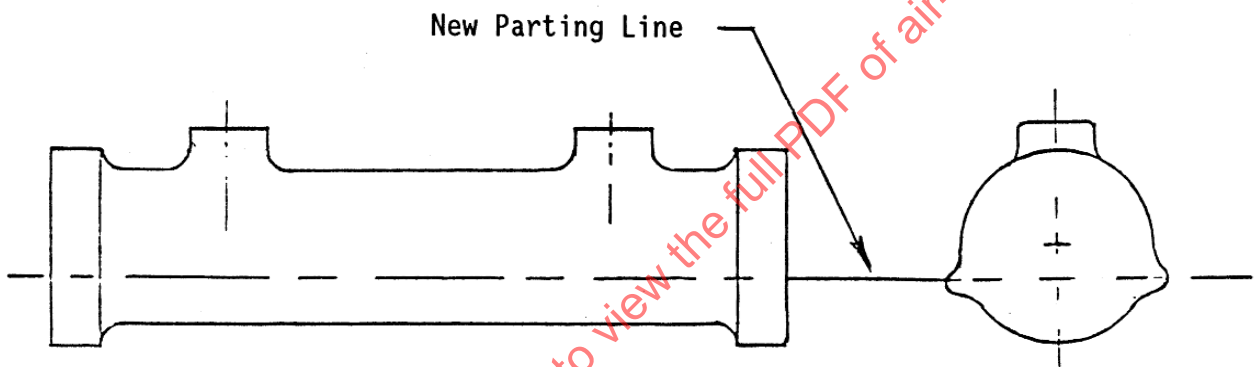
ILLUSTRATION: - 2

PROBLEM: Fatigue failures in cylinders with parting plane through ports.

ISSUE: The parting line placement on the cylinder centerline for "shallow draw" forging creates stress risers at the ports and at the thinnest section of the cylinder. This can result in fatigue failures or shortened life (see Illustration 1).

SOLUTION: Relocate the parting line off the cylinder centerline and completely off the ports (see Illustration 2).

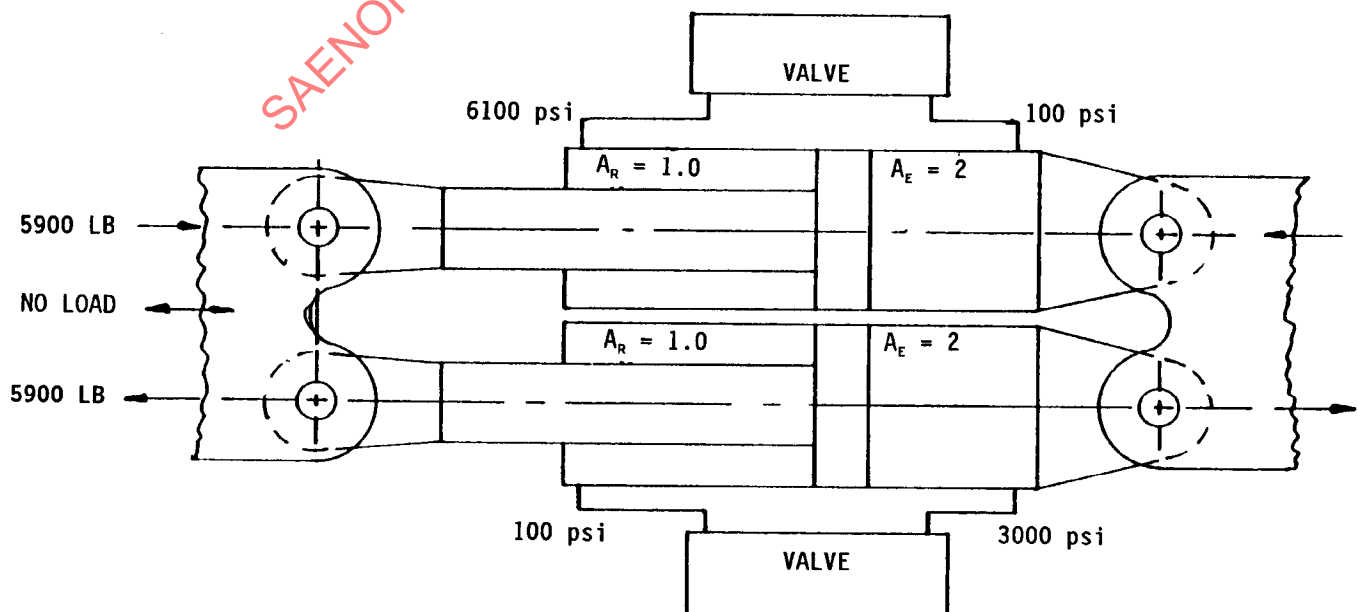
PROBLEM: Fatigue damage to loaded structure and cylinders of side-by-side cylinders.

ISSUE: Force fight in side-by-side cylinders driven by separate valves.

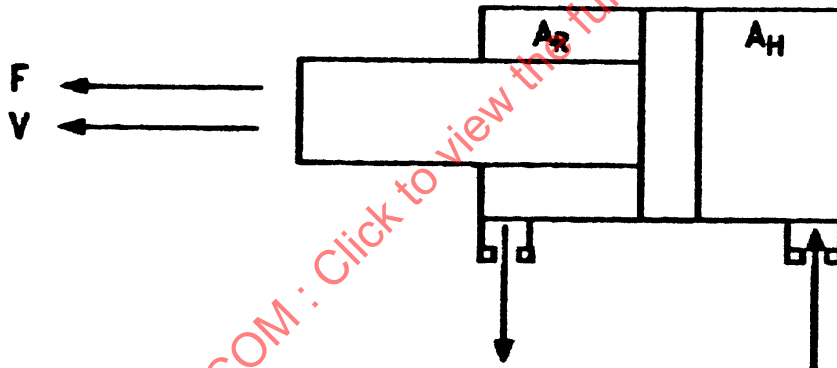
PROBLEM: Damage caused by poor velocity control of extending actuator.

ISSUE: Velocity control restrictors must be sized to prevent overpressure and cavitation.

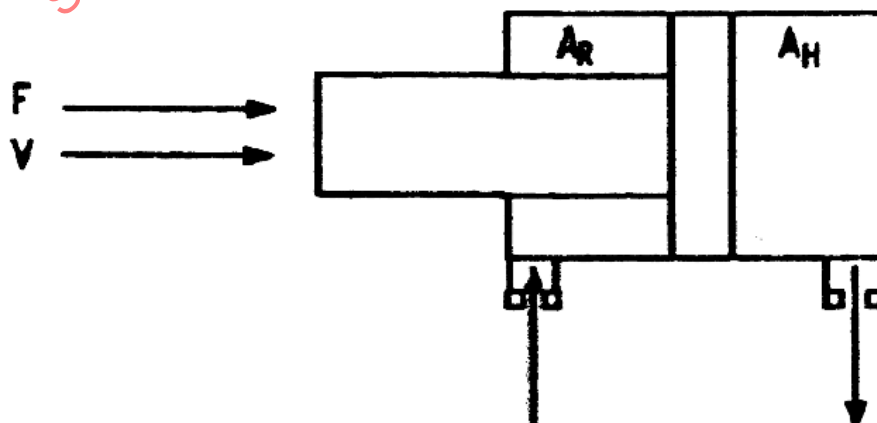
PROBLEM: Damage caused by poor velocity control of retracting actuator.

ISSUE: Velocity control restrictors must be sized to prevent overpressure and cavitation.

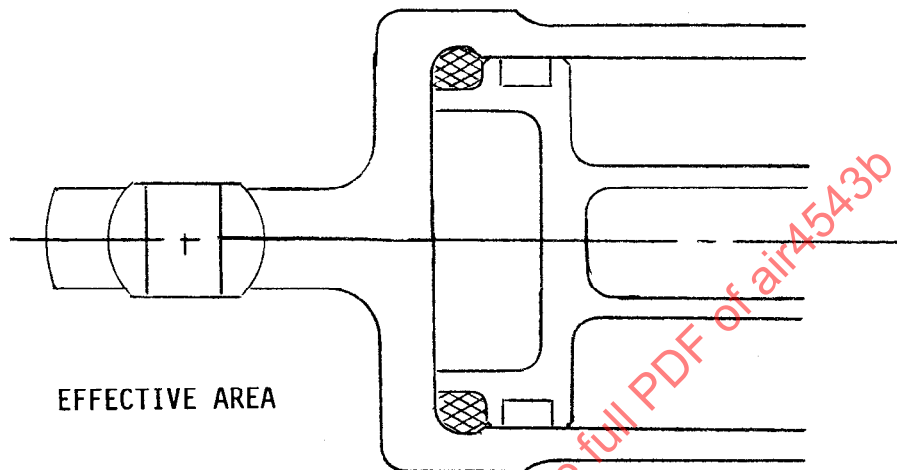
PROBLEM: Fully retracted actuator fails to extend against load.

ISSUE: Piston retract stop ring acts as face valve, reducing extend area.

SOLUTION: Add flow slot in retract stop ring to assure that full head area is pressurized.

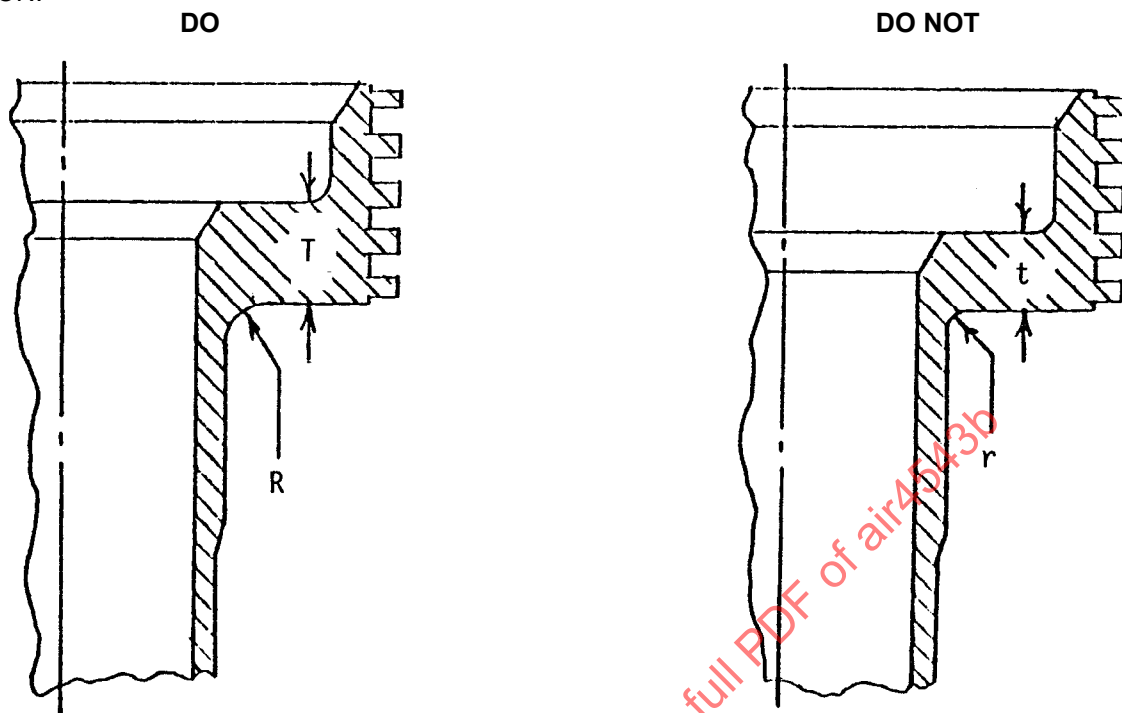
PROBLEM: Piston head separation in service.

ISSUE: Hydraulic cylinder piston heads have separated from the piston rods at the fillet between the head and rod.

**SOLUTION:** Design pistons with ample wall thickness ( $T$ ) and generous fillet radii ( $R$ ). Consideration must be given to peak transient loading. The type loading, whether pure tensile or combined tensile and bending, must be considered in relation to the stress distribution at the piston head fillet to prevent stress risers.

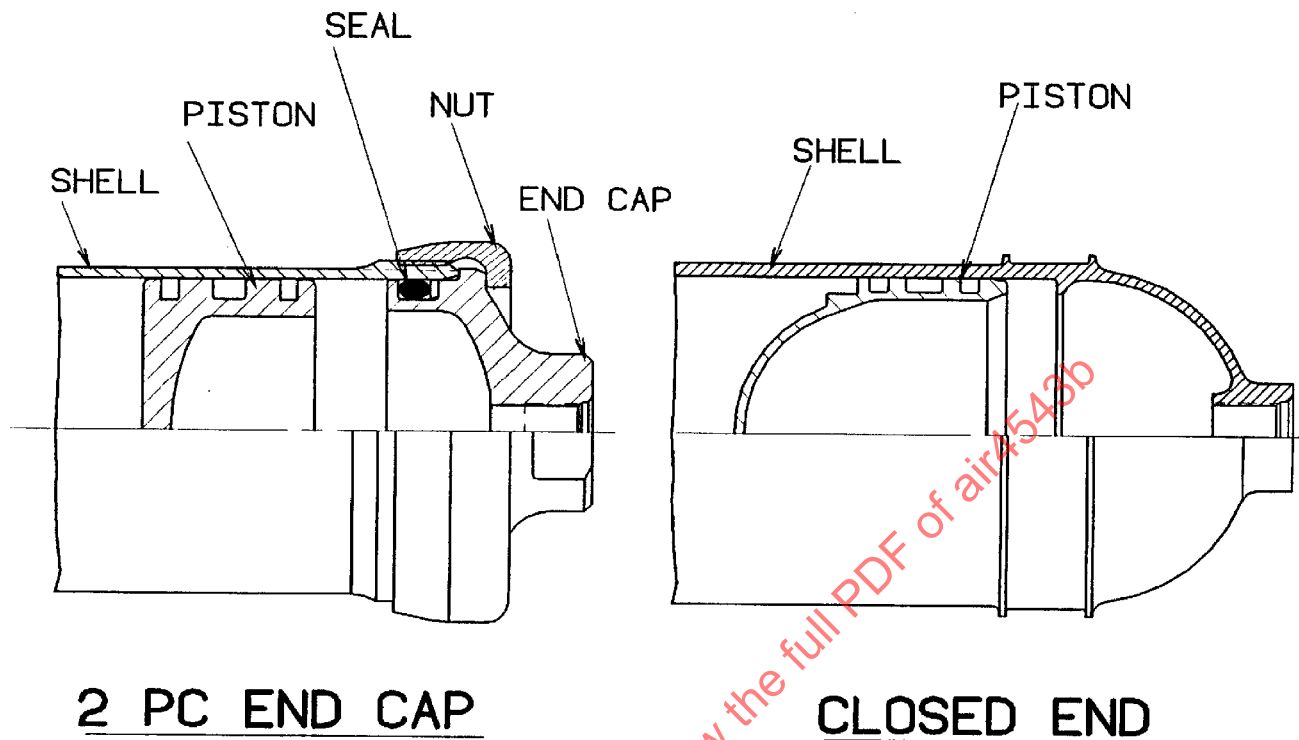
**PROBLEM:** Excessive or premature leakage across accumulator seals.

**ISSUE:** Gas leaking into the system can cause a loss of aircraft or system.

- Ensure that the chrome plate is controlled to minimize cracking (cracks inherent in chrome plating process).
- Ensure that the seal compound meets all temperature, pressure, and pressure discharge requirements. Minimize the compression set and explosive decompression.
- Use the closed end cap on gas side (eliminate static seal).
- Improve the seal concept to improve sealing capability (multiple seals, metal bellows, etc.).

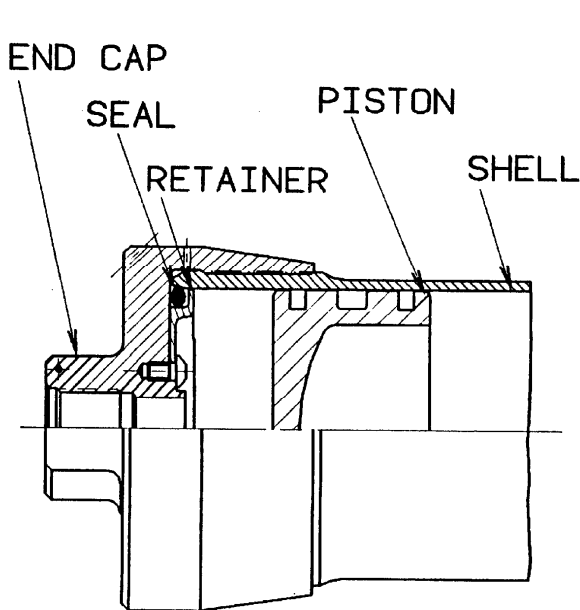
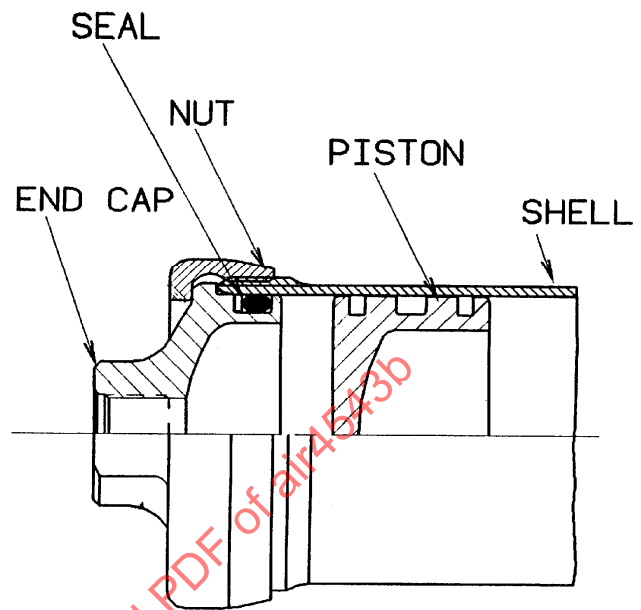
PROBLEM: Premature failure of accumulator end caps.

ISSUE: Failed accumulators are an extreme hazard to aircraft.

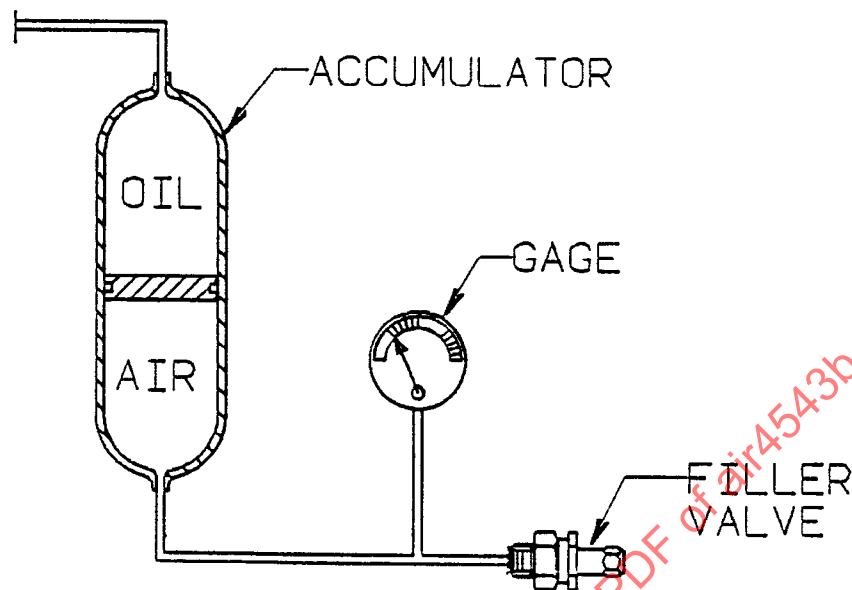
- a. The line and filler valve volume on the air side of the accumulator were not correctly included in the air side calculations.
- b. The fill valve had been relocated after initial sizing. The accumulator piston bottomed before reaching 3000 lbf/in<sup>2</sup> (20 700 kPa).

SOLUTION: The accumulator pre-charge was recalculated and adjusted to the correct value.

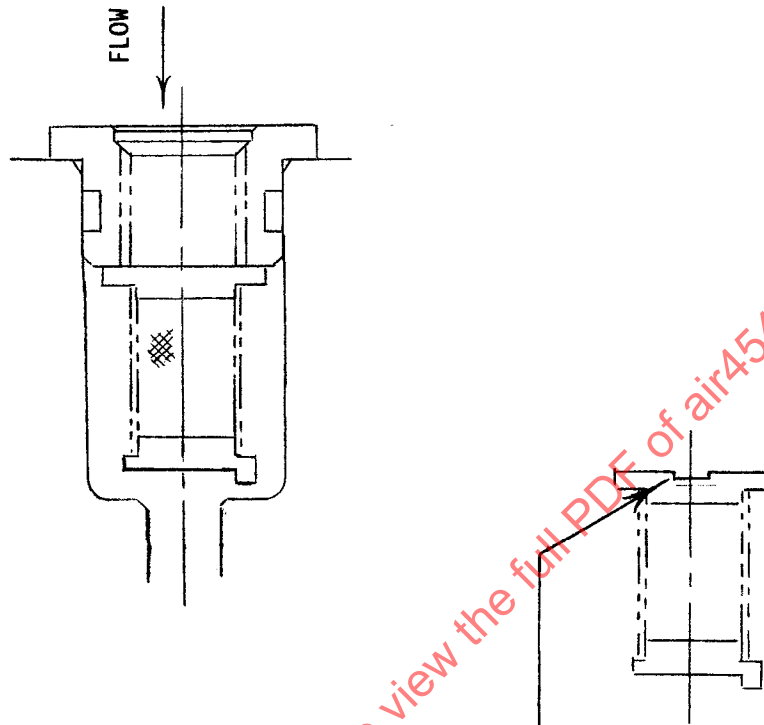
ISSUE: Inlet screen housing acts as a check valve preventing the module from depressurizing after the system's isolation valve is actuated.

SOLUTION: Provide a relief slot on the face of the filter housing.

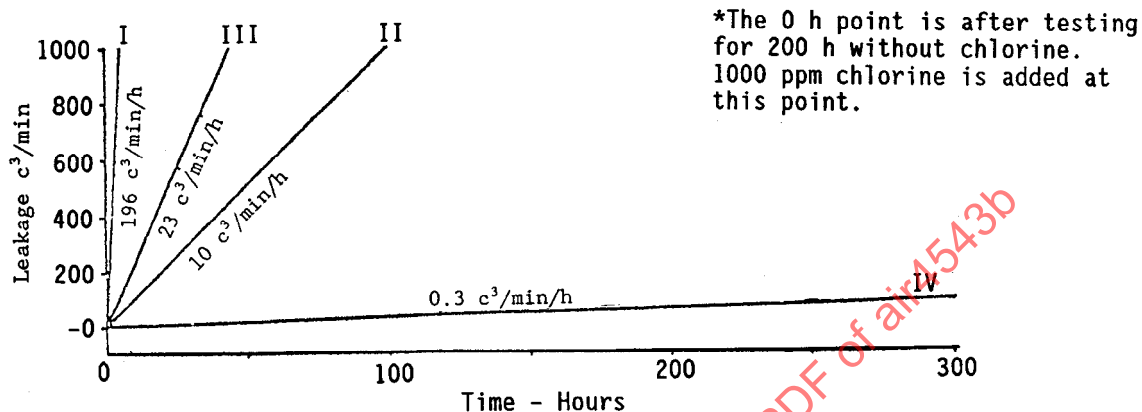
ILLUSTRATION 1: Erosion of Servovalve with Types I, II, III and IV Fluid with 1000 ppm Chlorine Added (Stabilized Rate of Erosion Occurring During Test A)

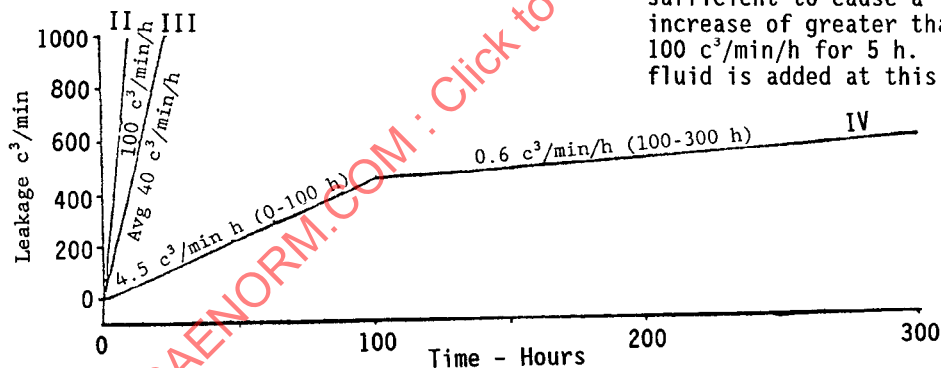
ILLUSTRATION 2: Erosion of Servovalve with Types I, II, III and IV Fluid with 1000 ppm Chlorine Added (Stabilized Rate Following Addition of Type IV Fluid During Test B)

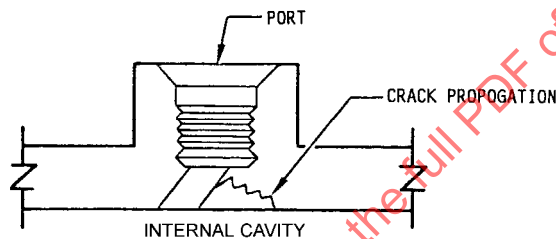
ISSUE: Early fatigue failures due to notch effect of hole intersections.

- a. Keep hole intersection angles as near 90° possible (Illustration 1).
- b. Break edges at hole intersections (Illustration 1).
- c. Add a localized compressive stress layer if feasible (various methods) (Illustration 2).
- d. Design to avoid - remove discontinuities where possible (Illustration 3).

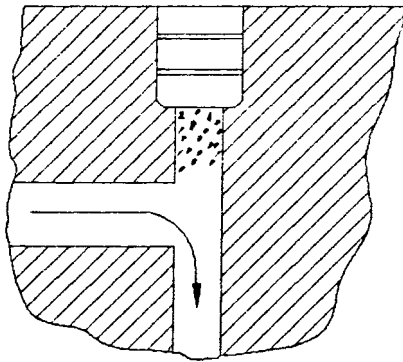
ISSUE: Dead end passages collect the contaminant.

- Reroute the flow passage to eliminate potential traps where flow will flush the contaminant through the valve.
- Reduce the trap size.

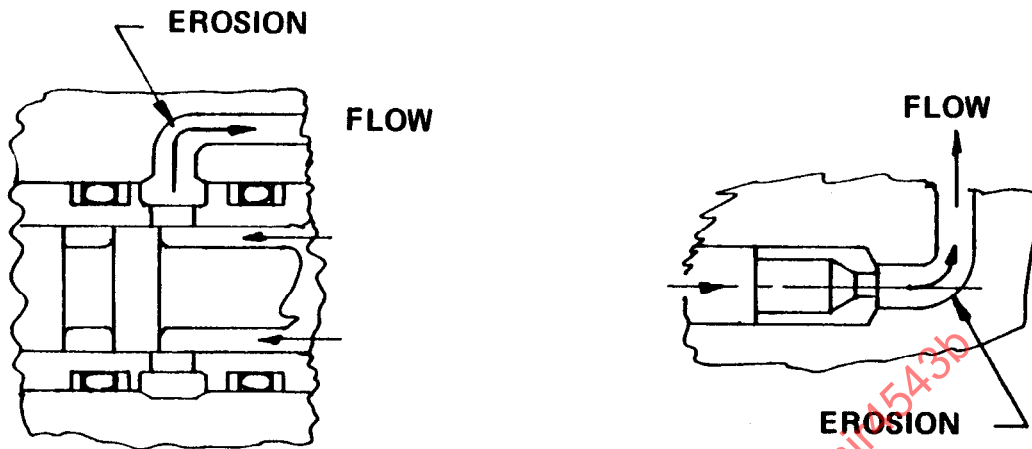
PROBLEM: Erosion of aluminum valve bodies due to jet action of restrictors.

ISSUE: High pressure impingement or deflected flow of fluid can erode through aluminum valve manifolds.

- Reduce restrictor exhaust velocity by using multiple series orifices.
- Move restrictor exhaust jet away from the manifold wall so that fluid can expand and reduce velocity prior to impingement on the wall.
- Reduce restrictor exhaust jet energy concentration by using multiple smaller parallel orifices.
- Incorporate the steel deflector or jet diffuser downstream of the restrictor.

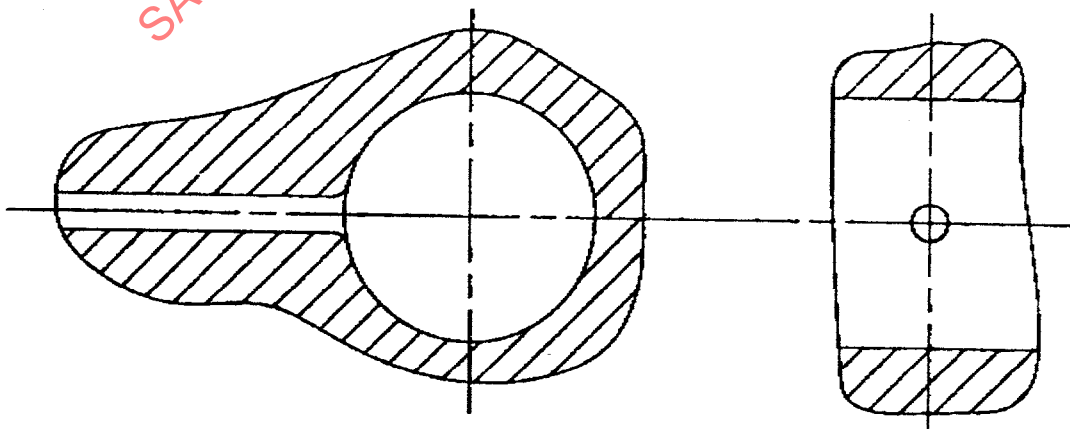
ISSUE: Small bores intersecting large bores increase stress,  $K = 2.5$ .

SOLUTION: Simulate an elliptical intersection,  $K = 1.5$ . Put radius of .030 to .040 in (0.7 to 1.0 mm) on edges.

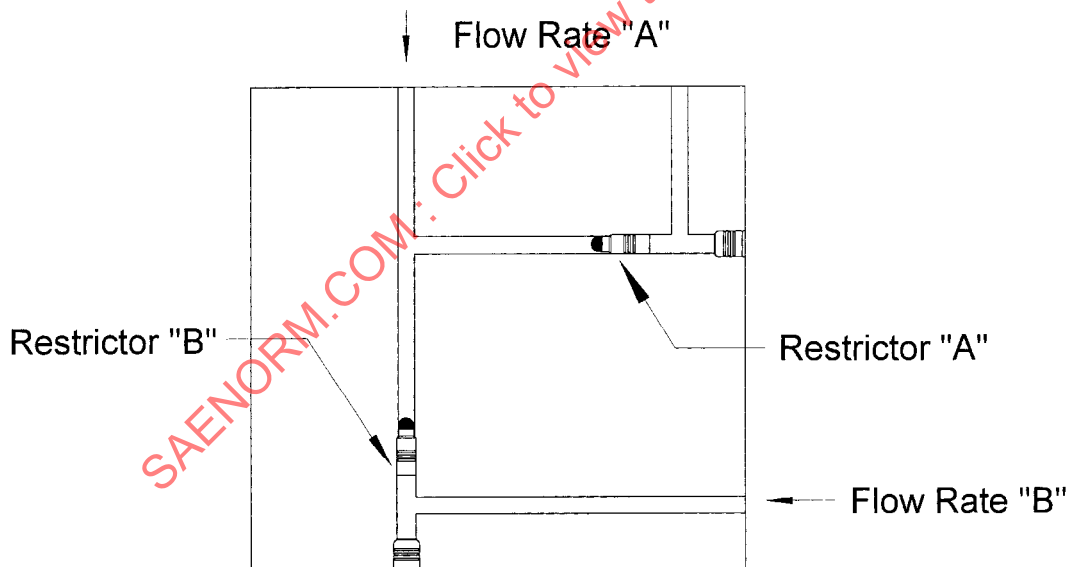
PROBLEM: Various size flow orifices may be used in the same component and may be misinstalled.

ISSUE: When different size flow orifices are used in the same component to regulate various flows, provisions must be made to assure installation in the proper flow circuit.

SOLUTION: When two or more different flow restrictors are used in a component, use different ODs to prevent installation of improper restrictor in flow circuits.

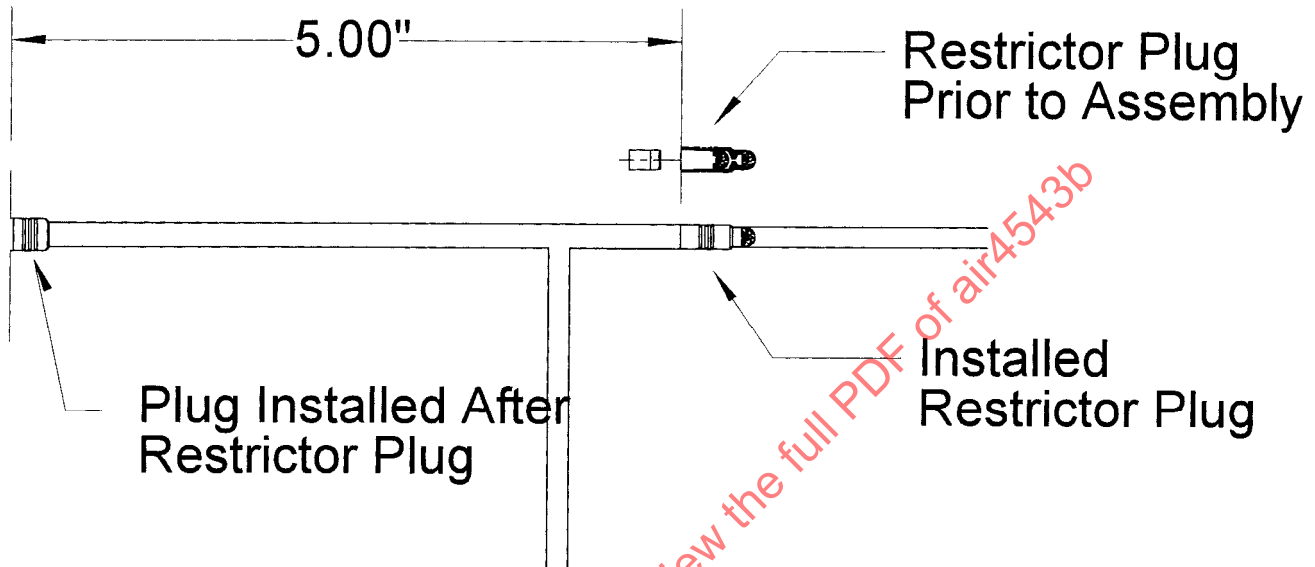
**ISSUE:** Small diameter orifices that are installed deep within components are extremely difficult to remove if removal is necessary.

Small Diameter Orifices That Are Deeply Recessed Are Extremely Difficult To Remove

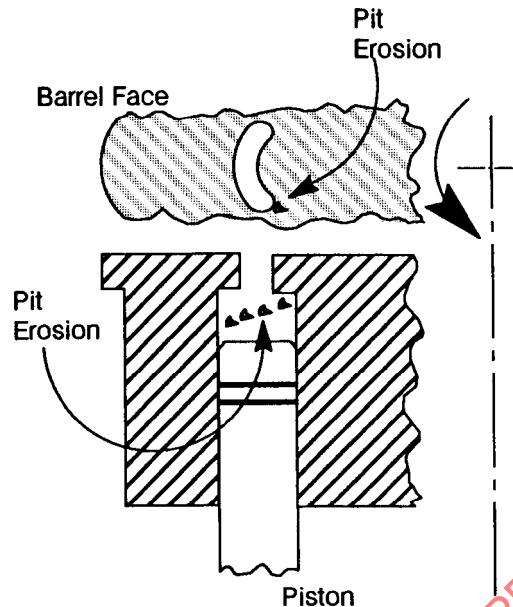
- a. Implosion/erosion in pumps
- b. Low output flow
- c. Noise
- d. Vibration/excessive wear

- a. Dynamic analysis of inlet filling component
- b. Streamline inlet filling (lines)
- c. Size inlet lines to match pump requirements (pressure)
- d. Contour filling of pump inlet coverage
- e. Increase inlet pressure

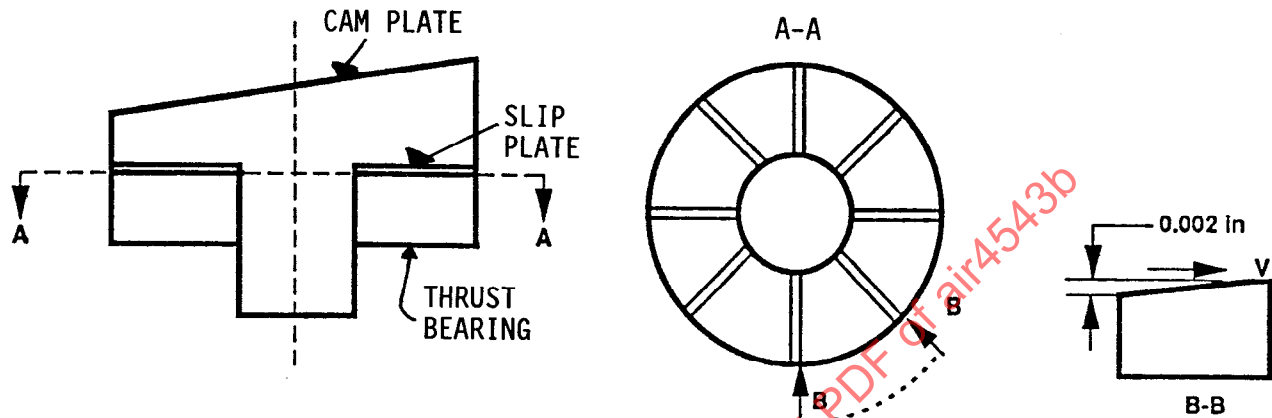
**ISSUE:** The turbines accelerated to full speed of 37 500 rpm (3750 at the pump shaft) in 1 s. The flat bronze thrust bearings galled due to failure of the oil film to carry the load.

**SOLUTION:** The bearing pads were tapered to aid the development of a positive load-bearing oil film.

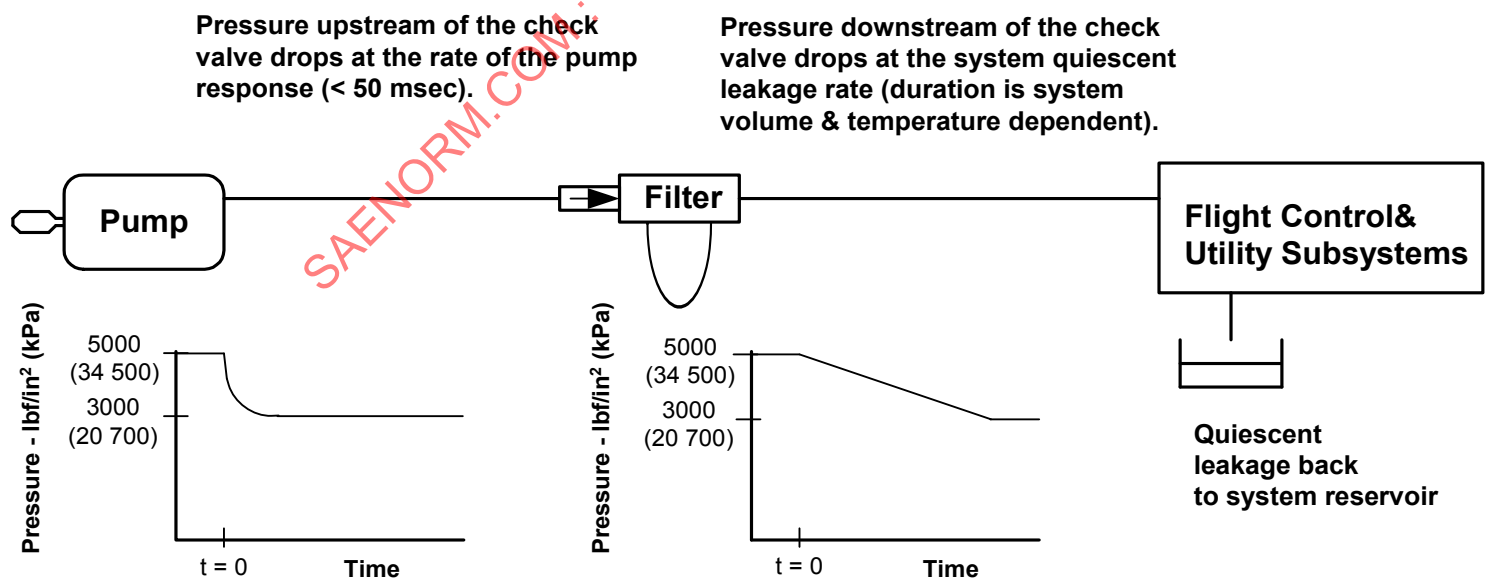
PROBLEM: Dual pressure pump unstable when switching pressure.

ISSUE: Switching from high pressure to low pressure causes the high pressure filter check valve to close resulting in inadequate system volume downstream of the dual pressure pump to maintain stability.

SOLUTION: Specify a dual pressure pump response rate, from high pressure to low pressure, which is slower than the system quiescent leakage rate.

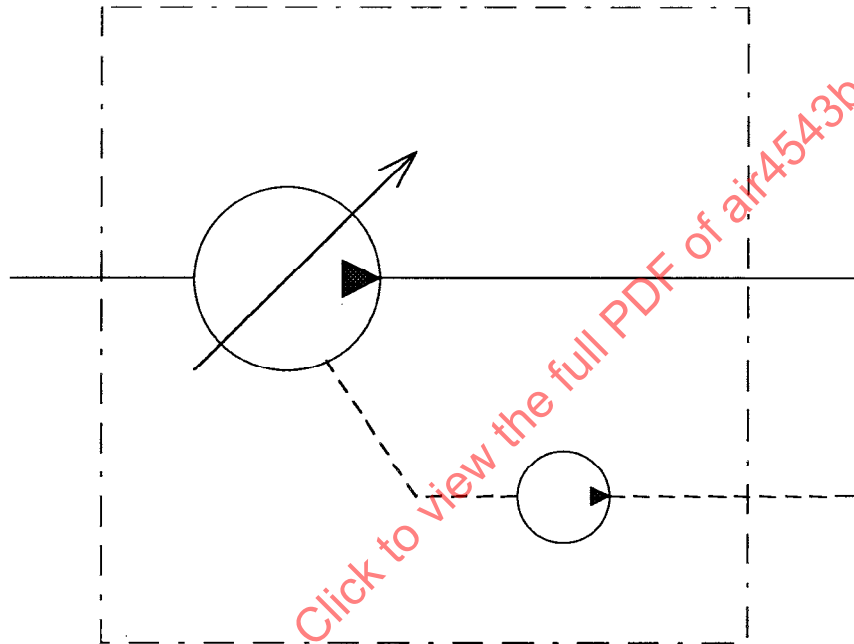
SCAVENGE PUMP SCHEMATIC

ISSUE: High pump case back pressures occur due to case drain line routing, contaminated filters, flow surges and restrictions. This results in pump overheating due to reduced case flow, deterioration of wear surfaces due to high internal pressure loading, fatigue of pump cases due to pressure spikes, high discharge pressures, and excessive heat rejection caused by higher discharge pressures, pump deterioration, pressure loading, and high fluid temperature.

SOLUTION: Incorporate case scavenge device to provide positive case drain flow.

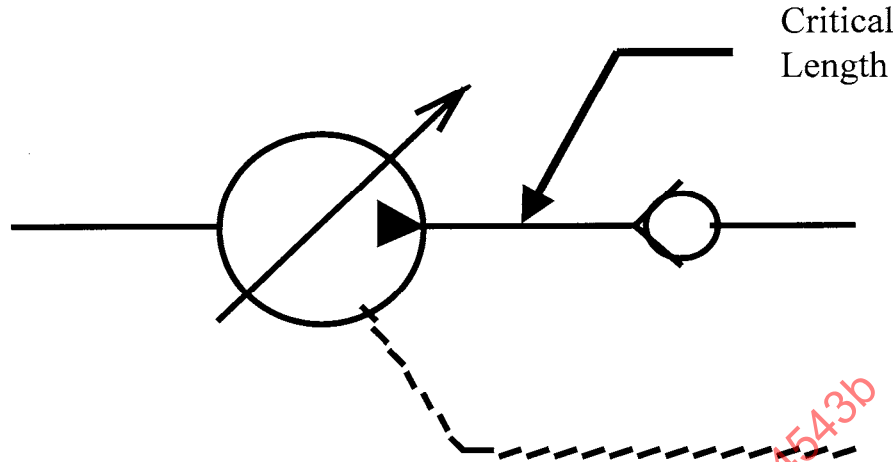
ISSUE: Pump instability due to close proximity of outlet check valve to pump. Location of the check valve in the pump outlet line can have a great impact on pump stability. Locating check valve too close to pump requires additional design considerations. Additional leakage may also be required to improve stability which results in reduced efficiency and increased power loss.

- a. Locate check valve as far away from pump outlet as possible.
  1. Improves stability
  2. Allows for lower internal leakage
  3. Improves performance
  4. Increases life
- b. If check valve must be located close to pump, then special design considerations are required.
  1. Yoke over stroke angle
  2. Compensator spool clearances
  3. Compensator spool overlap
  4. Compensator spring rate
- c. Check valve location and associated system volumes must be known early in pump design process to prevent problems and delays later in the program.

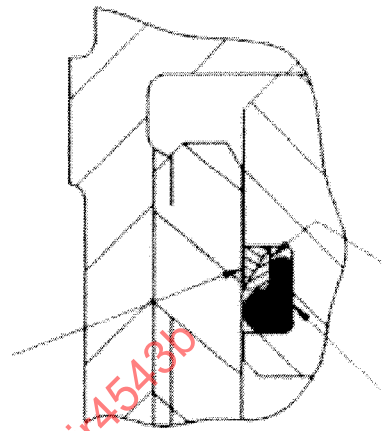
ISSUE: Because of the orientation of the pump in the aircraft, the compensator valve would be directly exposed to the flame. Seal damage and resulting external leakage would result.

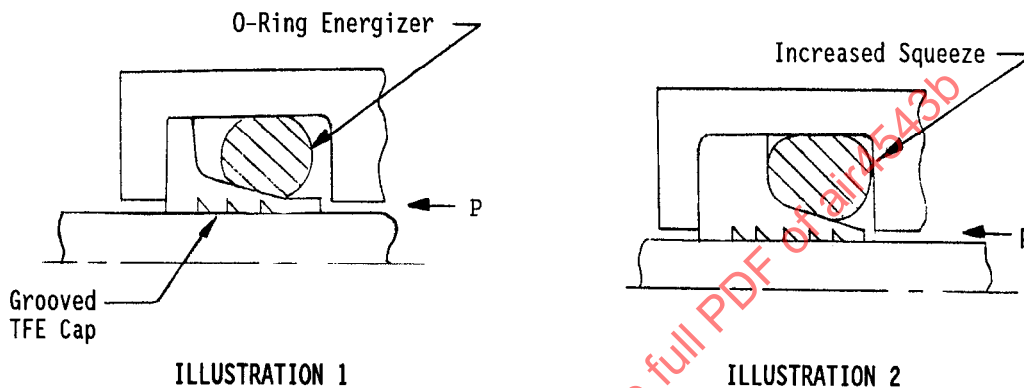
ISSUE: Actuators designed and qualified for low friction (manual reversion) applications sometimes fail leakage tests for no apparent reason. TFE capped rod seals, such as shown in Illustration 1, are usually employed to meet low friction.

- Low friction simultaneously with low leakage is a contradiction and a challenge. Analyses and development tests in concert with seal supplier(s) is required early to arrive at optimum seal configuration. (Reference Table 1).
- Strive to qualify at least one alternate seal to preclude production and delivery problems later.
- Roughening the surface of the seal with a mild abrasive prior to assembly can improve leakage. However, improvement is only temporary and uncontrolled process is undesirable.
- Typical Example: An actuator with nine capped seals suddenly experienced a 50% rejection rate after several years of production. Rejections were eliminated by increasing squeeze (fill) from 51% to 91% and increasing the number of grooves (see Illustration 2). The friction penalty was doubled, but the total friction was still well within the 104 lbf (43 N) limit.

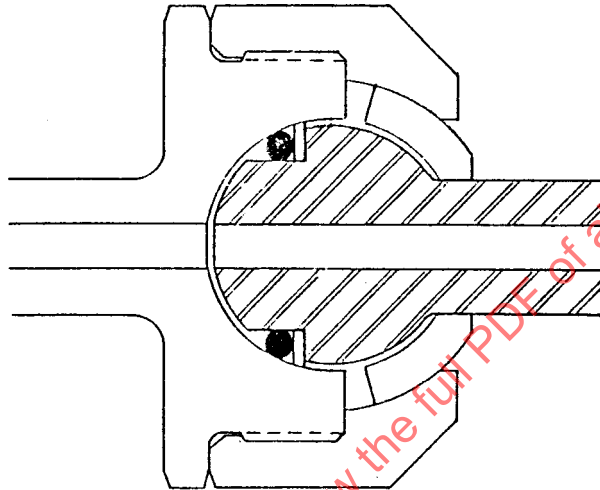
ISSUE: Many spherical ball swivels tend to leak when initially pressurized. This is caused by the ball moving, within the clearance space, away from the seal.

- Use coiled tube rather than spherical swivels, if possible.
- Increase seal squeeze, and reduce ball to housing clearance as much as possible in the design of the swivel.

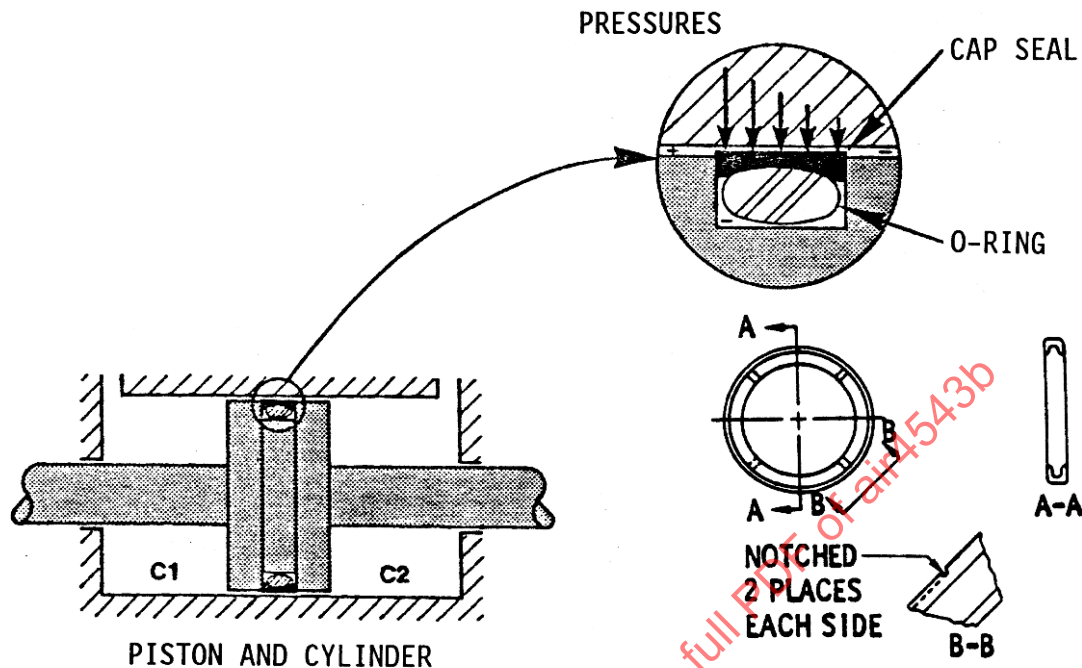
- Use of the TFE cap seal to improve wear life of piston head O-ring may result in piston stalling following a command to reverse the direction.
- Edge of TFE cap may seal on the sidewall of the seal groove following the reversal of cylinder pressures. This can momentarily trap lower pressure under the cap seal and allow bypass flow over the top of the seal.
- Without the sidewall notches, the piston cap may seal on the sidewall of the groove rather than on cylinder I.D. This can result in leakage flow from C-1 to C-2.

**SOLUTION:** Specify the addition of notches on the sidewalls of TFE or similar piston cap seals. Refer to AIR1243 for more discussion.

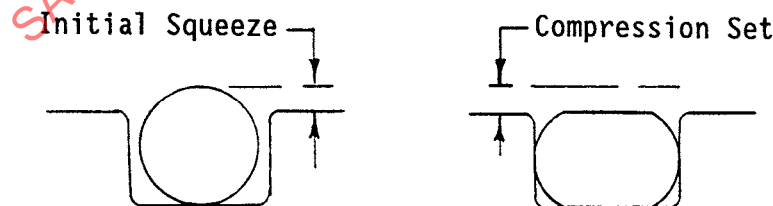
ISSUE: Small cross-section static seals, typically 0.070 in (1.8 mm) diameter, per MS28775 (superceded by SAE AS28775) or MIL-P-83461 (Nitrile) (superceded by AMS-P-83461) are prone to leakage failures. A contributing factor may be local "necking down" caused by uneven installation stretch forces for large sizes. However, the primary problem is due to compression set of the elastomer, which is critical for small cross-sections. High temperature operation for a few hours results in a permanent loss of squeeze with leakage pronounced at normal as well as colder temperatures and low pressures.

Where external seepage would result, avoid small cross-section seals especially for sizes above a 2 in (51 mm) diameter. Where they must be used, the elastomer compound should be changed:

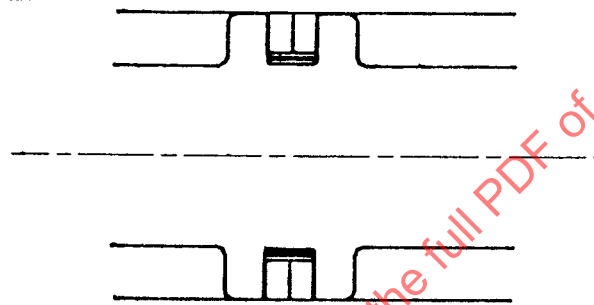
ISSUE: Small servoactuator has low flow rate, piston ring leakage prevents the cylinder to buildup  $\Delta P$  on the small piston area. The actuator lost response.

SOLUTION: Design with no-leakage-type piston ring with minimum shuttling of the seal during reversing of the flow direction.

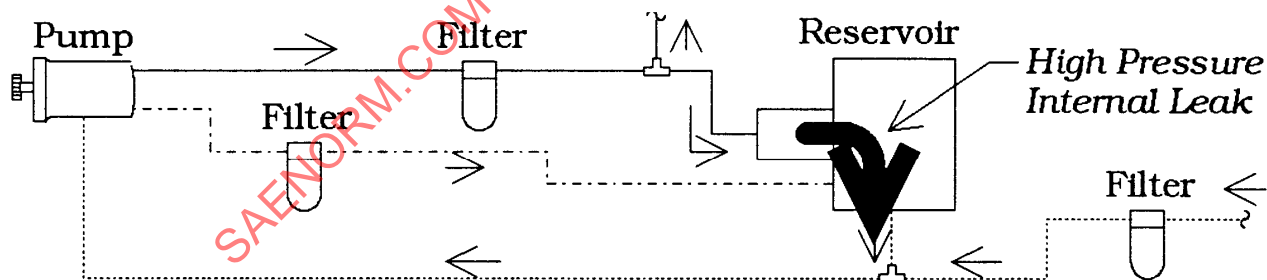
ISSUE: Extrusion/feathering of piston and rod seals results in high volume internal leakage within the reservoir and elevated system temperatures to 260 °F (127 °C).

SOLUTION: Utilize extrusion resistant materials and/or dual configurations on the high pressure piston and rod seal locations of a bootstrap reservoir and/or dual.

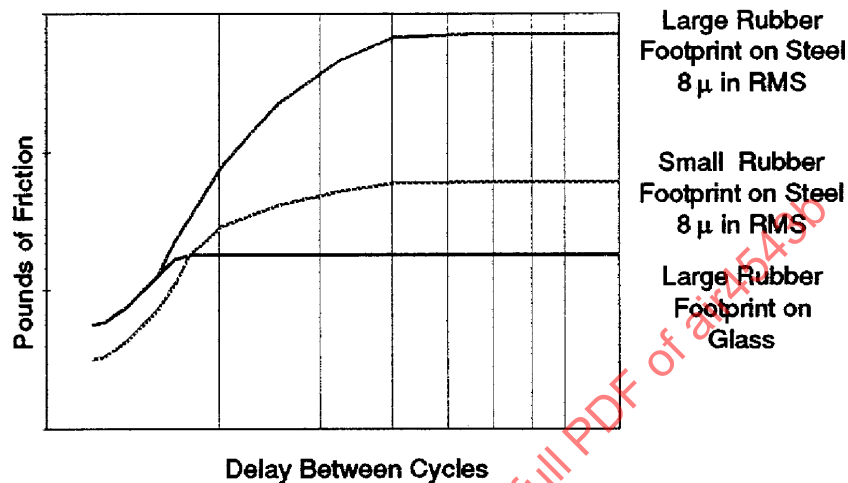
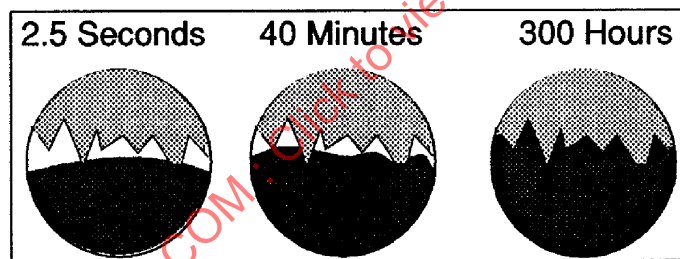
Hard coat anodize and a large rubber footprint is an unfavorable combination. The rubber extrudes into the voids and crevices of the hard coat. The degree of elastomer imbedding is time dependent but reaches a finite value  $\approx 100\%$ . The force required to shear is proportional to the amount of imbedded rubber and potentially can exceed the force available from the reservoir pressurization device.

SOLUTION: Be cognizant of the micro-surface, its relationship with seals and select seals and finishes appropriately. For this particular application, a new low pressure seal with a small controlled rubber footprint was selected. This limited the amount of extruded rubber, therefore, reducing the shear force required to an acceptable level.

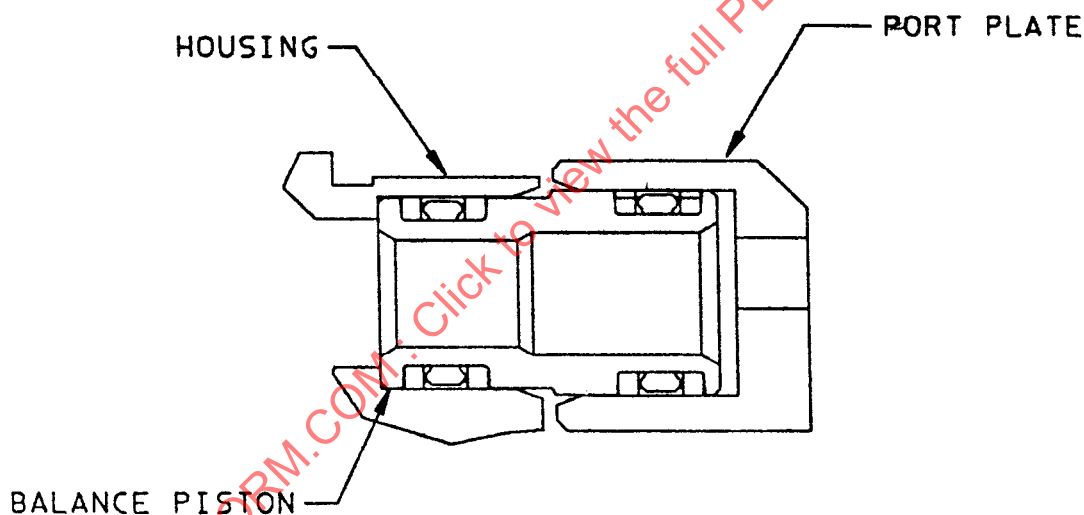
ISSUE: Cyclic/reversing pressures on floating port plate type units causes dithering wear on seals at high frequency. Can cause leakage and contamination debris

SOLUTION: Unbalancing of transfer tube causes greater force in one direction and prevents dithering motion, thus reducing seal wear and leakage.
