**(R) Aerospace Hydraulics and Actuation Lessons Learned**

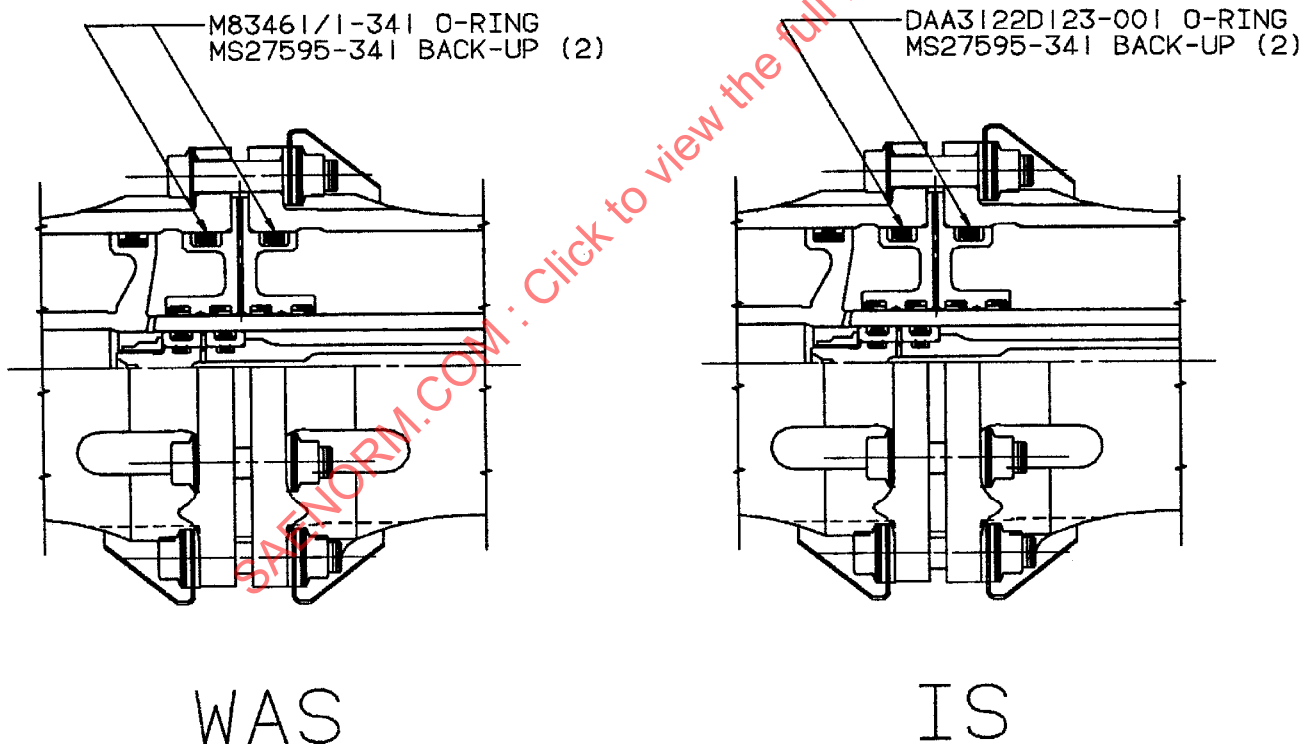
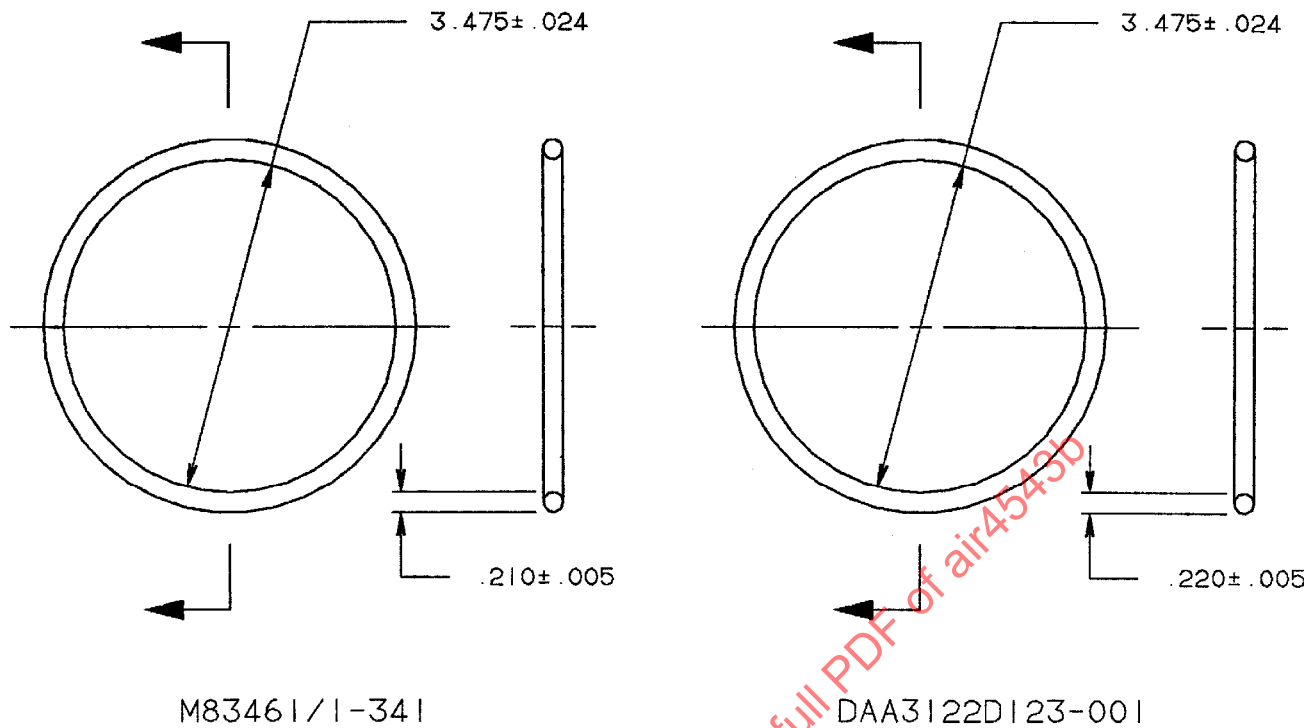
ISSUE: Leakage occurred at 4000 lbf/in<sup>2</sup> (27 600 kPa) when barrel would be expected to breathe by approximately 0.001 in (0.03 mm). Parker Handbook says high temperature Nitrile good to -20 °F (-29 °C).

SOLUTION: Changed to DAA3122D123 seal wherein cross section was enlarged by 0.010 in (0.3 mm). Minimum squeeze now 9.71% or 0.021 in (0.5 mm) passed test.

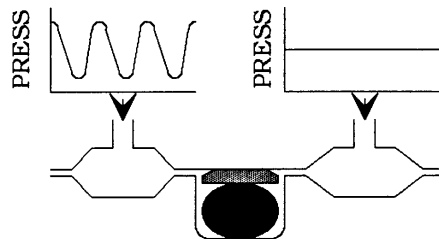
ISSUE: High cycle exercising of static seals within grooves can cause internal or intersystem leakage due to wear of sealing elements and surfaces.

SOLUTION: Utilize dual seals (vented to atmosphere) where mis-phased oscillating pressures of similar magnitude can be expected.

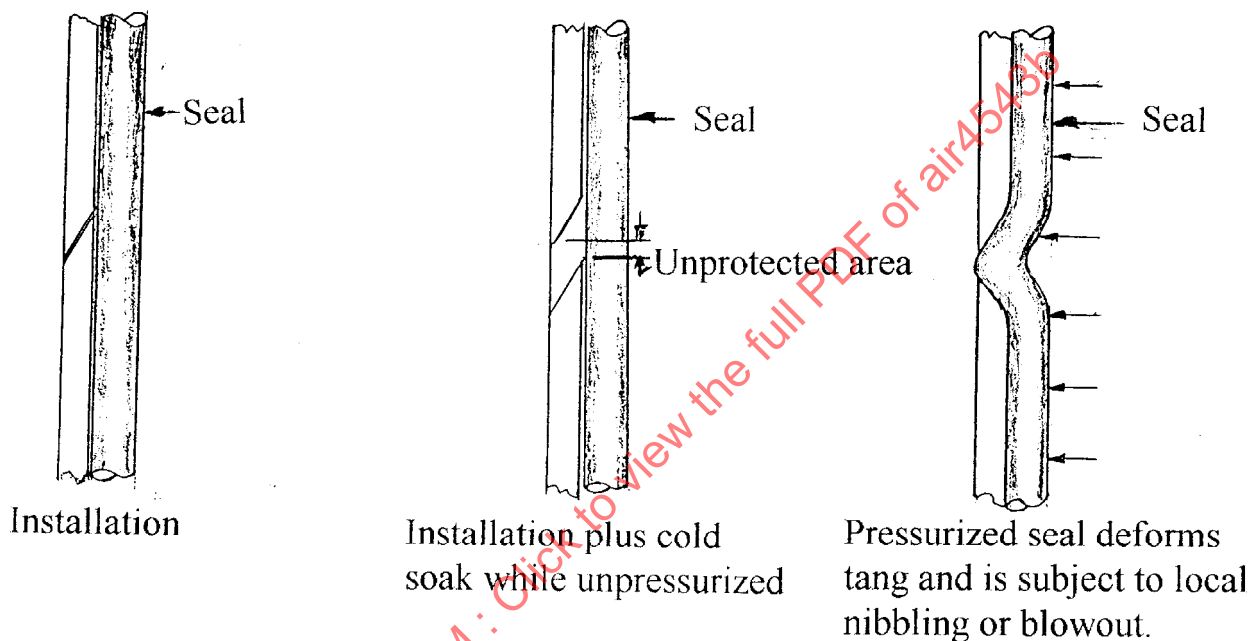
**ISSUE:** When subjected to low temperatures with zero or very low pressure applied, Teflon backup rings will shrink. On large size static seals [approximately 4 in (102 mm) bores and larger sizes], 0.052/0.045 in (1.3/1.1 mm) thickness MS28774 (inactive for new design, no known superceding document, AS4716 is relevant SAE document) scarf cut backups will gap beyond the scarf cut length with conditions of an initial room temperature followed by a cold soak at approximately -40 °F (-40 °C) and with zero or very low pressure applied. Subsequent high pressure application, while in the shrunken condition, will drive the elastomer into the gap and subject it to possible blowout or nibbling failures.

- Use uncut Teflon backups for larger bore sizes. Do not use MS28774 (inactive for new design) which are not designed for current gland standards.
- An applied axial seal pressure of approximately 100 lbf/in<sup>2</sup> (690 kPa) or greater will prevent shrinkage at low temperatures. (Considers elastic modulus of Teflon, coefficient of friction of Teflon on a smooth metal surface and the projected axial force on the backup due to pressure.) However, this is not a situation that one would live with.

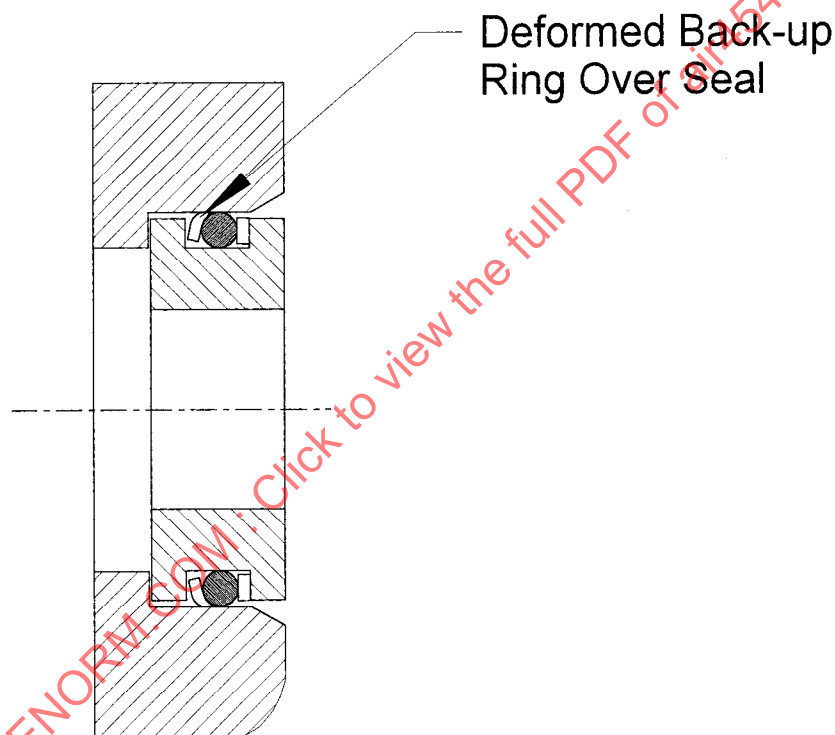
**ISSUE:** Installation of O-ring seal with two backups resulted in first backup deforming over O-ring.

**Use Only One Back-up Ring**

**SOLUTION:** Change design to eliminate upstream backup, i.e., single backup design which has short insertion of backup ring.

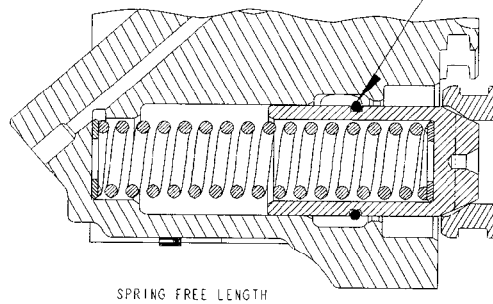
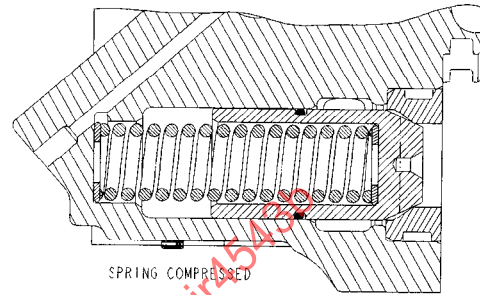
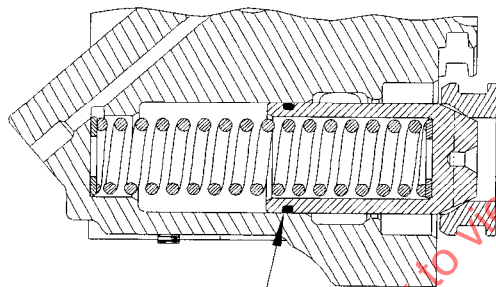
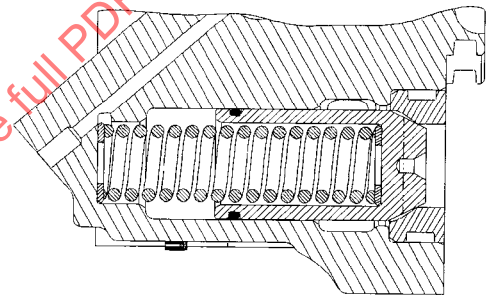
**ISSUE:** Seals are damaged and leak on pistons which are used to preload springs in components. Seals do not engage bores before springs begin to compress.

Seal Not Engaged  
Prior To Blind Assembly

SOLUTION: Design components so that seals engage bores prior to assembly of mating components, i.e., compressing springs. Assembly is simplified and avoids damage to seals.

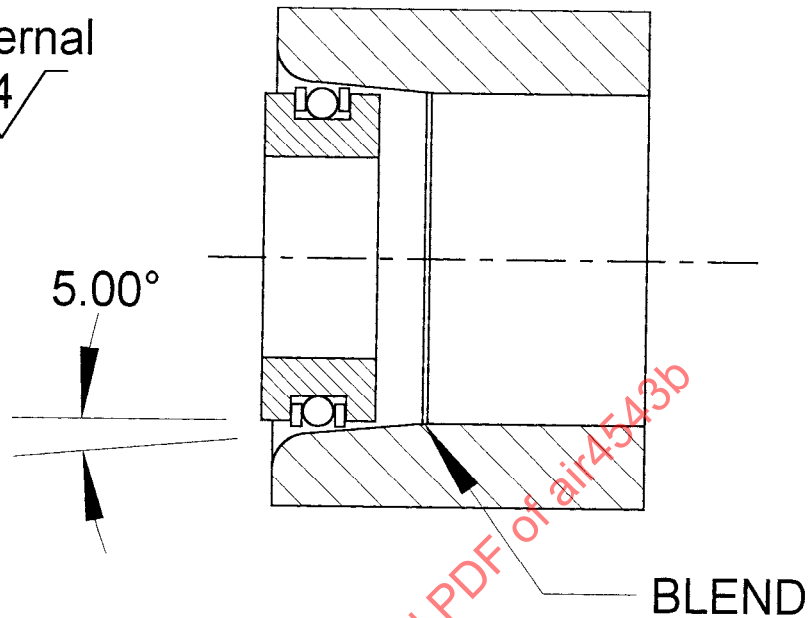
ISSUE: Upon installation of solid backup rings and O-rings of a piston seal into a bore, damage to backup rings occurred.

SOLUTION: Use a compression type assembly tool to size backup rings prior to assembly into bores.

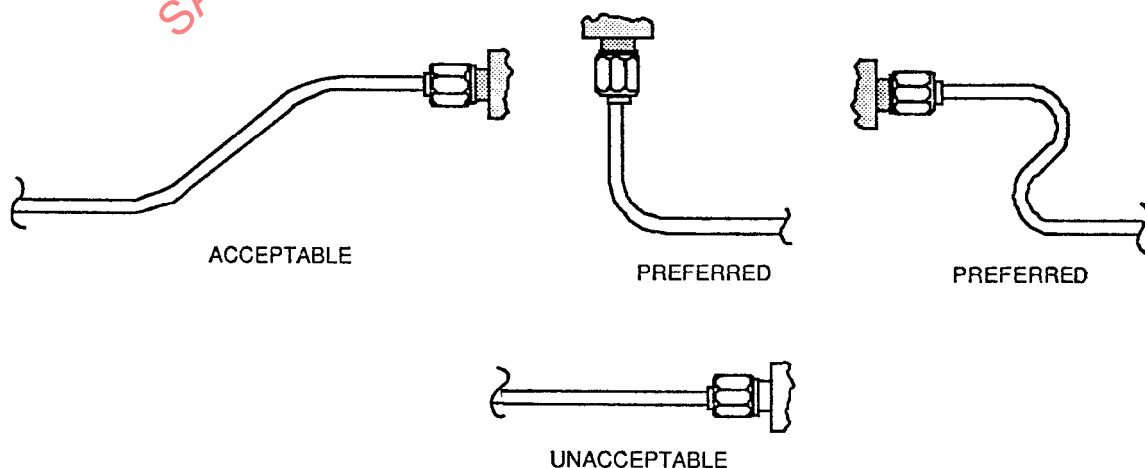
- During initial installations, tubes without flexibility cannot be sufficiently extended for fit.
- Tubes without flexibility sustain damage from pressure surges and vibration.

SOLUTION: Incorporate bend(s) in the hydraulic tubing to increase the tolerances and dissipate surges.

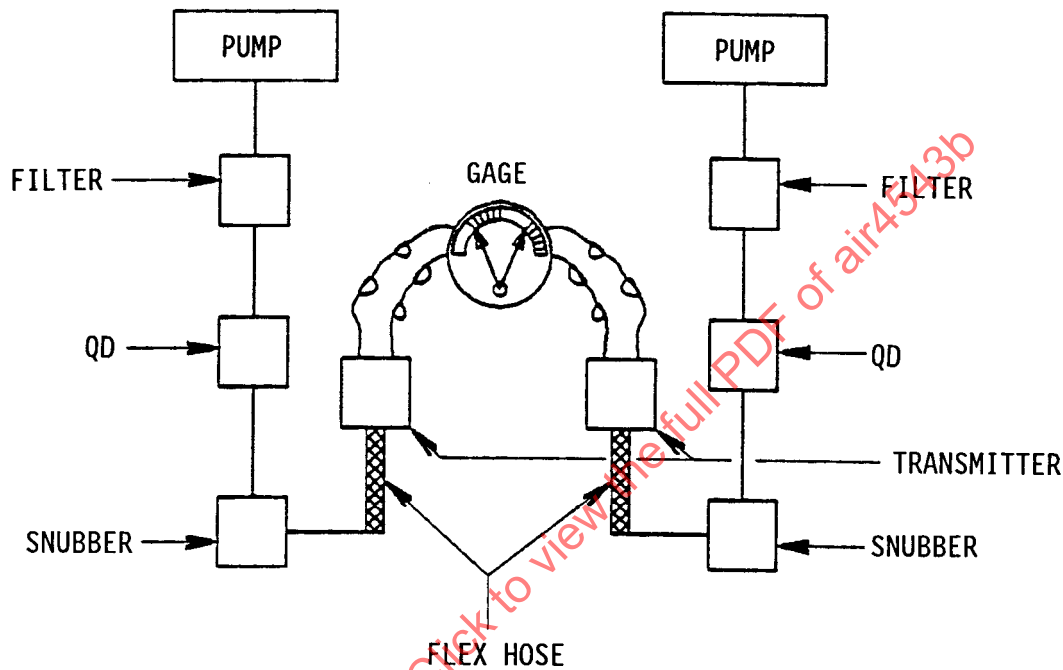
ISSUE: While both pumps were off one gage indicated a pressure reading. It was discovered that the inner lining of the flex hose collapsed and had acted like a check valve.

SOLUTION: Replace the flex hose.

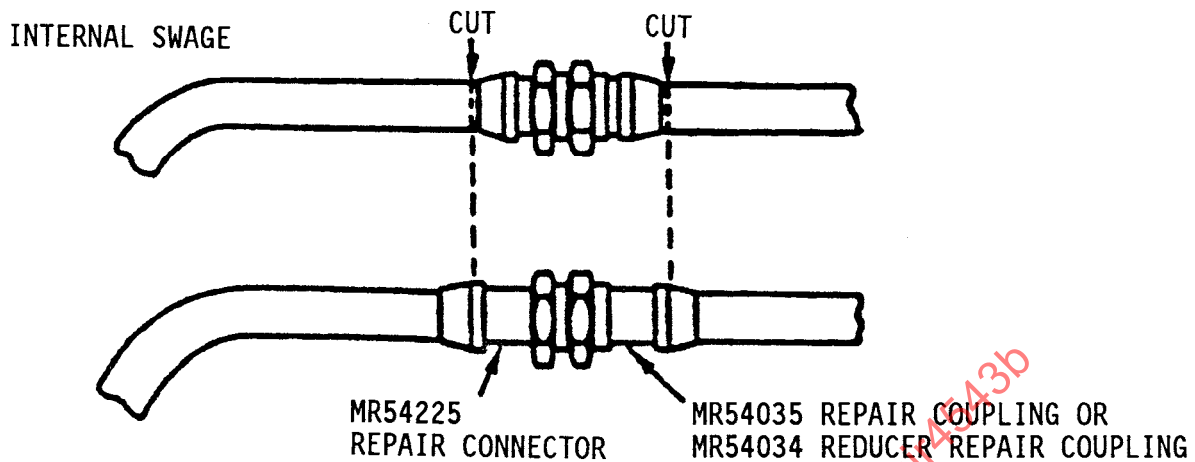
- A repair fitting is an option for leaky and/or damaged fittings if a sufficient clearance and straight tubing section is available.
- Leaky or damaged fittings cannot be repaired.

SOLUTION: Allow sufficient clearance and straight tubing sections at fittings so that repair fittings may be employed.

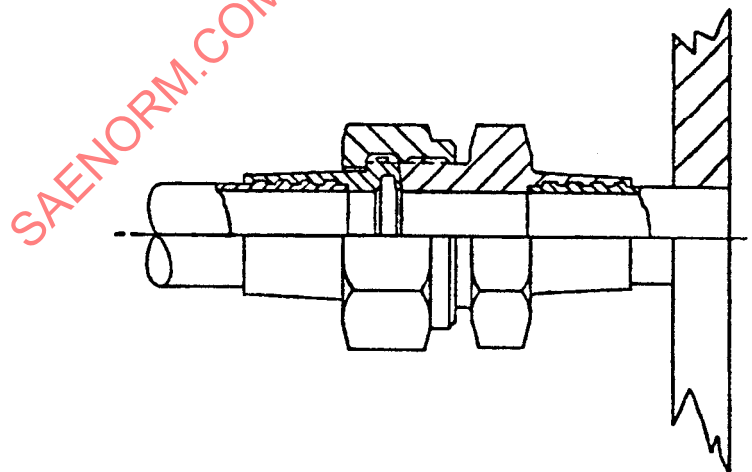
- When a male/female connection of a permanent installation or tubing is damaged, the female connector usually sustains the damage.
- The female fitting is more susceptible to damage since the male fitting is more durable and can be dressed.

SOLUTION: Incorporate the female fitting on the removable component. The male end can be repaired in place.

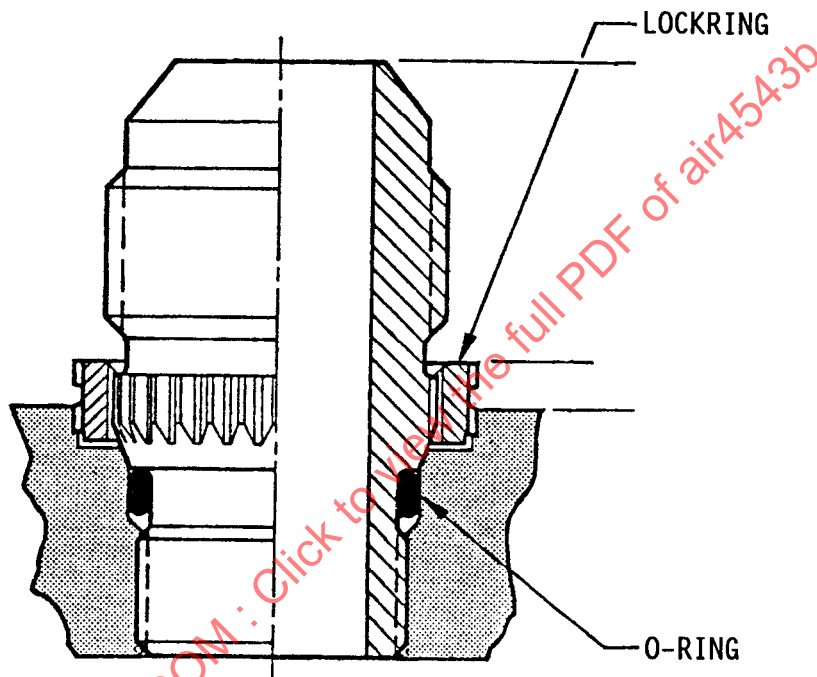
- A component with a damaged port can be salvaged if removable boss fittings are employed.
- When the port of a component is suddenly impacted (dropped, struck) and damaged, the component is discarded if the port is not replaceable.

SOLUTION: Removable boss fittings should be employed whenever possible.

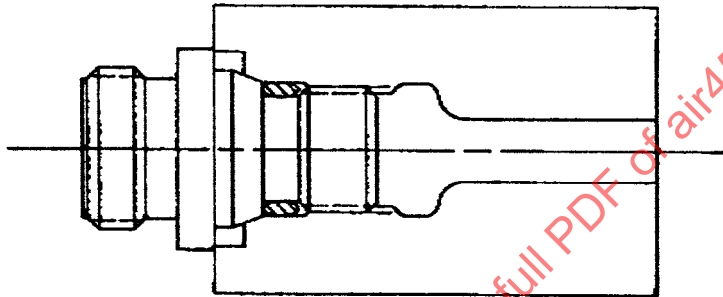
Standard -6 Rosan Port

ISSUE: "Wet" thread configuration caused short failure life 700,000 cycles.

SOLUTION: "Dry" thread increased fatigue life to 2.8 million cycles by incorporation of an O-ring and back-up at bottom of thread.

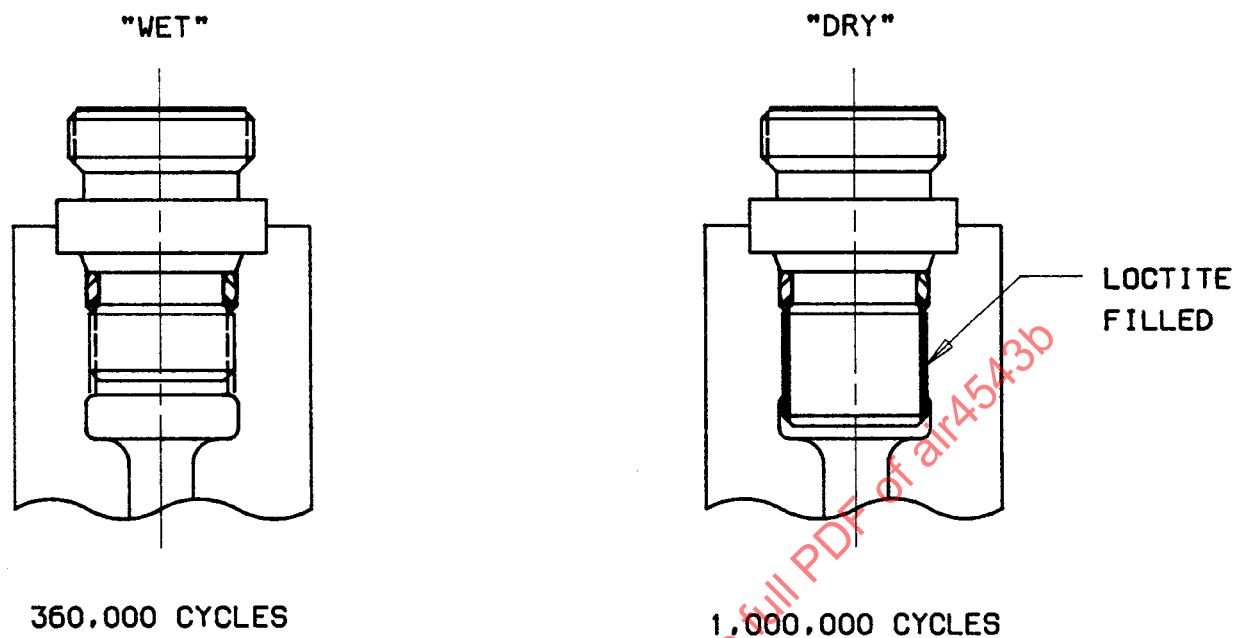
ILLUSTRATION:

PROBLEM: Boss fatigue failure.

ISSUE: "Wet" threads reduce life at 7500 lbf/in<sup>2</sup> (51 700 kPa), 200 °F (93 °C).

NOTE: Sample Sizes of Six

SOLUTION: Use "dry" threads with plug threads extended beyond port threads.

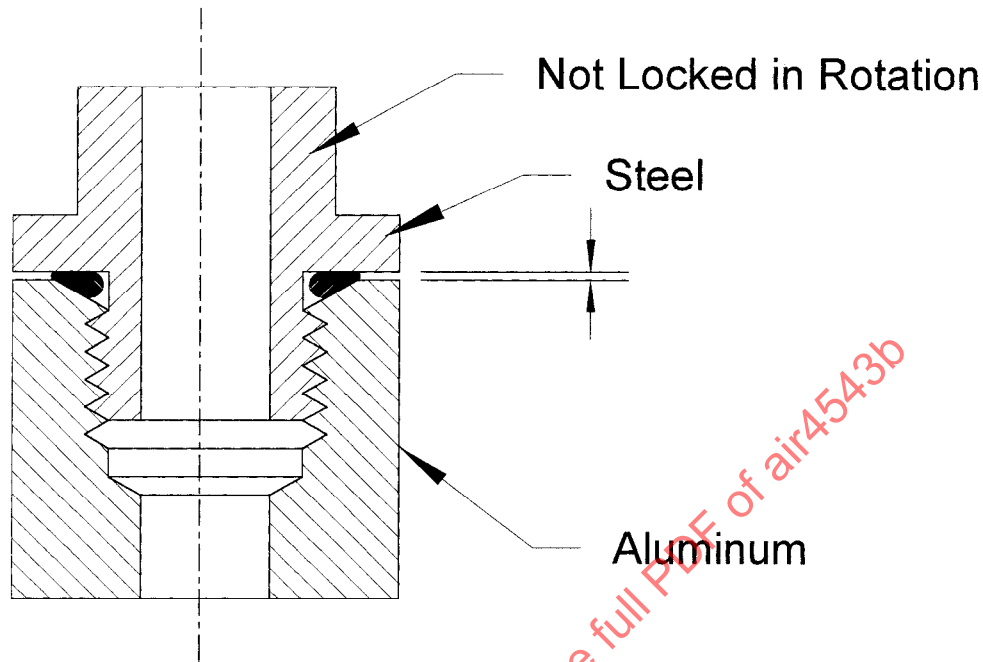
ILLUSTRATION:

PROBLEM: Quick disconnects (steel) of the MS boss type loosen in service when installed in aluminum manifolds due to pressure impulse.

ISSUE: MS boss type quick disconnects were backing out of aluminum bosses. No positive lock for rotation other than torque was incorporated.

SOLUTION: The use of Loctite on the quick disconnect to boss threads has eliminated this loosening and backing out.

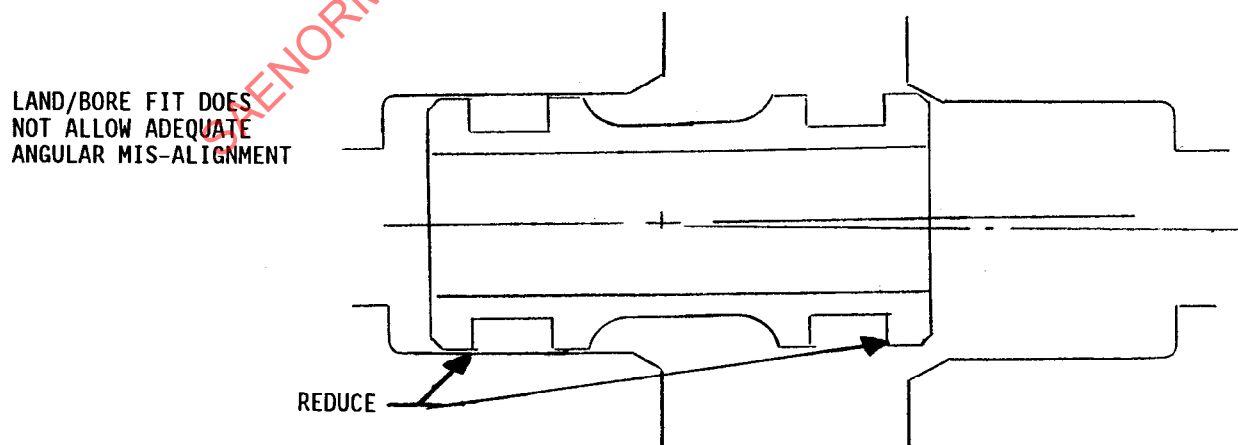
ILLUSTRATION:

ISSUE: Quills do not accept housing misalignment.

SOLUTION: Reduce the diameter of the seal lands furthest from the interface to provide angular play.

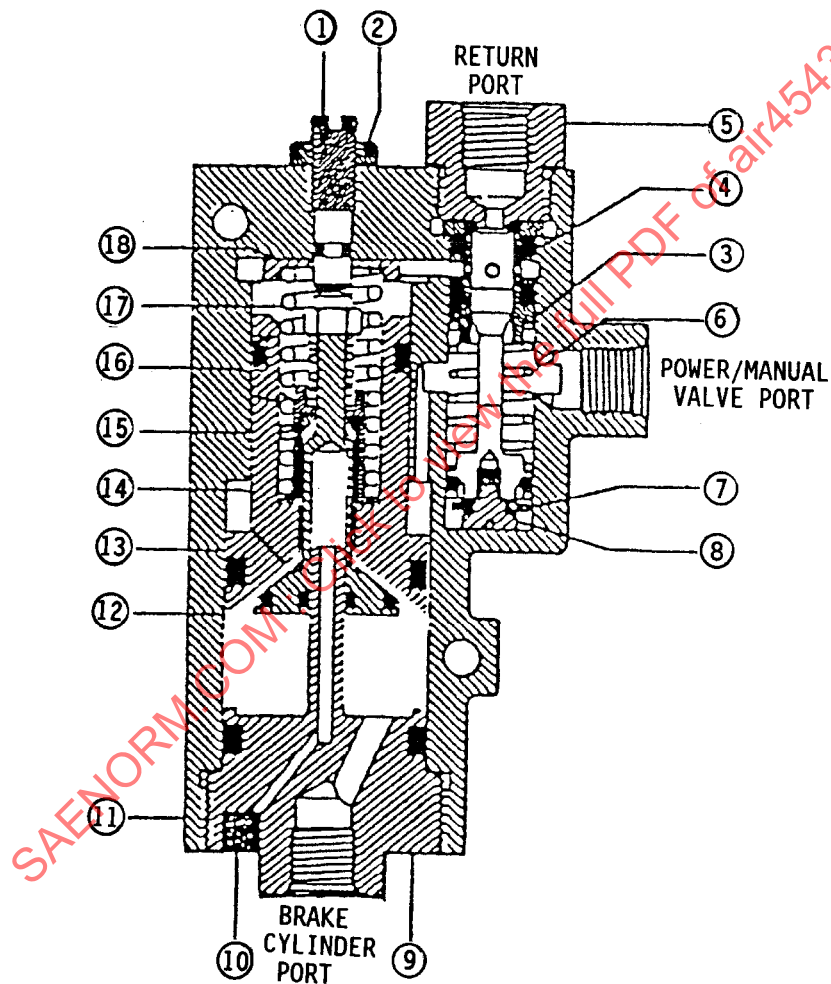
ILLUSTRATION:

- a. Many hydraulic components have areas requiring atmospheric vents protected by filter screens.
- b. Some screens have been totally clogged by improper painting.

SOLUTION:

- a. Do not paint vent holes.
- b. Insure that the design aids vent hole recognition.

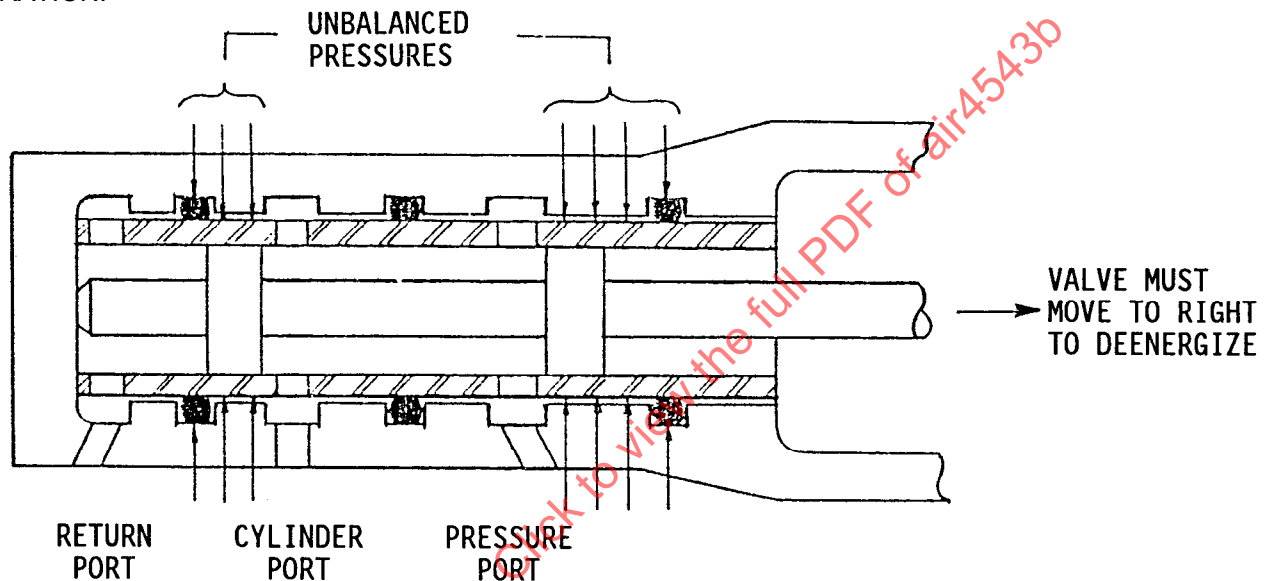
**ILLUSTRATION:**

**PROBLEM:** Unbalanced pressures cause sleeve to pinch valve slider.

**ISSUE:** Many valves have hung up or failed to operate because a high pressure on the outside of a sleeve was not balanced by an equal pressure inside the sleeve. In the valve shown, the controller would not return to the de-energized position.

**SOLUTION:**

- Attempt to balance the pressures inside and outside of the sleeve so that there will be no reduction in sleeve diameter.
- When complete balancing is not possible, increase the clearance between the sleeve and slider. Include an acceptance test to demonstrate valve operation at a pressure higher than that to be experienced in service.
- Incorporate at least three pressure balance grooves in each controller land.

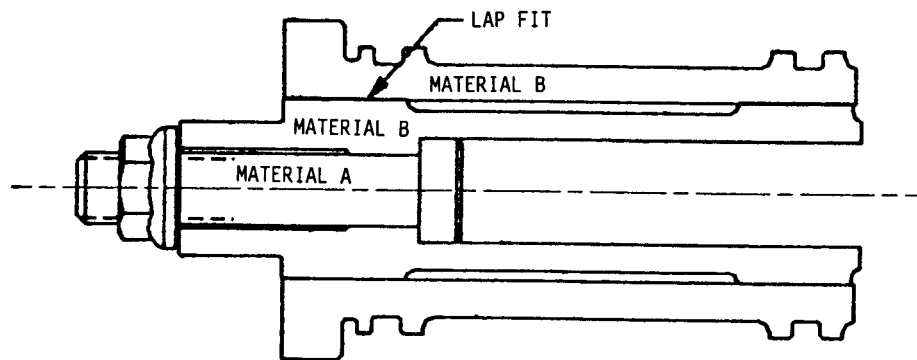
ILLUSTRATION:

- Spool is clamped/loaded with different materials of A and B.
- Lap fitted diametral clearance changes due to axial load increasing from differential thermal expansion axially.

SOLUTION: Increase lap clearance during manufacturing.

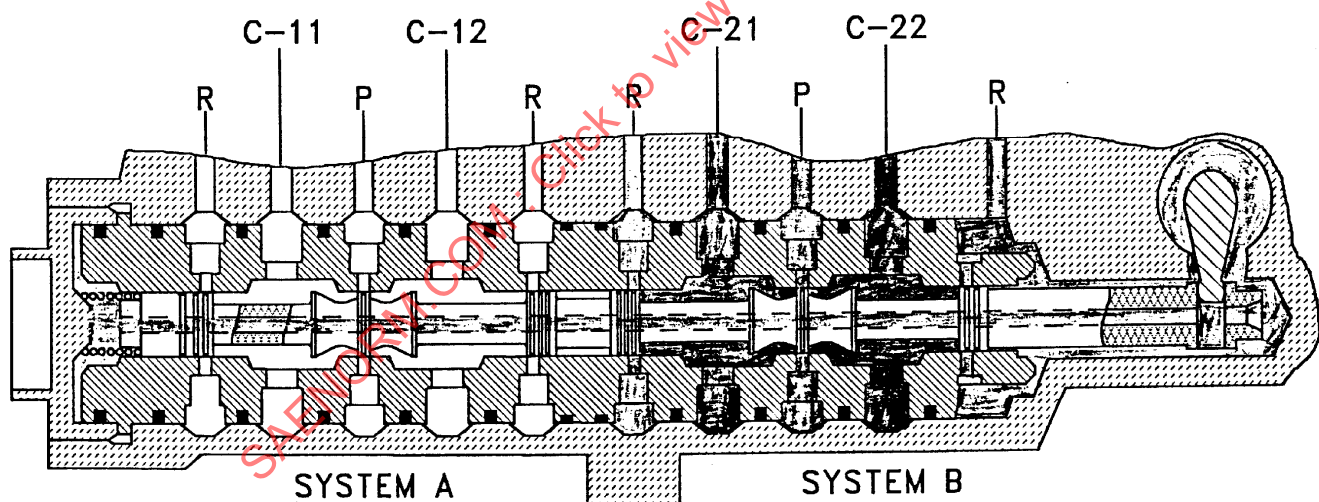
ILLUSTRATION 1 – CURRENT VALVE DESIGN

ISSUE: Pressure impulses in valve return act on valve spool and cause valve oscillations.

SOLUTION: Mask ends of spool from pressure impulses.

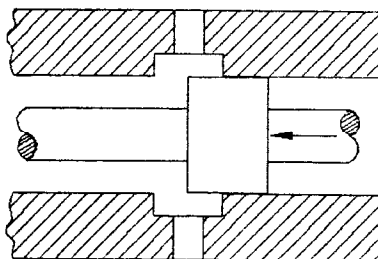
ILLUSTRATION:

ISSUE: Spool land having to cross by an undercut in the valve sleeve.

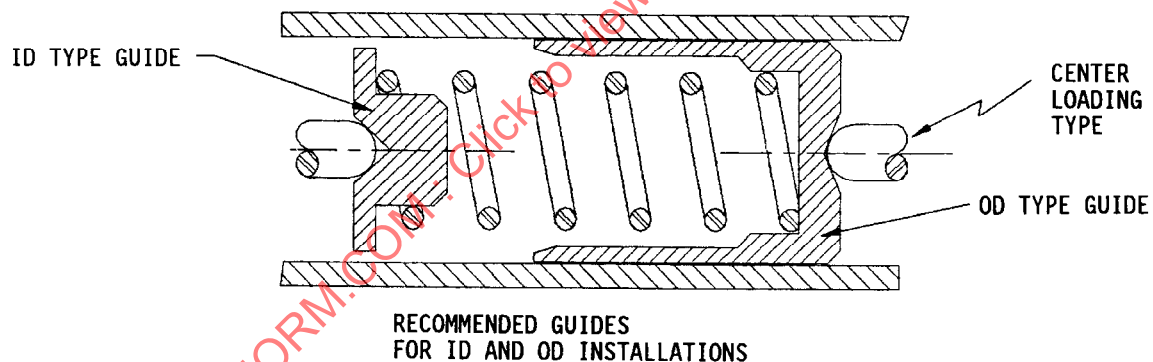
## ILLUSTRATION:

PROBLEM: Spring friction in valves.

ISSUE: Inadequate or improper guide.

## SOLUTION:

- a. Provide guide, with chamfers, at both ends of the spring (ID or OD) for 1-1/2 to 2 coils.
- b. Increase the clearance between the guides and bore diameter.
- c. Where possible, eliminate the side loading by centering the spring load.

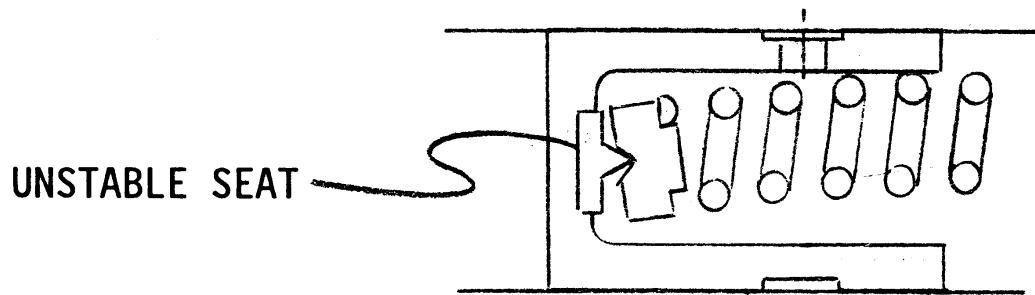
ILLUSTRATION:

ISSUE: Spring pivots, located outside of the spring, cause the spring to buckle and bear against the valve spool.

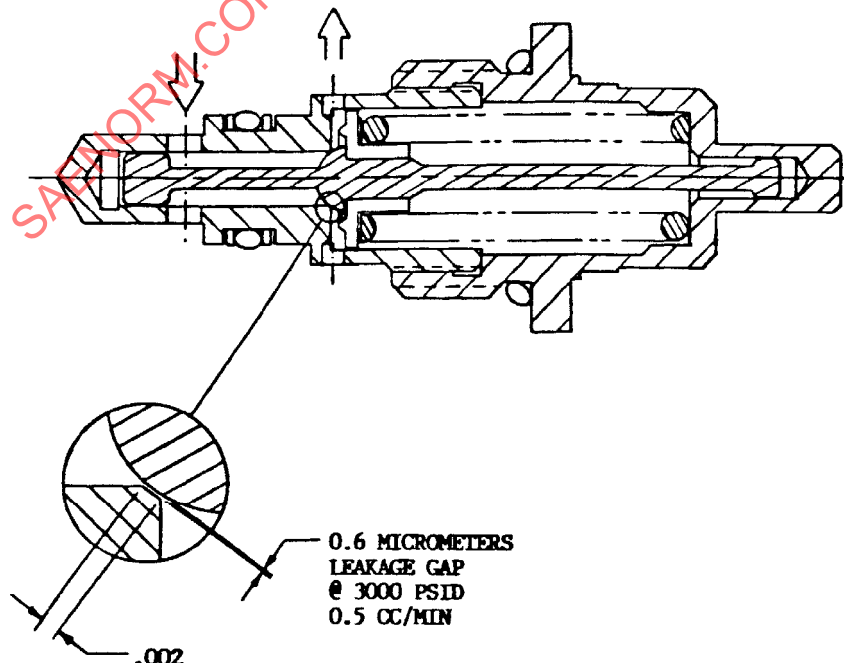
ILLUSTRATION:

PROBLEM: Poppet style metal-to-metal relief valves for high pressure hydraulic systems (3000 lbf/in<sup>2</sup> (20 700 kPa) and up) demonstrate erratic shutoff performance for leakages less than 1 cc/min. High reject levels (10 to 20%) occur between the valve manufacturer and the system contractor, resulting in costly documentation, retest and often, Not-As-  
Stated reports.

ISSUE: Relief valve leakage is usually measured on decreasing pressure tests at slightly below the cracking pressure. Net poppet force, hence seat stress, is low since the upstream pressure force is only slightly less than the spring force. Low seat stress means microscopic voids from seat imperfections and fluid particles.

SOLUTION: Assure that the valve leakage specification is realistic. Consistent shutoff to 1 or 2 drops per minute can be achieved with ideal conditions but not in real hydraulic environments. Elastomeric sealing may be required for repeatable near zero leakage.

Assure test conditions are the same at the valve manufacturer and system contractor, and that they accurately simulate the valve's end use.
