**Plain bearings — Appearance and  
characterization of damage to metallic  
hydrodynamic bearings —**

**Part 1:  
General**

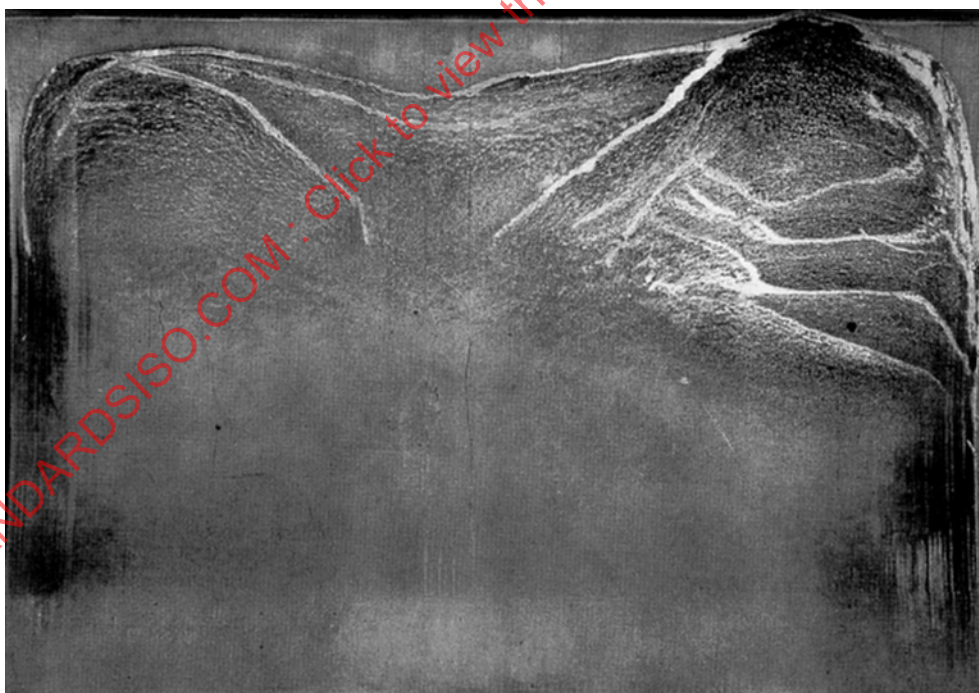
Figure 3 — Creep deformation, shown by crack-free semicircular bulges in the direction of rotation (material: steel/tin-based white metal)

Creep deformation: shallow depressions of bearing material in the region of maximum load and temperature, beginning smooth and ending in crack-free semicircular bulges in the direction of rotation, sometimes like crests of waves (see Figure 3).

Loading of the bearing was higher than that allowed for in the design and/or the bearing temperature was higher than estimated for an extended period.

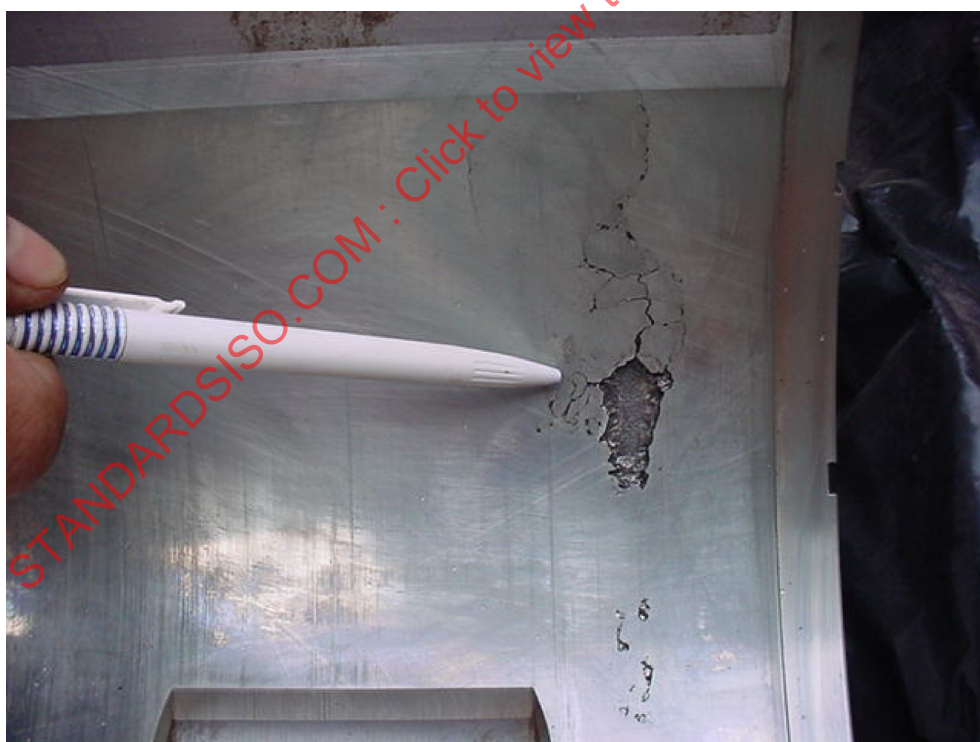
**Figure 10 — Fatigue cracks and material relief by dynamic overload  
(material: steel/tin-based white metal)**

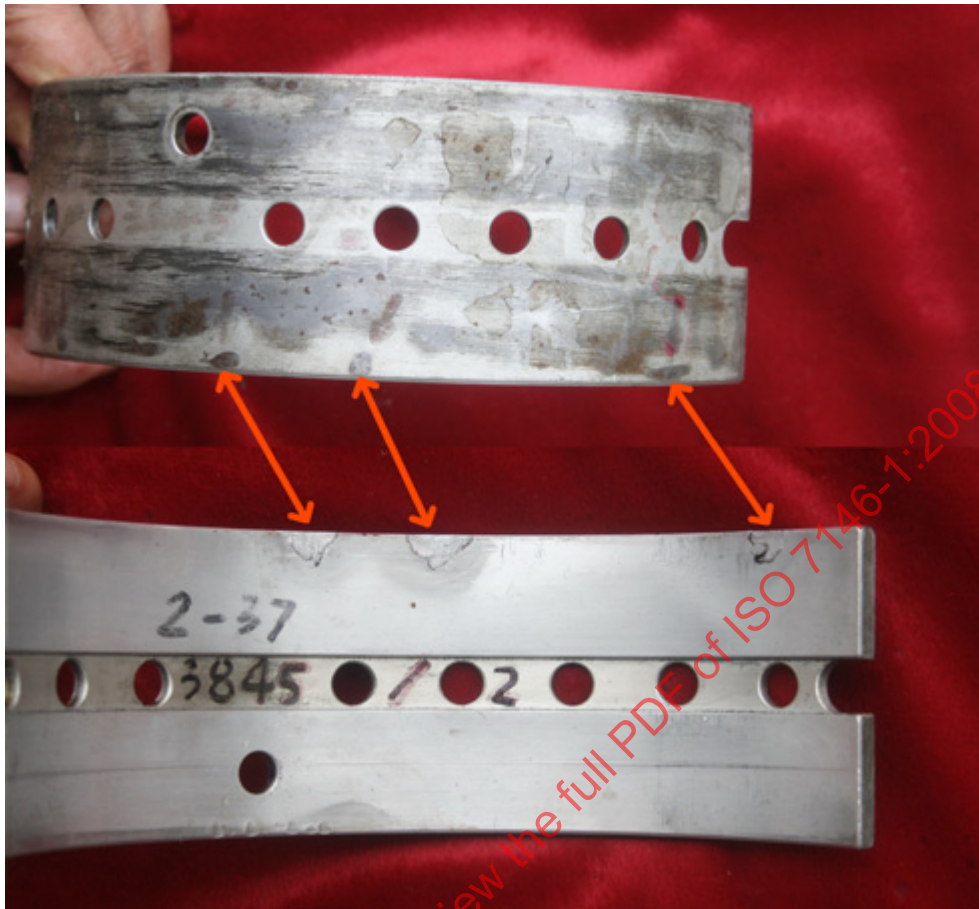
Figure 11 — Material relief by dynamic overload because of insufficient fit on the bearing back  
(see also 7.2)

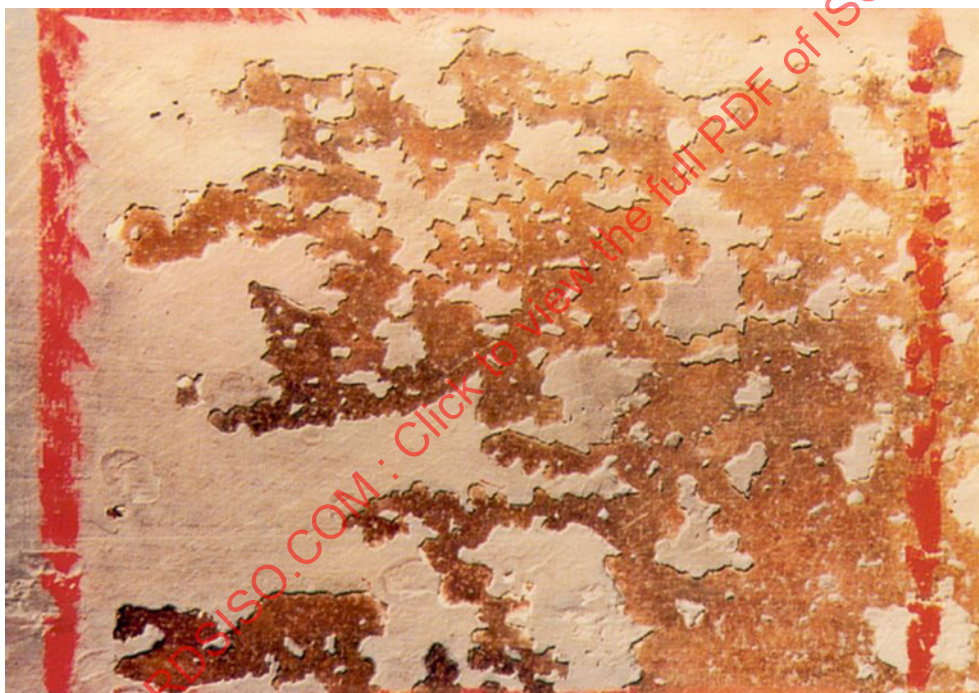
b) section from Figure 12 a): clear illustration of the defect at increased magnification

**Figure 12 — Detachment of the overlay leaving occasional residual islands relieved by a dark background (material: steel/lead bronze/electroplated overlay)**

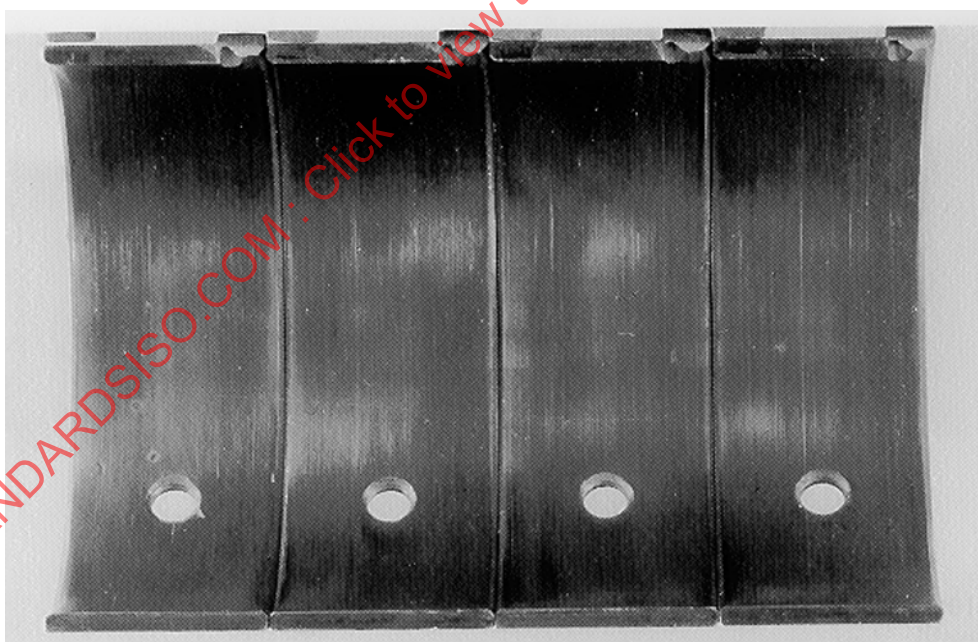
**Figure 13 — Running-in polishing and burnishing in the main loaded area of a thin-walled bearing (material: steel/AlSn)**

Polishing happens during a short period of mixed lubrication on start and stop conditions. As long as this polishing does not give rise to a detectable reduction in wall thickness, such running-in marks are normal. This is not damage in the sense of the definitions of this part of ISO 7146 (see Figure 13).

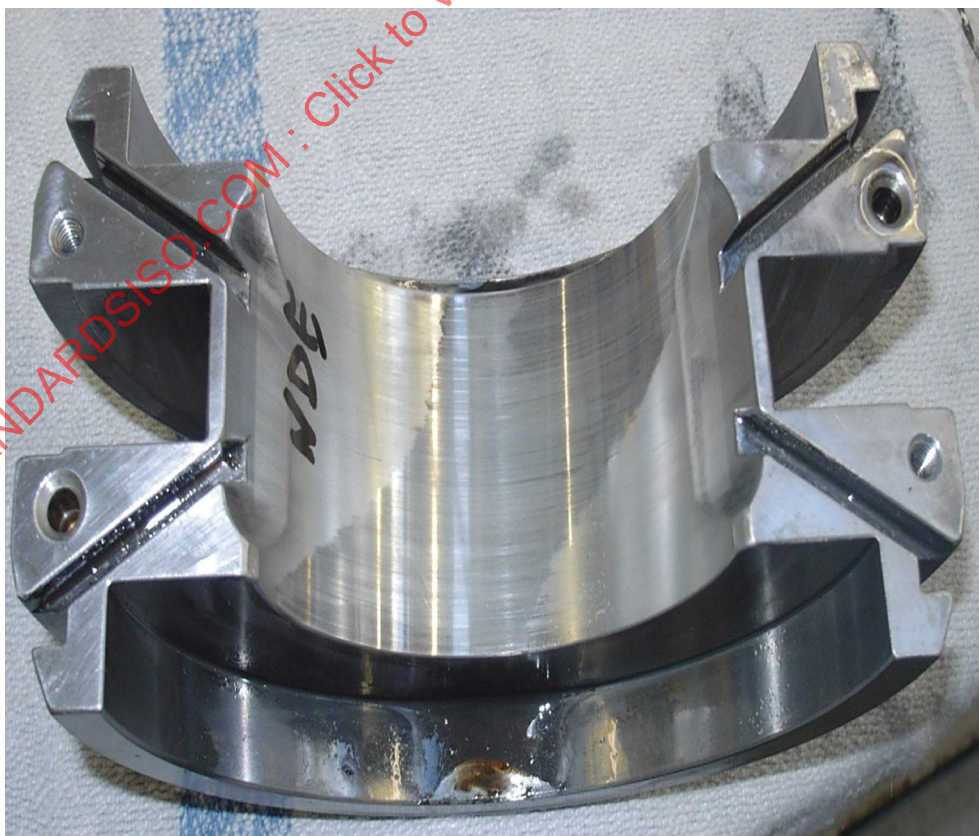
**Figure 17 — Wear by misalignment between bearing backing and shaft (material: steel/tin-based white metal)**

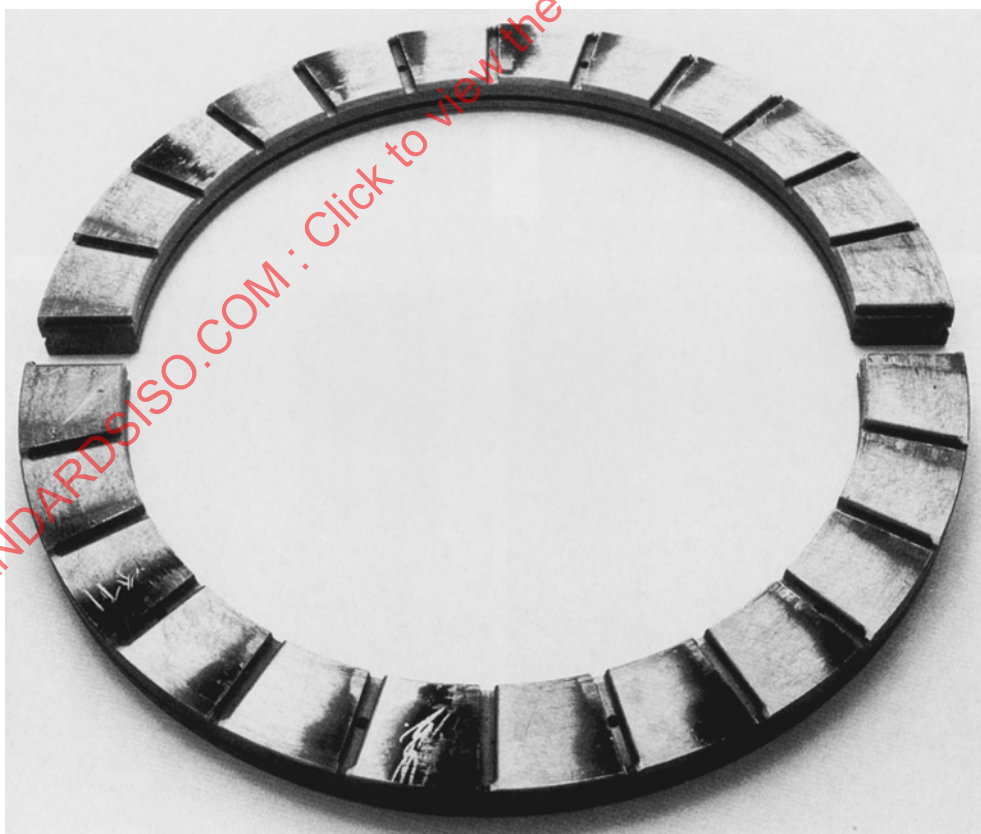
**NOTE** The black/brown deposit is easily removed using the thumbnail (see lowest segment).

**Figure 20 — Deposit of oil carbon on a thrust bearing ring (material: steel/tin-based white metal)**

Brown or black deposits appear on the bearing surface, but not as a result of chemical attack between the bearing material and the lubricant. The discoloration is due to very thin lacquer-like oxidized layers in areas of maximum temperature. It is relatively soft and can generally be removed using a solvent cleaning fluid or scratched off using a pointed instrument (see Figure 20).

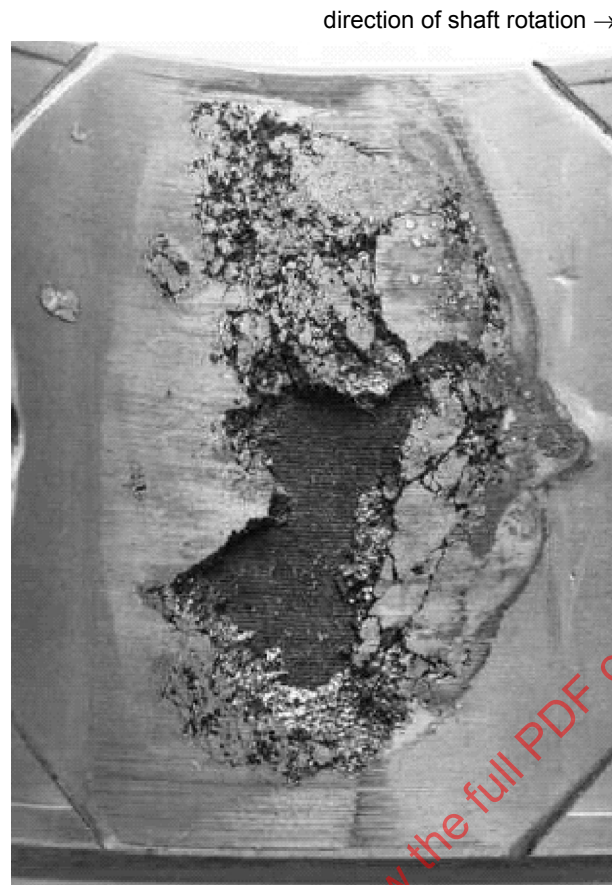
**Figure 21 — Radial segments with thermal cracks and worn material  
(material: steel/tin-based white metal)**

Thermal cracks have an irregular unsystematic orientation characteristic. These typical appearances can be characterized as creep deformation, traces of mixed lubrication and worn material (see Figure 21).

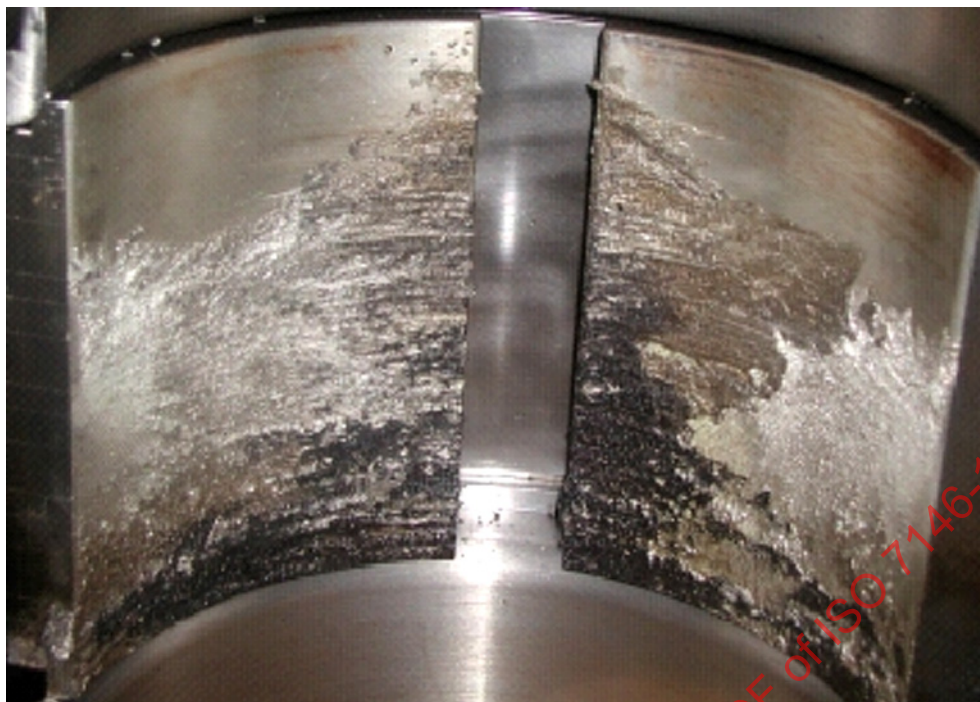
**Figure 27 — Coloured surface due to loss of lubricant, melting out, seizure  
(material: steel/tin-based white metal)**

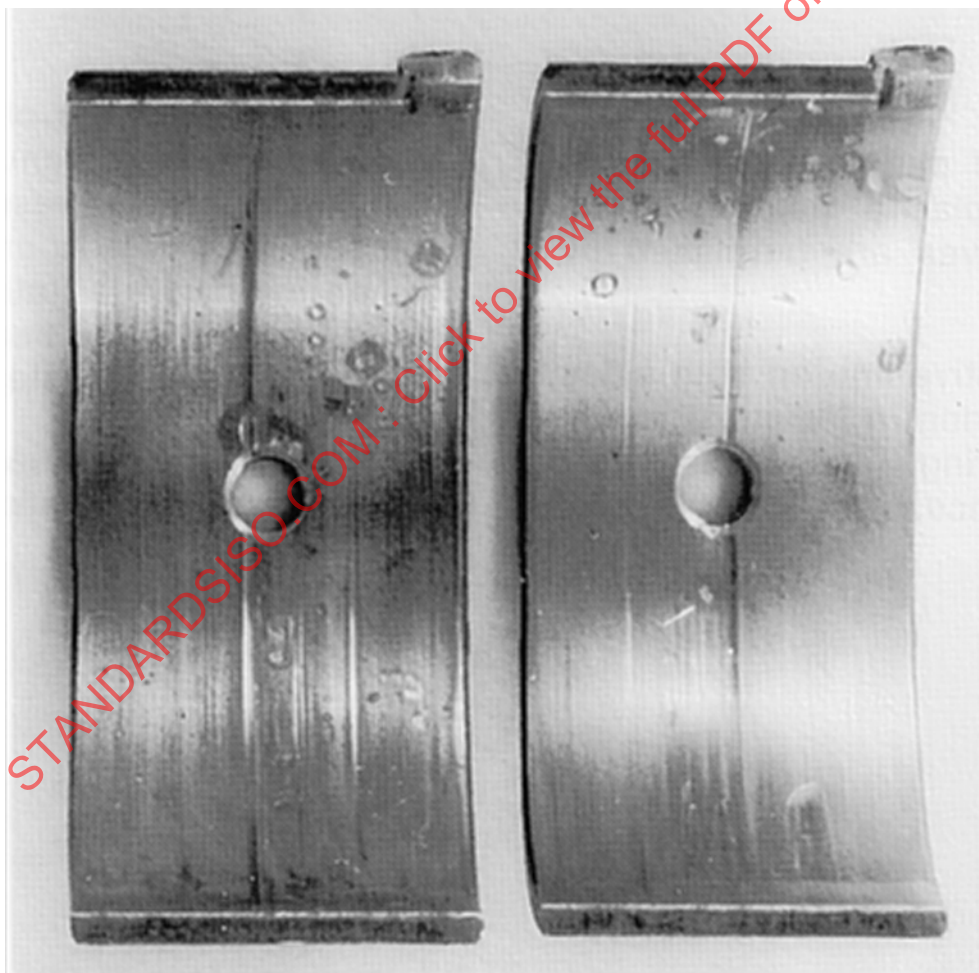
Figure 29 — Embedding of particles, characteristic of embedding, see Figure 28, and migration tracks (material: steel/AlSn)

Particle-migration tracks (see Figures 29, 32, 33 and 34).

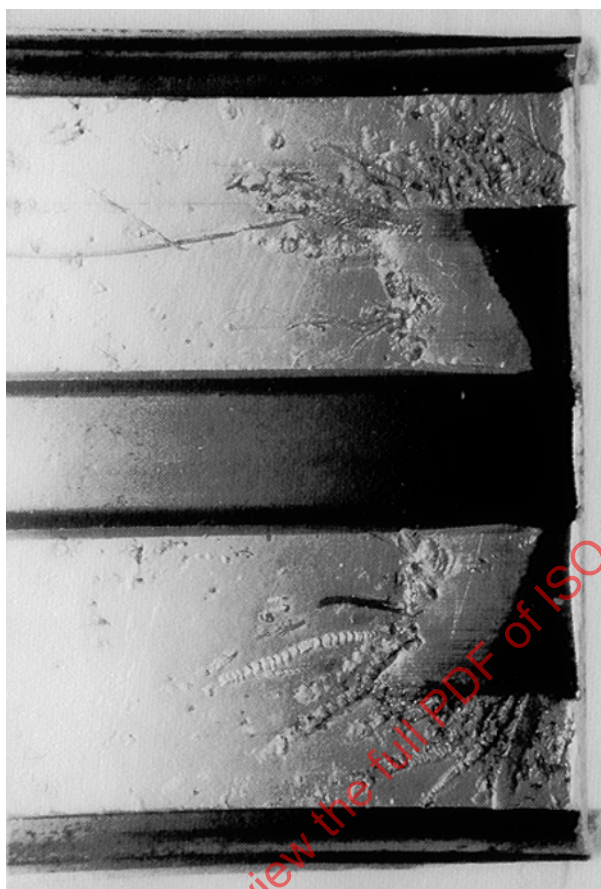
**Figure 34 — Particle-migration tracks concentrated to the pocket area of a thin-walled bearing  
(material: steel/AlSn)**

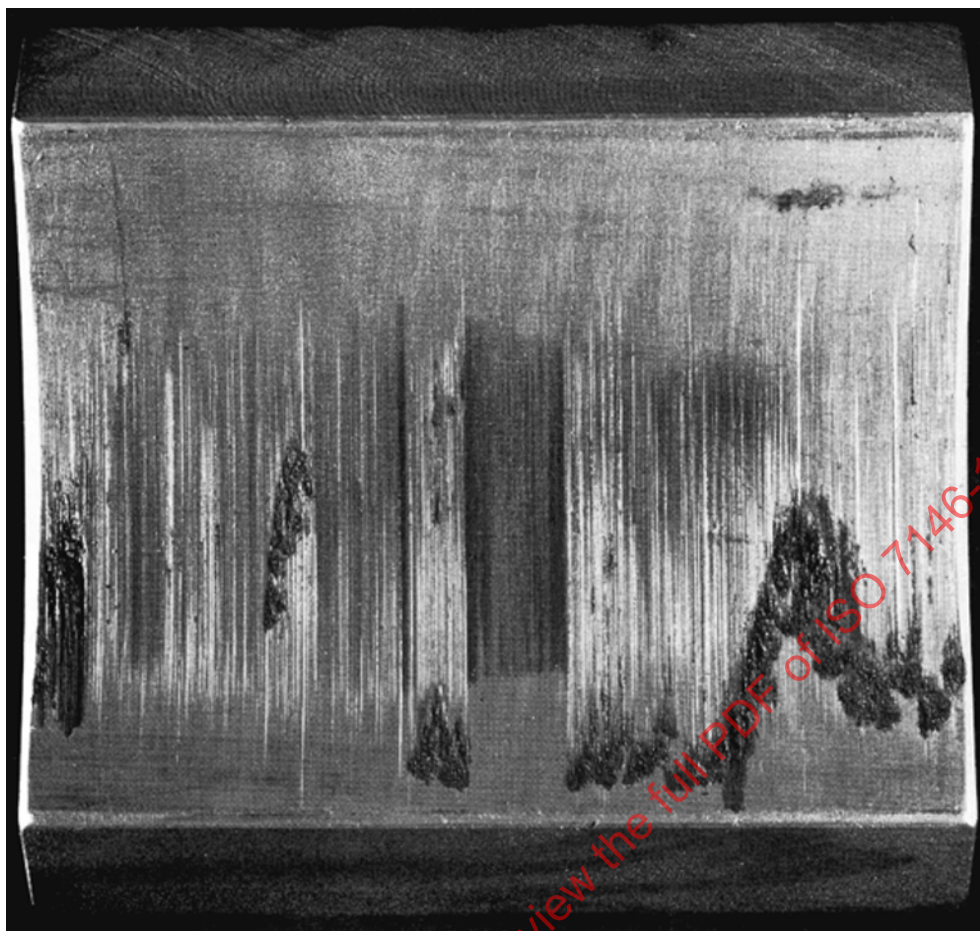
a) wire wool on a journal pad (material: steel/tin-based white metal)

b) wire wool on the shaft

**Figure 35 — Attack caused by abrasive and adhesive effects in the initial stage (wire wool) (material: steel)**

The formation of wire wool can be caused by hard foreign particles partially embedded in the bearing surface cut into the rotating shaft thereby removing material from the shaft surface. Wire wool formed in this way can also be once more embedded in the bearing metal and usually brings about total failure very quickly (see Figure 35).

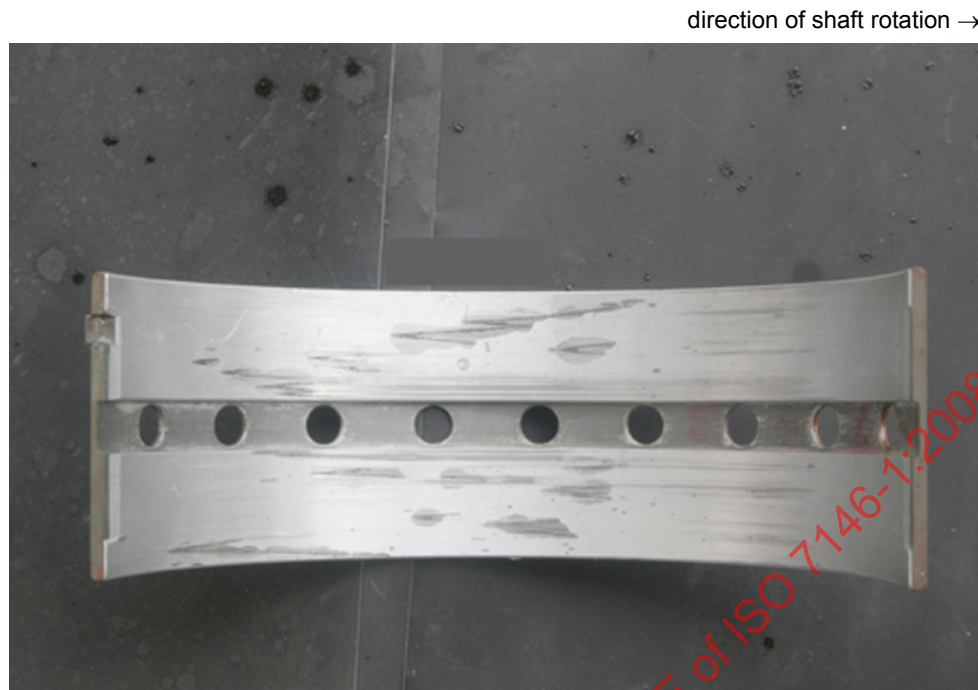
**Figure 36 — Chevron-like defect caused by particles from iron nitride compound layer of nitrided shafts (material: steel/lead bronze/electroplated overlay)**

Chevron appearances are particle-migration tracks generated by hard particles. The chevrons point in a direction opposite to the direction of rotation of the journal (see Figure 36).

Chevron appearances: The migration tracks are caused by particles originating from the surface of nitrided journals. Particles with magnetic properties spall from the journal due to insufficient grinding and removal of the white friable layer.

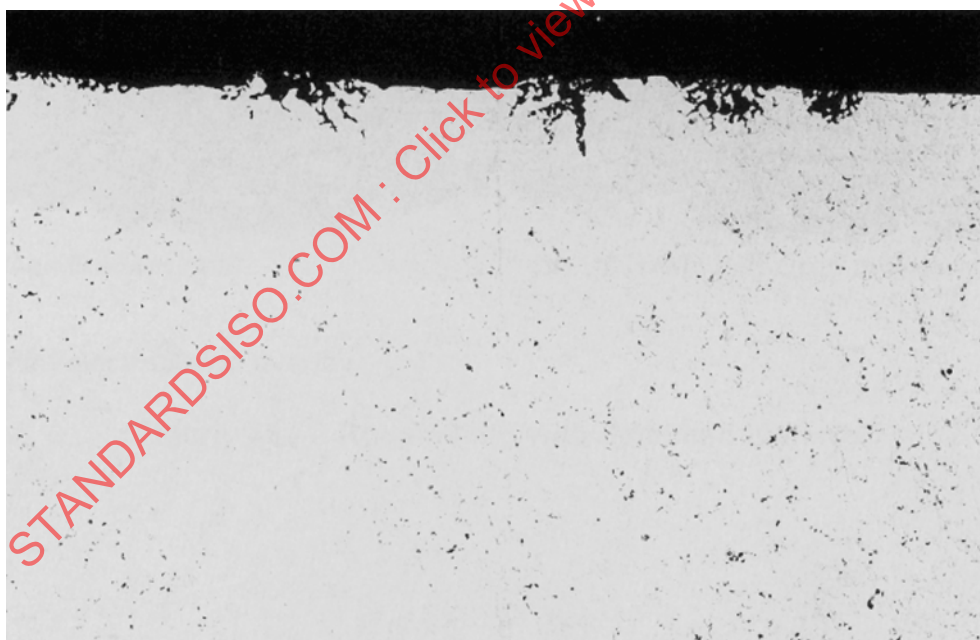
**Figure 40 — Corrosion of the surface layer with selective attack on copper and lead in a  
tin-based material, unetched (material: steel/tin-based white metal)**

← direction of shaft rotation

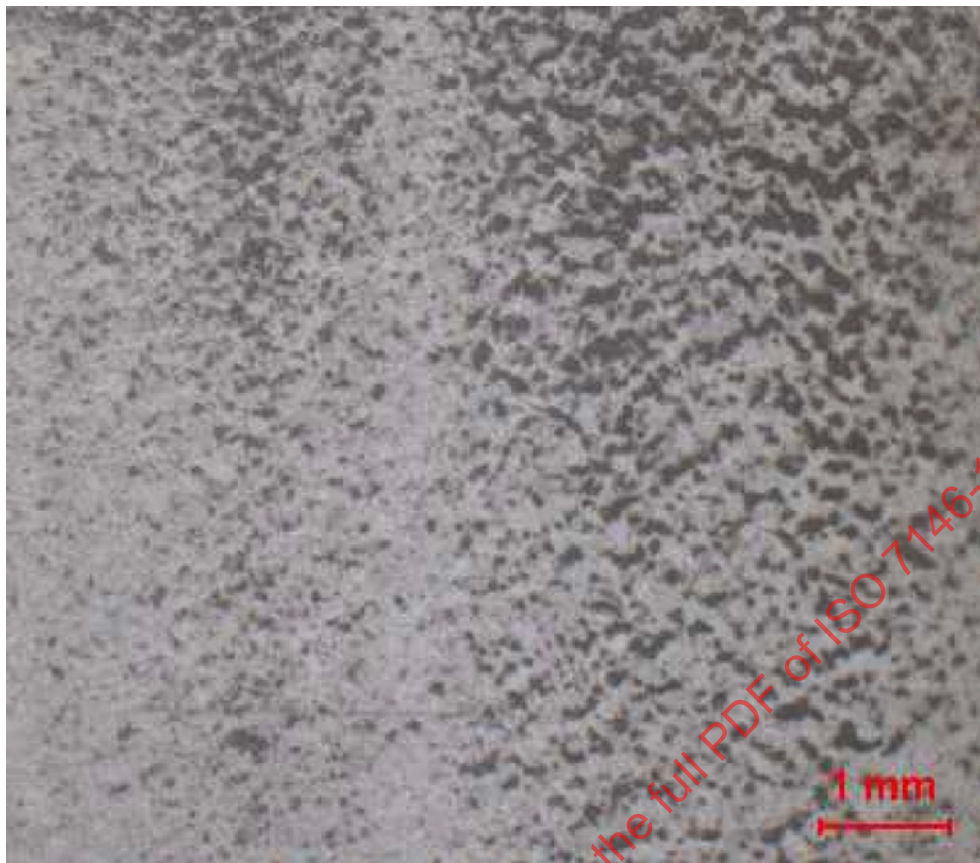
Figure 42 — Deposit of oil carbon on galvanic surface

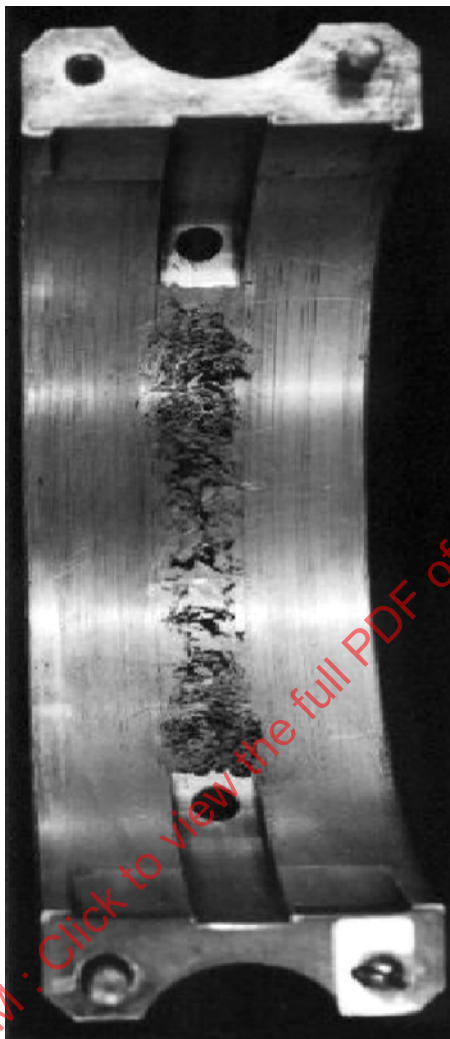
Figure 43 — Typical cavitation erosion on a thick-walled bearing (material: steel/tin-based white metal)
