**ARP1658****REV. B**

## Hose Assemblies, Installed, Visual Inspection Guide For

This SAE Aerospace Recommended Practice (ARP) covers visible surface defects on aerospace hose assemblies which have been installed and are functioning within a working environment at the time of visual inspection.

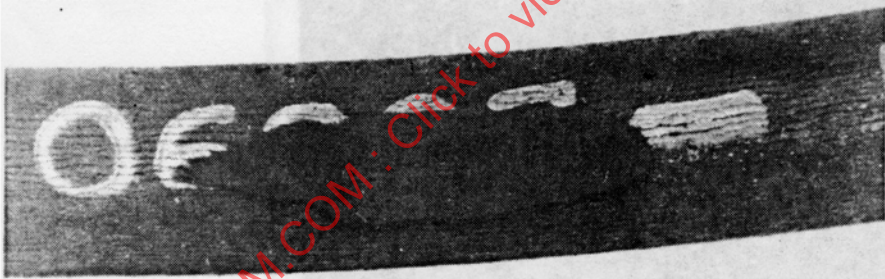
FIGURE 5 - Kinked Assemblies - Minor and Major  
Low and Medium Pressure PTFE Hose (MIL-H-25579/MIL-H-27267, AS620, AS1227, or AS1946)

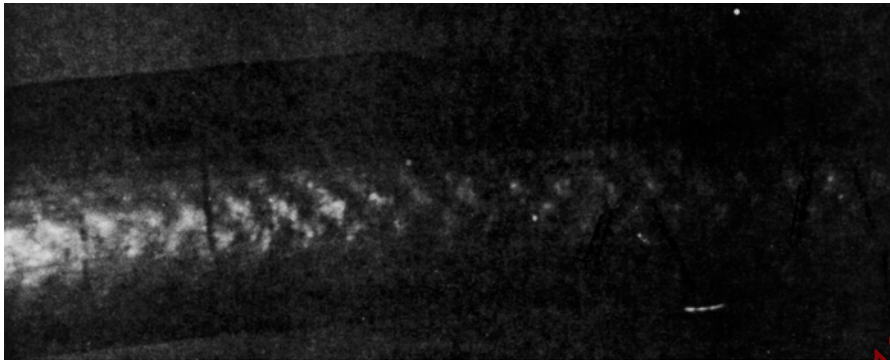
FIGURE 13 - Weathering - Minor and Major  
High Pressure Rubber Hose With Rubber Covering (MIL-H-8788)

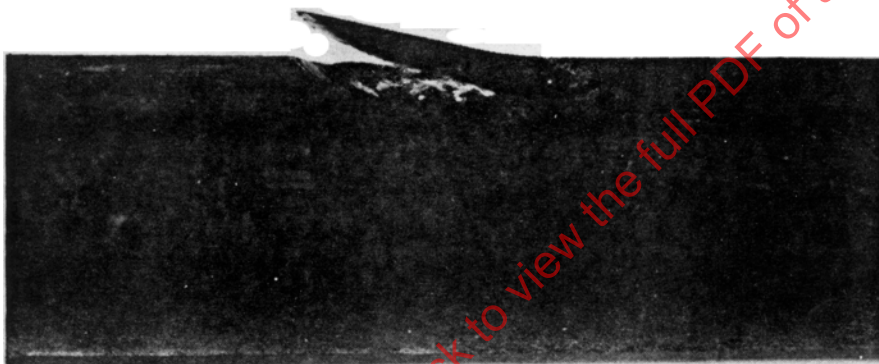
FIGURE 23 - Tears - Minor and Major  
High Pressure Rubber Hose With Rubber Covering (MIL-H-8788)

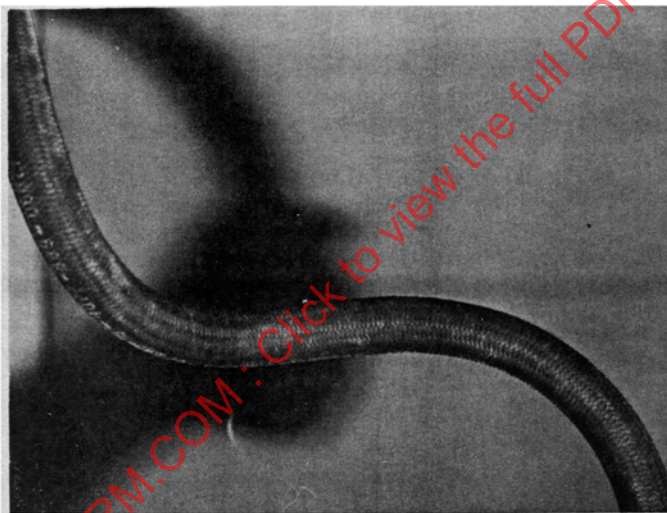
FIGURE 24 - Twist - Minor and Major  
Medium Pressure Rubber Hose With Fabric Cover (MIL-H-8794)

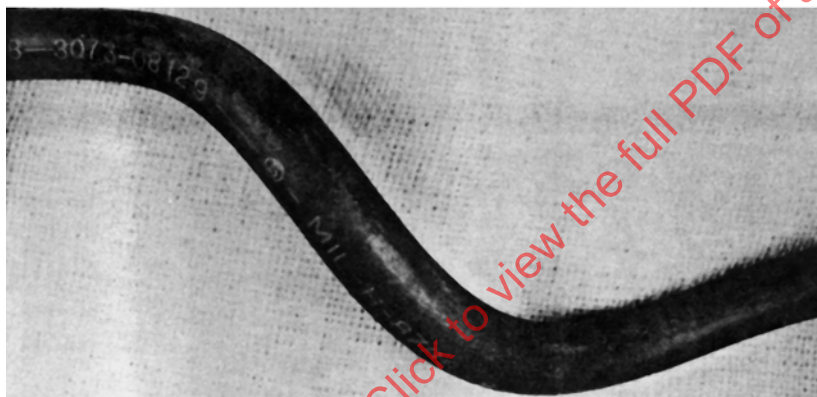
FIGURE 25 - Twist - Minor and Major  
High Pressure Rubber Hose With Rubber Cover (MIL-H-8788)
