SAE AS1895/21

FIGURE 1 - AS1895 COUPLING FLANGES AND SEAL

| | INSTALLATION, JOINT,<br>V-RETAINER COUPLING ASSEMBLY | | | |

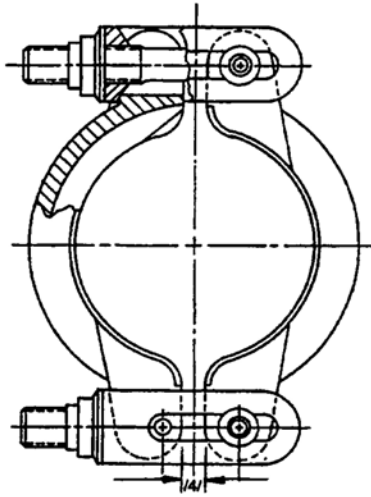
FIGURE 2 - CORRECT INSTALLATION DOUBLE LATCH COUPLING

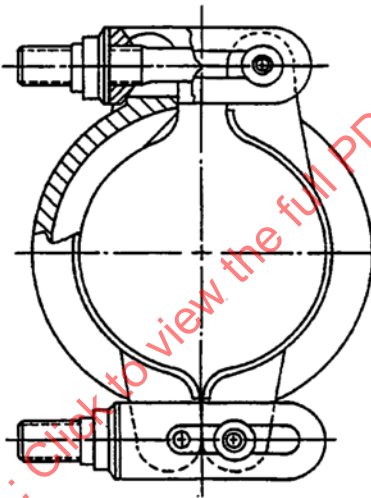
FIGURE 3 - INCORRECT INSTALLATION DOUBLE LATCH COUPLING /12c/

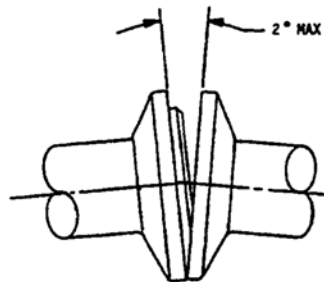
FIGURE 4 - INITIAL ANGULAR MISALIGNMENT /7/

- /5/ CRITICAL: FLANGE FLATNESS AFTER WELDING PER AS1895
6. CHECK COUPLING PART NUMBER TO BE SURE CORRECT COUPLING IS BEING USED.
- /7/ REMOVE PROTECTIVE CAP FROM FLANGE, INSTALL SEAL IN MALE FLANGE, AND BRING MATING FLANGE INTO POSITION. DO NOT INSTALL COUPLING OVER FLANGES, WHICH EXCEED THE ANGULAR MISALIGNMENT SHOWN IN FIGURE 4. IF FLANGES ARE MISALIGNED, DO NOT USE COUPLING TO ALIGN. CHECK SYSTEM AND FIND CAUSE. LOOSEN SUPPORT CLAMPS AS NECESSARY. UNHOOK LATCH ASSEMBLY FROM LUGS AND SLIP COUPLING OVER THE TUBING OR DUCTING ADJACENT TO THE FLANGE. MISALIGNMENT SHOWN IS INITIAL. FLANGE GAP MUST BE CLOSED WHEN INSTALLATION IS COMPLETE.

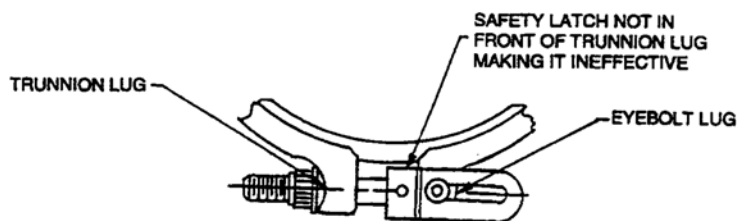
FIGURE 5 - INCORRECT INSTALLATION OF SAFETY LATCH /12/  
SINGLE AND DOUBLE LATCH COUPLING
