# SURFACE VEHICLE INFORMATION REPORT

J810™

(R) Classification of Common Imperfections in Sheet Steel

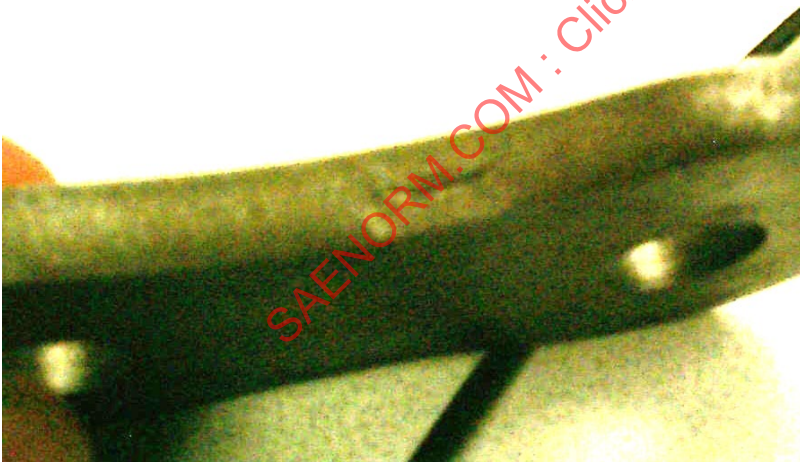
**Figure 2**

#### 4.2 Centerline Cracks

| <b>Description:</b> | An opening along the centerline of the as-cast slab that is oxidized during cooling and does not close on subsequent rolling. This subsurface tear may be continuous or interrupted. This defect may be exposed during shearing, cutting, or punching of the strip. |
| <b>Cause:</b> | Centerline cracking originates with the normal shrinkage of the steel at the center of the slab as it solidifies relative to the subsequent deformation of the strand during casting and can be caused by segregation, poor cooling condition during casting, and misalignment of caster segments. |

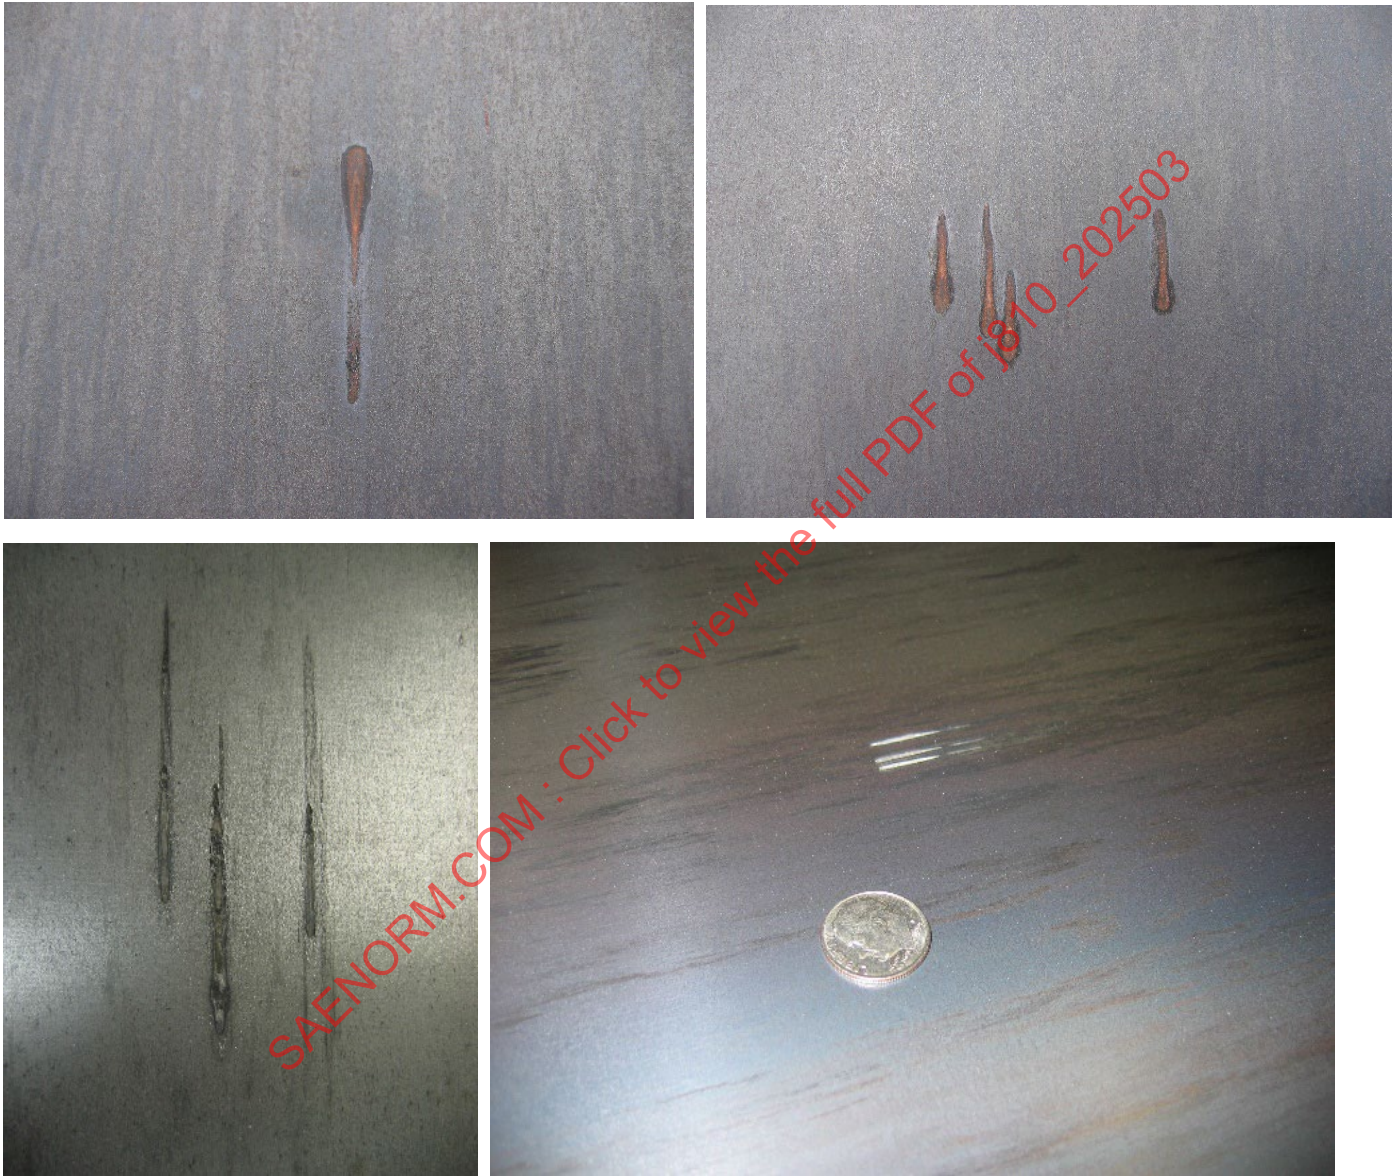
**Figure 3**

## 4.3 Entrapped Mold Powder

| <b>Description:</b> | Mold powder is used to lubricate the sides of the caster mold so that the steel solidifies and slides freely out of the bottom of the mold. The powder is specially designed to burn off, but occasionally, it will get entrapped in the steel and create a defect. |
| <b>Cause:</b> | Entrapment during turbulent liquid metal flow during casting. |

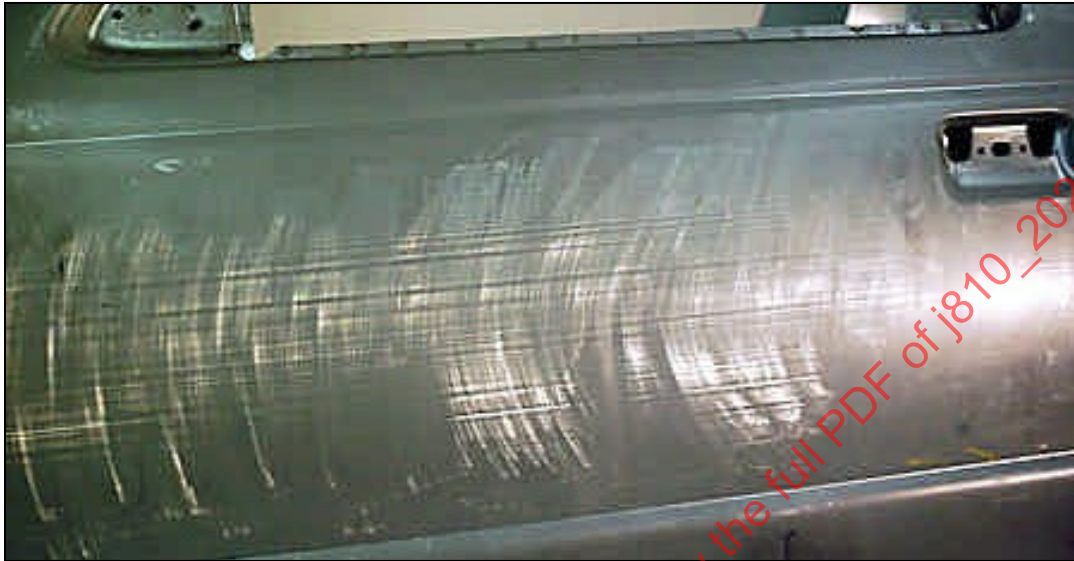
Figure 4

## 4.4 Ghost Lines

| <b>Cause:</b> | Ghost lines are caused by improper caster alignment and deoxidation practices. Ghost lines can also be caused by rolled-in alumina or phosphorus segregation. |

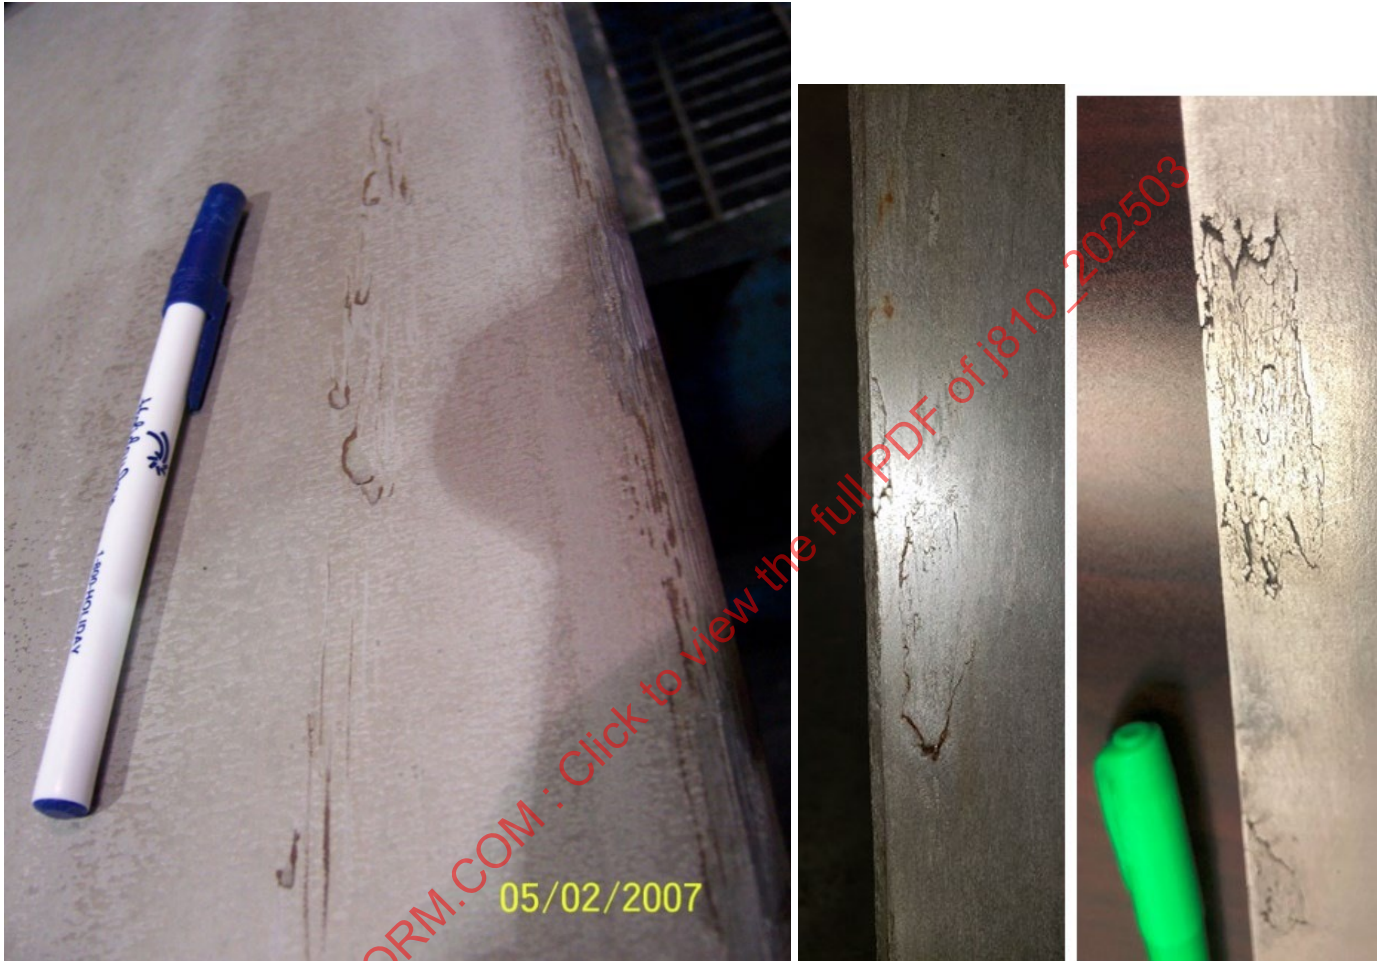
Figure 7

## 4.7 Lamination: Edge Lamination

| <b>Cause:</b> | Edge laminations are microsegregations on grain boundaries causing them to slide instead of pancaking during deformation at certain temperatures depending on the steel composition. |

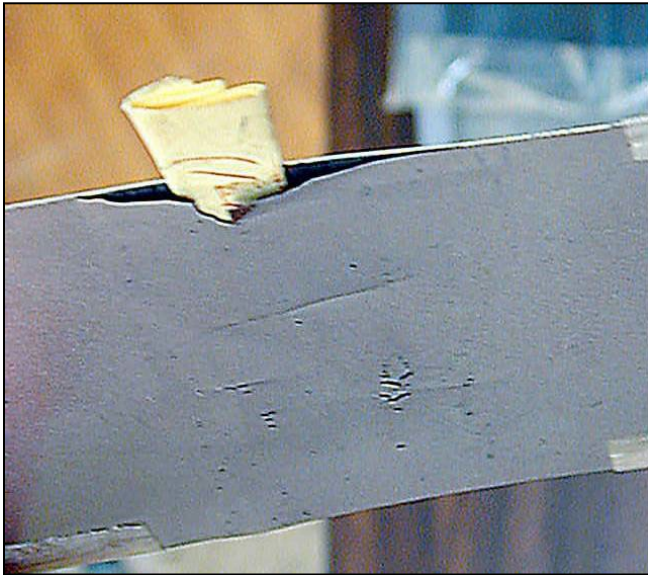
**Figure 8**

## 4.8 Lamination: Pipe Lamination

| <b>Cause:</b> | Pipe lamination results from centerline segregation and the presence of oxide inclusions. |

→  
Rolling  
Direction

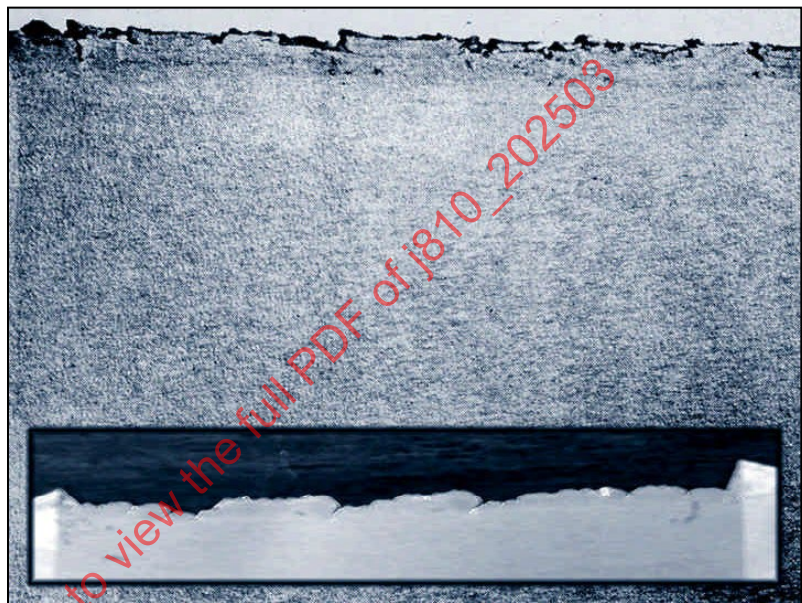
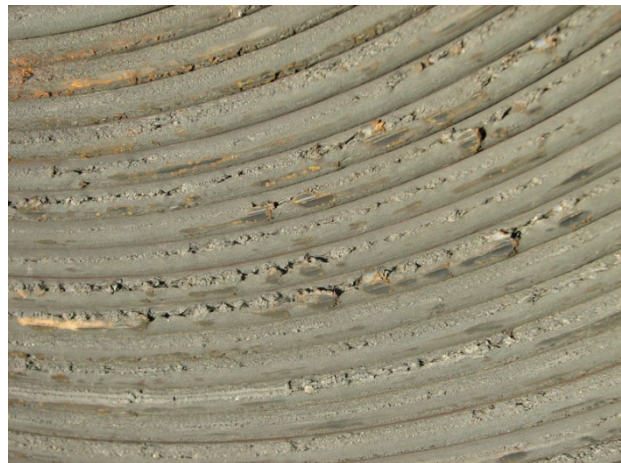
Figure 9

## 4.9 Ragged Edge

| <b>Description:</b> | Appears as a rough, broken-away mill edge or as splitting on the coil edge. Cracks generally run perpendicular to the rolling direction. Ragged edge is a serrated edge that has been work hardened and subsequently fractured or deformed during the rolling operation. |
| <b>Cause:</b> | Ragged edges can be caused by: <ul style="list-style-type: none"><li>- Bad heating practices</li><li>- Poor slitting or edge trimming</li><li>- Damage during annealing</li></ul> |

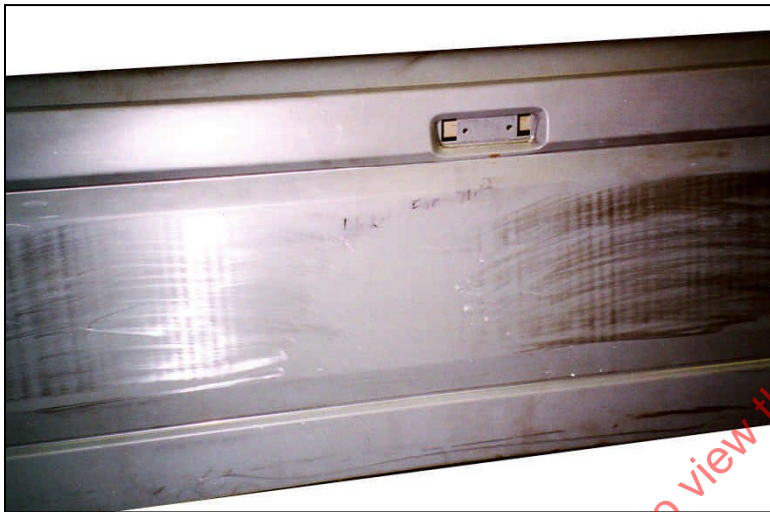
Figure 11

| <b>Cause:</b> | Chatter marks can be caused by: <ul style="list-style-type: none"><li>- Vibration during rolling</li><li>- Vibration during leveling</li><li>- Vibration of tools used to grind rolls</li><li>- Lubricant failure causing fluctuation in the coefficient of friction between the roll face and the sheet surface</li><li>- Improper tension between stands during rolling</li></ul> |

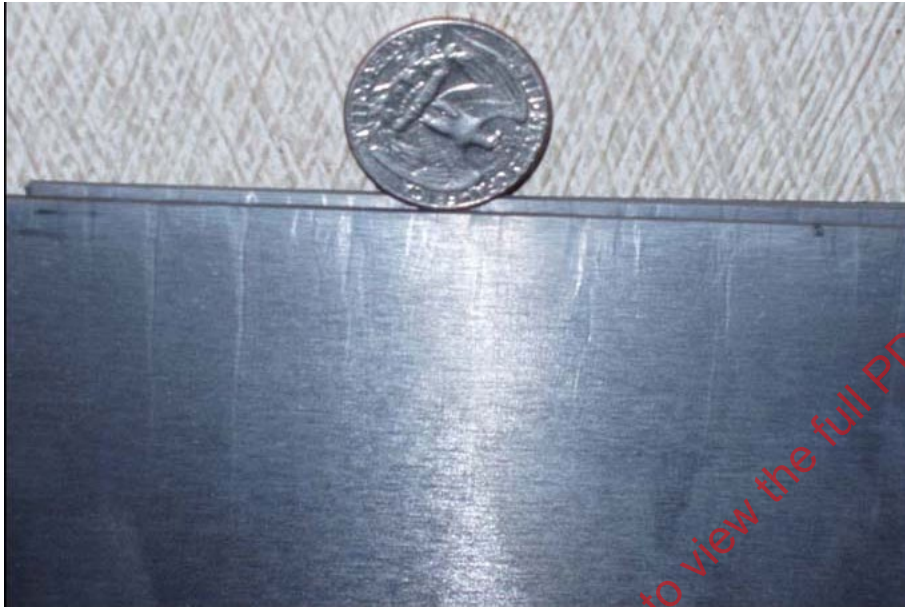
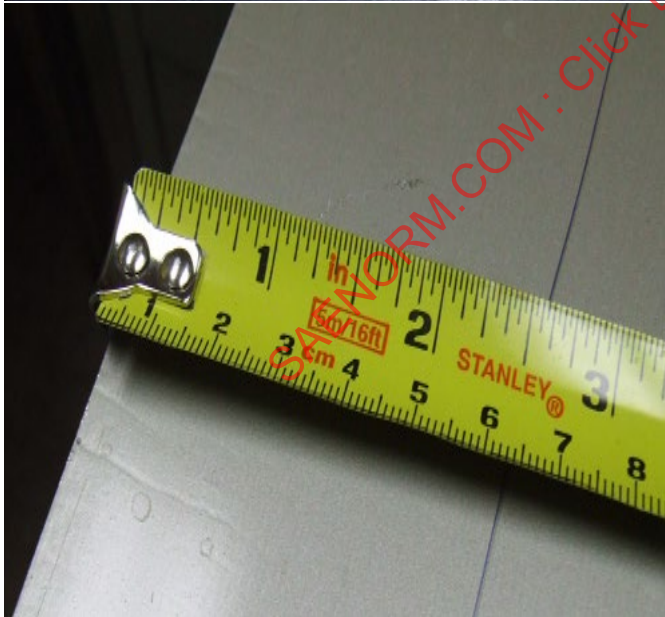
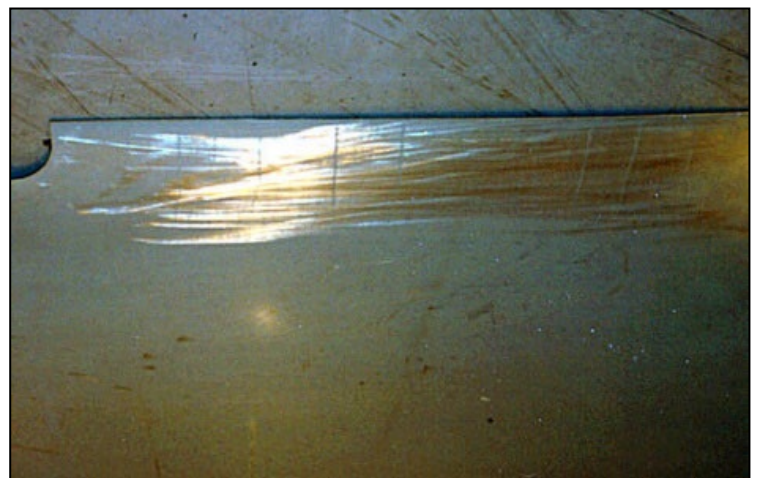
Figure 12

## 5.2 Edge Breaks

| <b>Cause:</b> | Edge breaks are caused by insufficient tempering and yield point elongation. Edge breaks occur in steel when the edges are substantially thinner than the rest of the sheet and do not receive sufficient temper reduction to minimize or eliminate yield point elongation. |

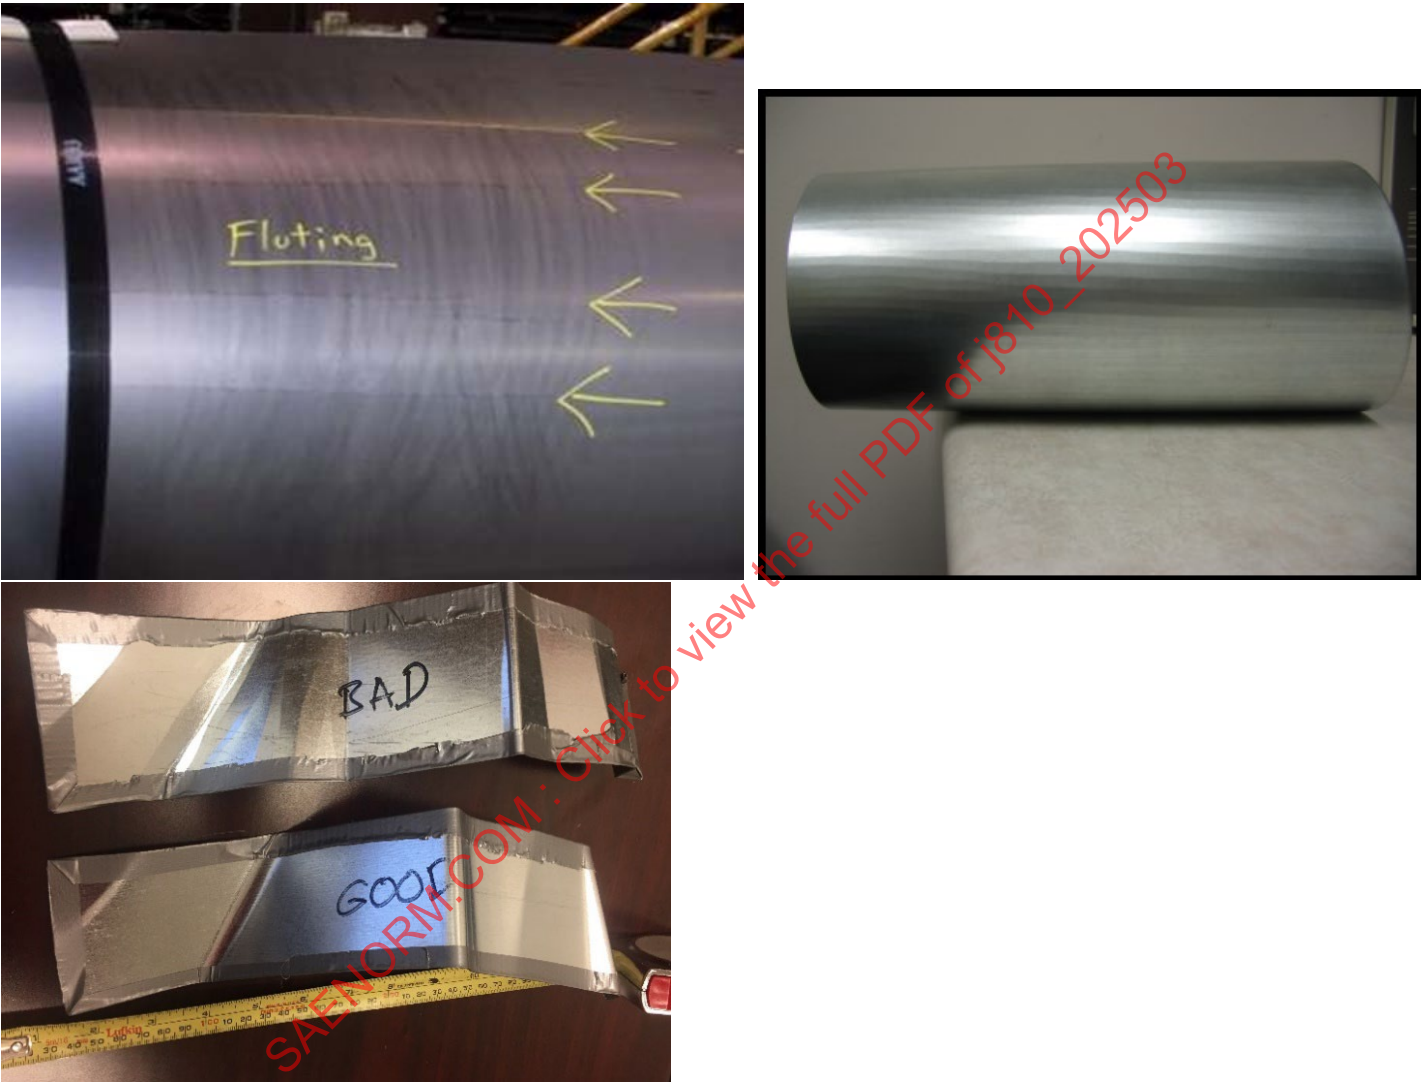
Figure 13

5.3 Fluting

| Cause: | Fluting typically occurs during roll forming to small diameters or stretching during stamping resulting from the presence of yield point elongation (YPE). |

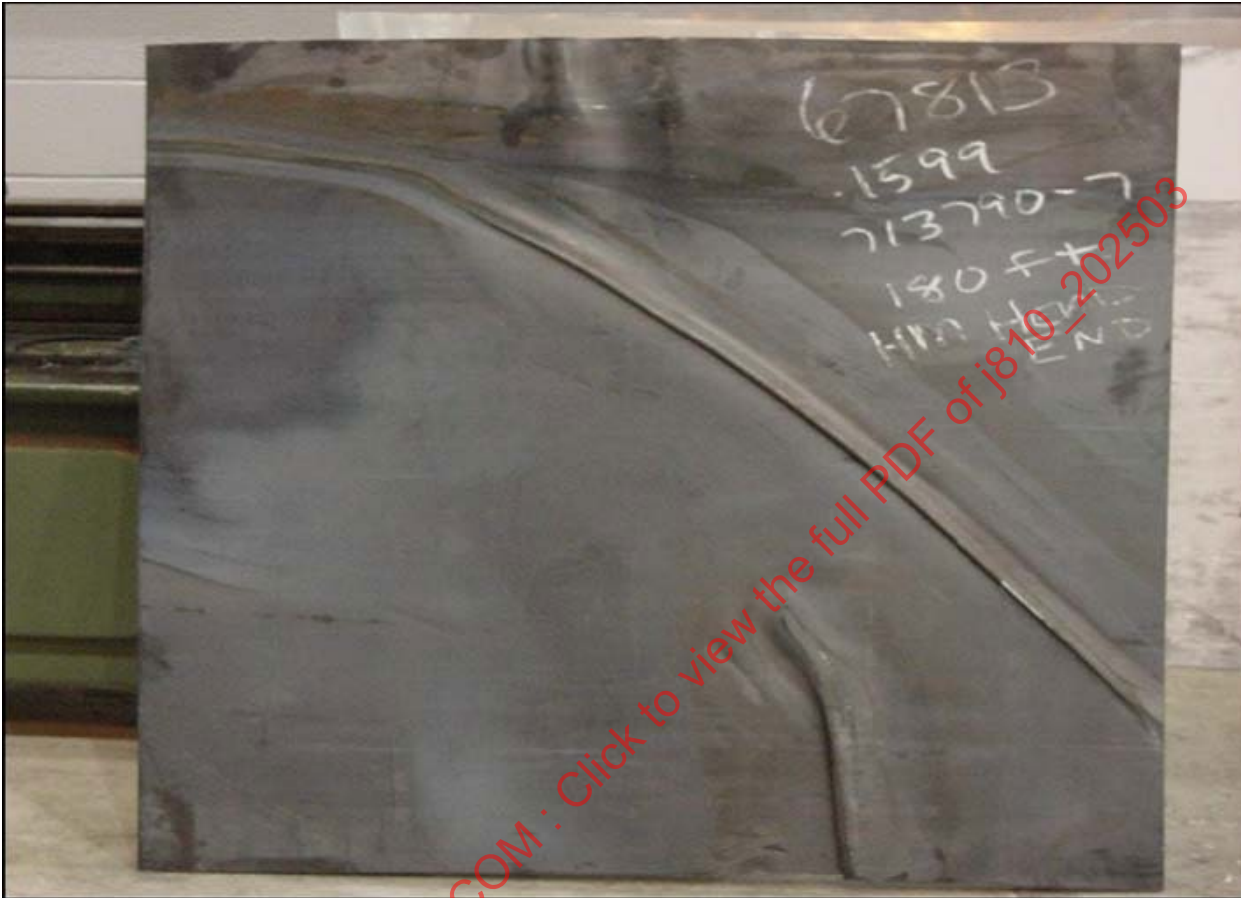
Figure 14

## 5.4 Fold Over

| <b>Cause:</b> | Fold over is caused by poor shape or tension control during rolling. |

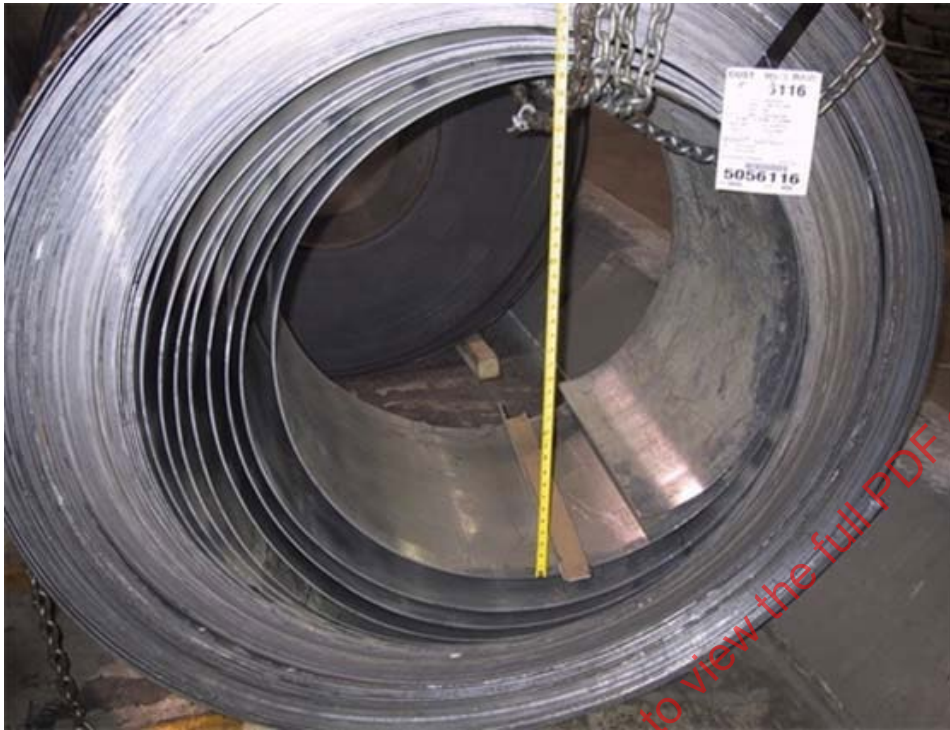
Figure 16

## 5.6 Loose Winding

| <b>Description:</b> | Loose laps typically near the ID (inside diameter) of a coil. |
| <b>Cause:</b> | Insufficient tension during winding. |

| Rolling Imperfections | Similar Imperfections | Figure |
|---|---|---|
| Loose Winding | Soft Coils; Telescoping; Clocksprung Coil | 16 |

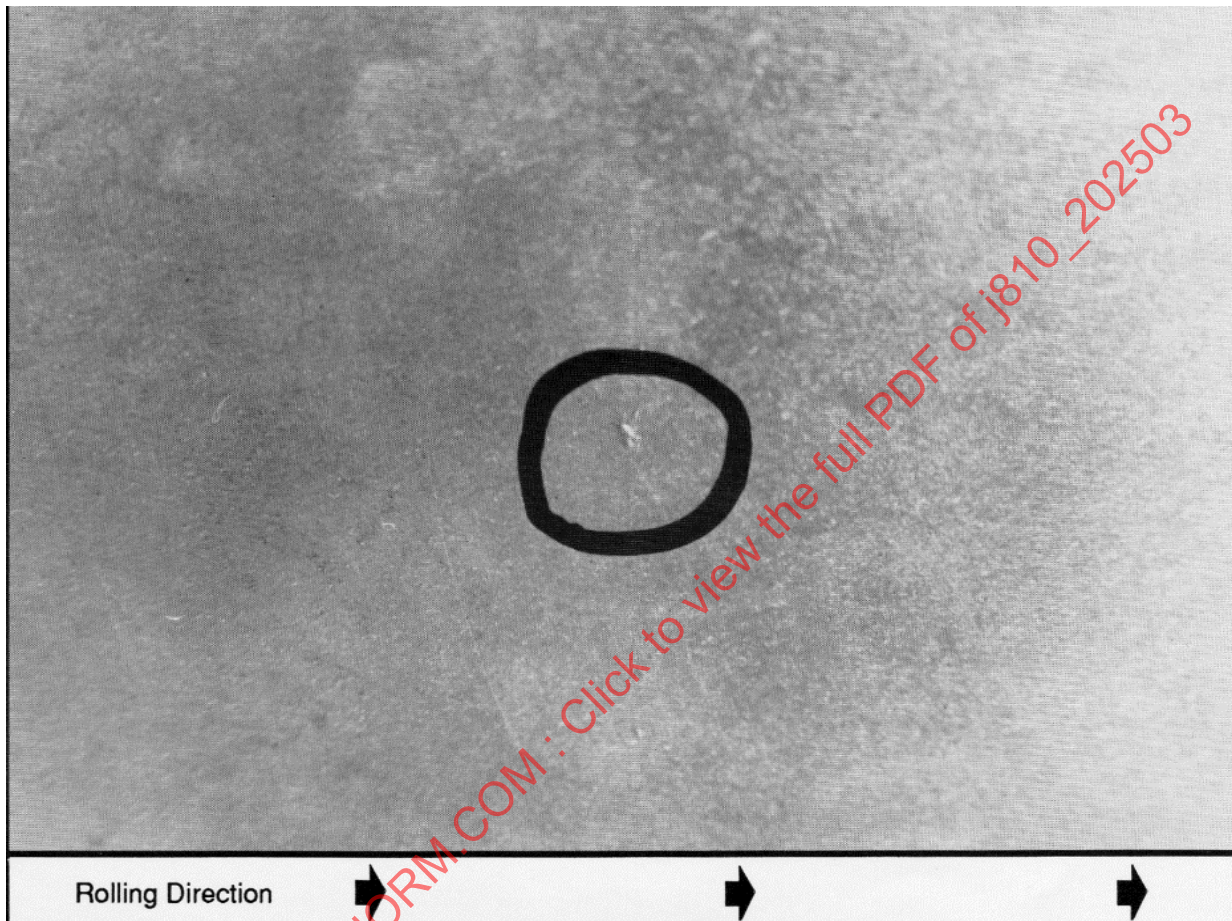
Figure 18

## 5.8 Pick-Up

| <b>Cause:</b> | Pick-up is caused when metallic or nonmetallic debris adhere to work rolls or other rolls. These particles could be the base metal or the galvanized coating if it occurs at that stage of processing.<br>Pinch roll pick-up, also called stickers, occurs when metal sticks to the hot mill coiler pinch roll and leaves a repeating impression on the strip. |

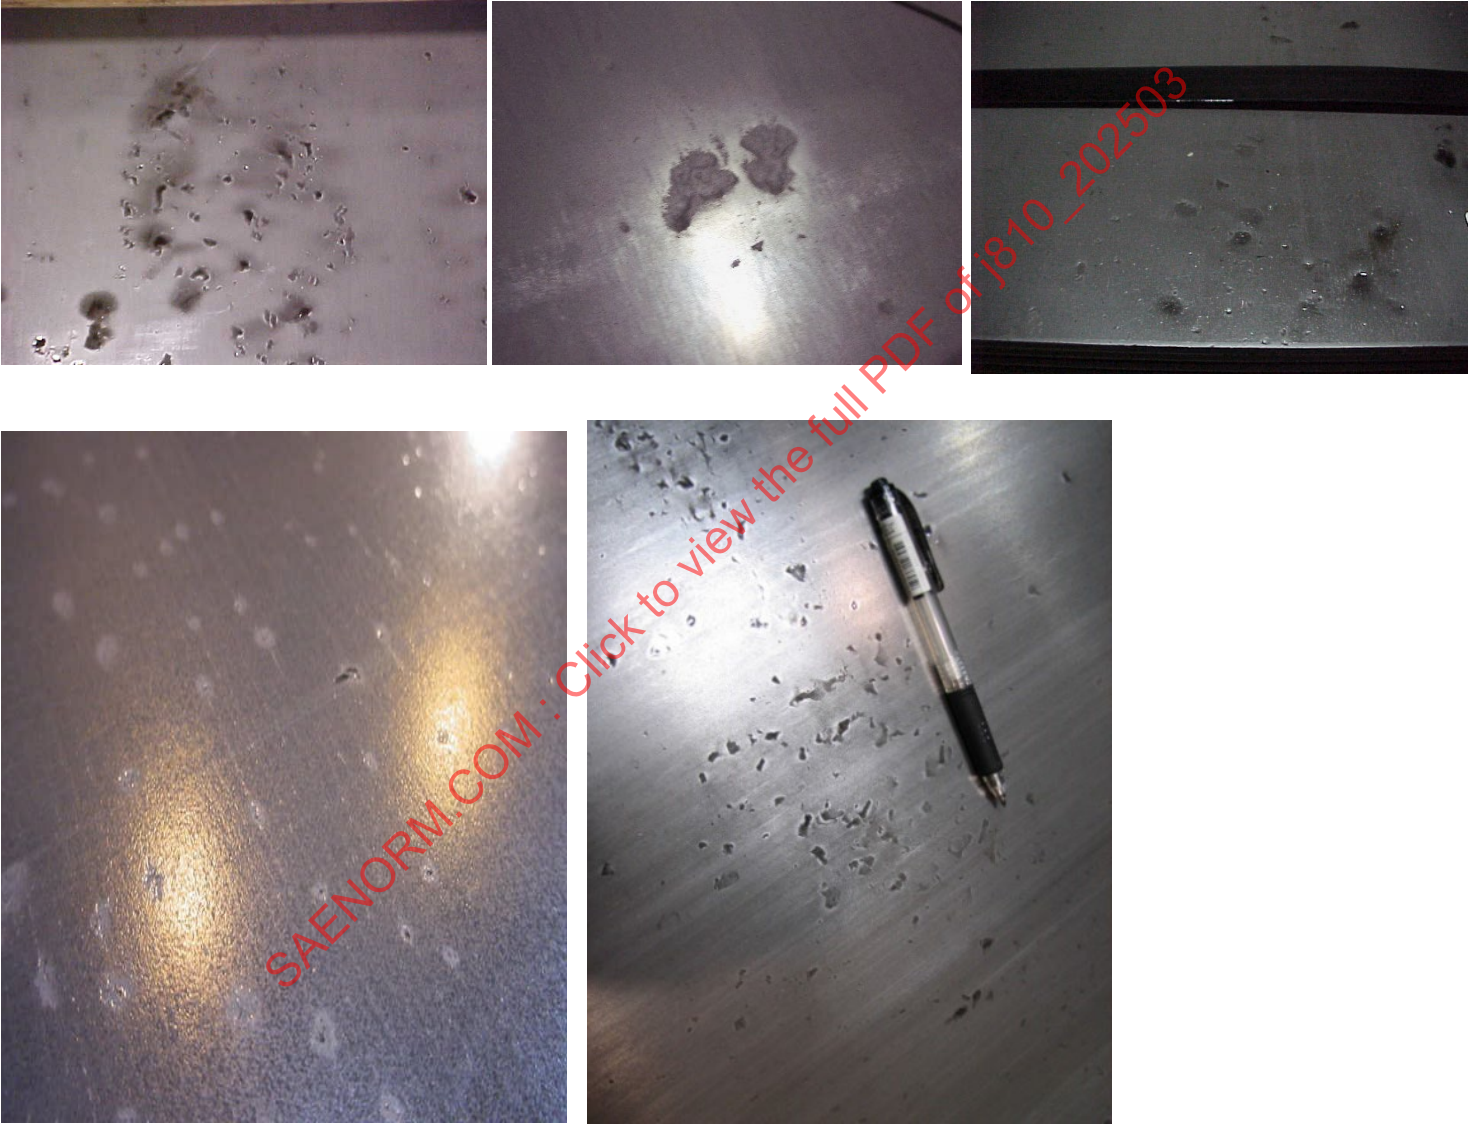
Figure 20

5.10 Pits

| Rolling Imperfections | Similar Imperfections | Figure |
|---|---|---|
| Pits | Pick-Up; Rolled-In Dirt; Rolled-In Scale; Corrosion Pits; Scale Pits; Grease Pits; Slug Pits; Scale Pits | 20 |

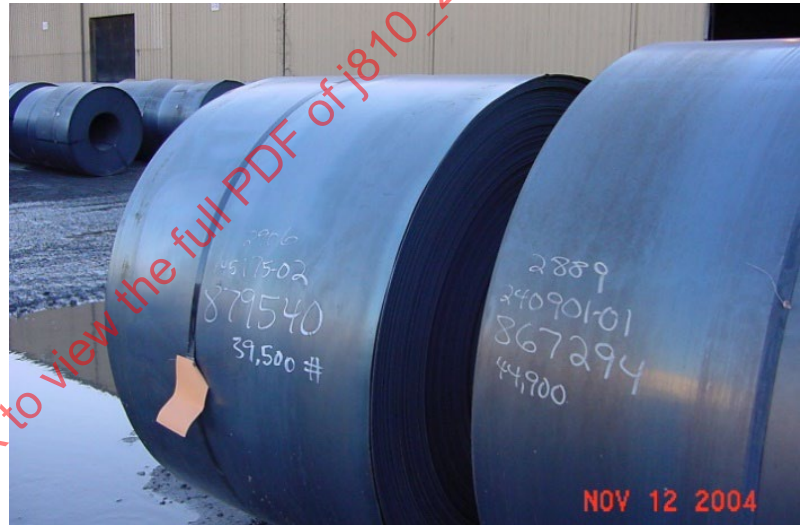
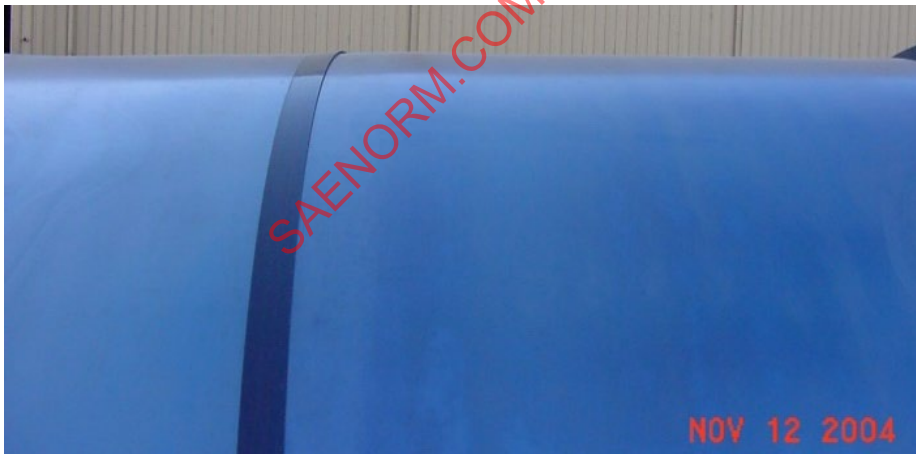
Figure 22

## 5.12 Ridge

| <b>Cause:</b> | Ridges can be caused by localized excess coating or strip thickness. Ridges can also be caused by improper work roll cooling during hot rolling. |

| Rolling Imperfections | Similar Imperfections | Figure |
|---|---|---|
| Ridge | Build-Up; Burnish Mark; Crease | 22 |

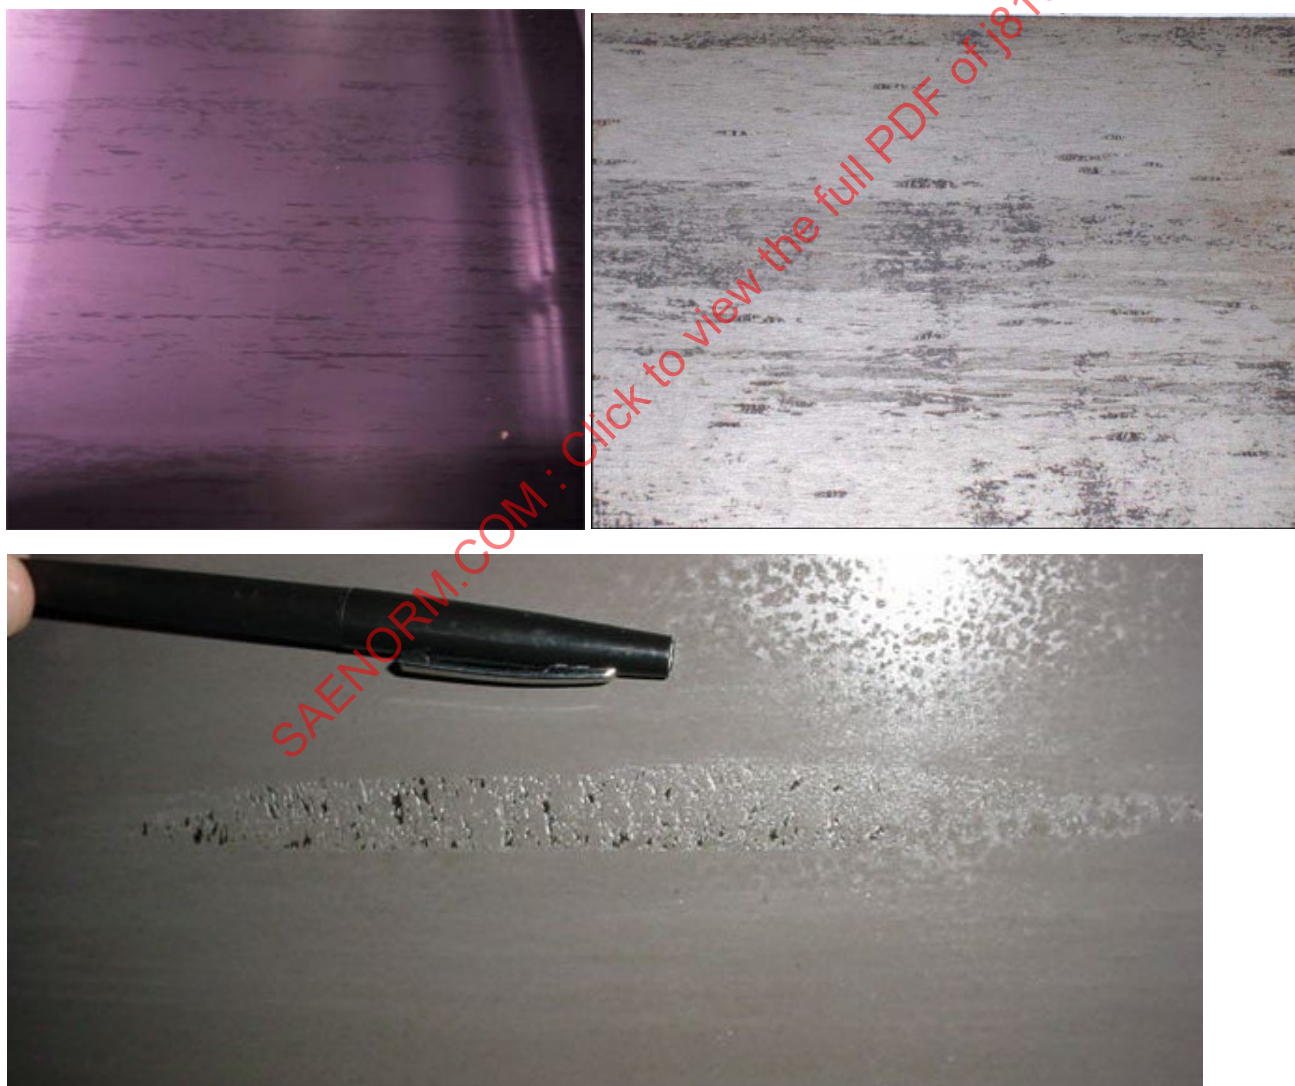
Figure 25

## 5.15 Scale: Rolled-In Scale

| Rolling Imperfections | Similar Imperfections | Figure |
|---|---|---|
| Scale: Rolled-In Scale | Fleck Scale; Spot Scale; Pepper Scale; Primary Scale; Peeled Roll Scale; Worn Mill Scale | 25 |

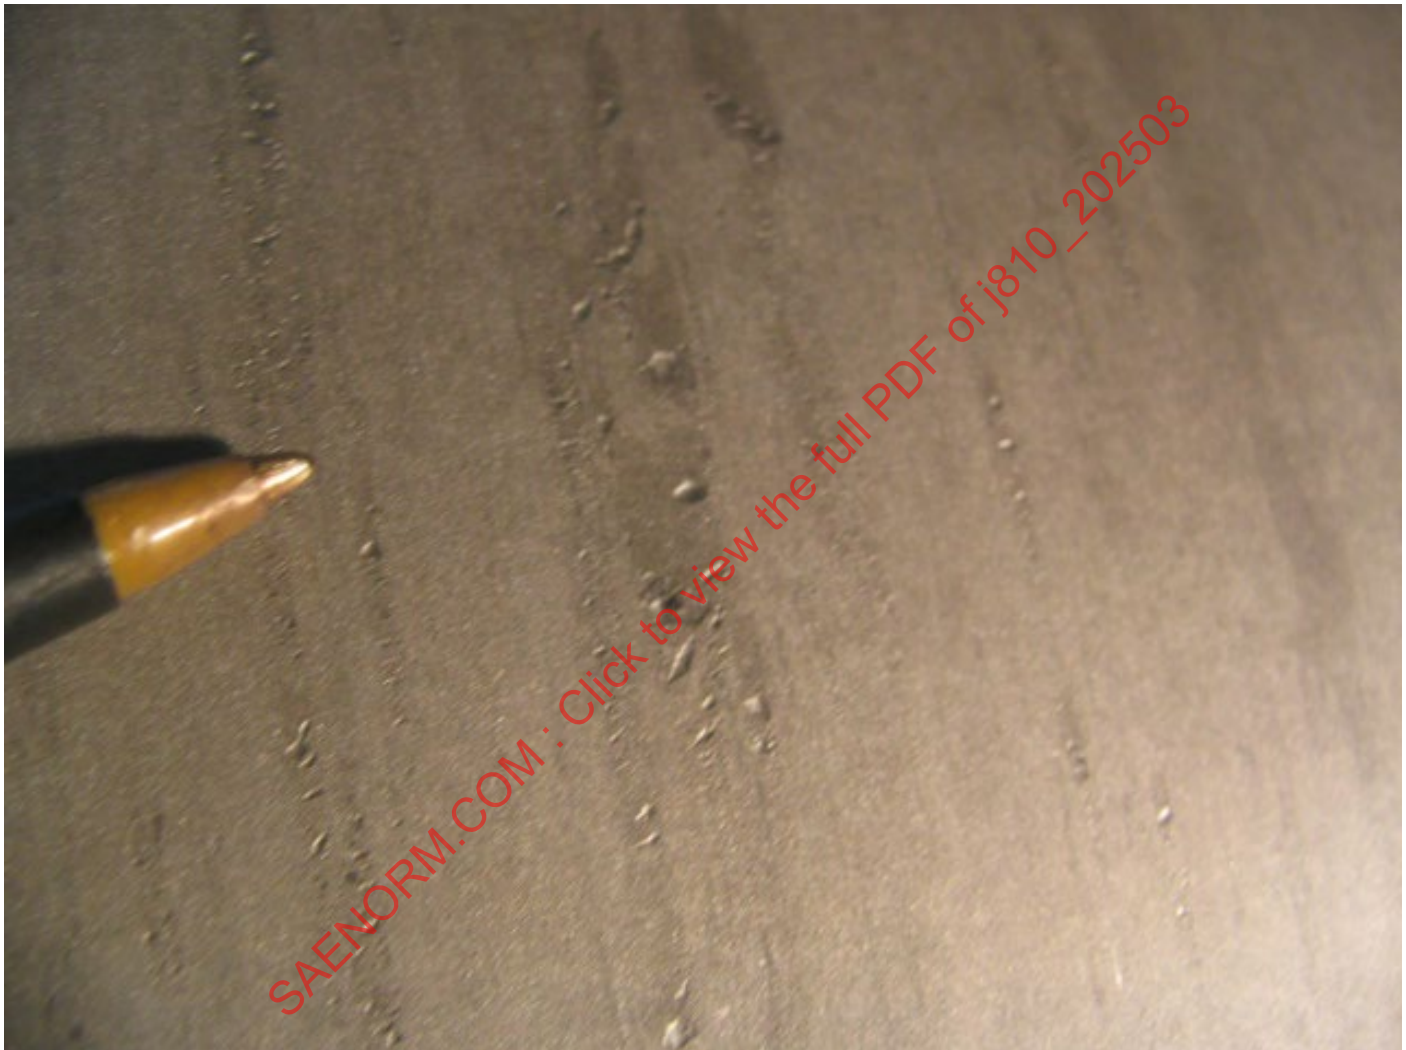
**Figure 28**

| <b>Product Affected:</b> | All products. |
| <b>Similar Imperfection:</b> | Pepper Scale; Streak Scale. |

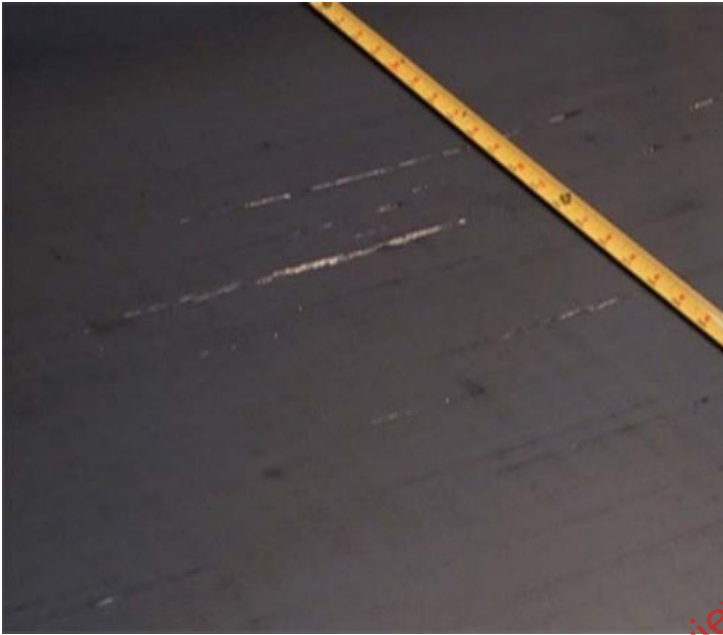
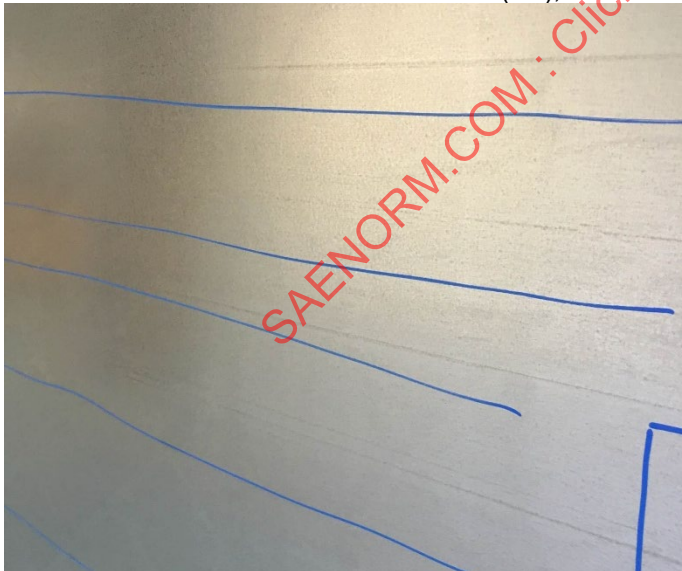
Figure 29

| <b>Cause:</b> | Scratches are typically caused by an object rubbing against the material surface. Scratches can come from a variety of sources. |
| <b>Similar Imperfection:</b> | Healed-Over Scratch; Friction Digs. |

Galvanized scratches (left); Galvanized scratches under 50X magnification (right)

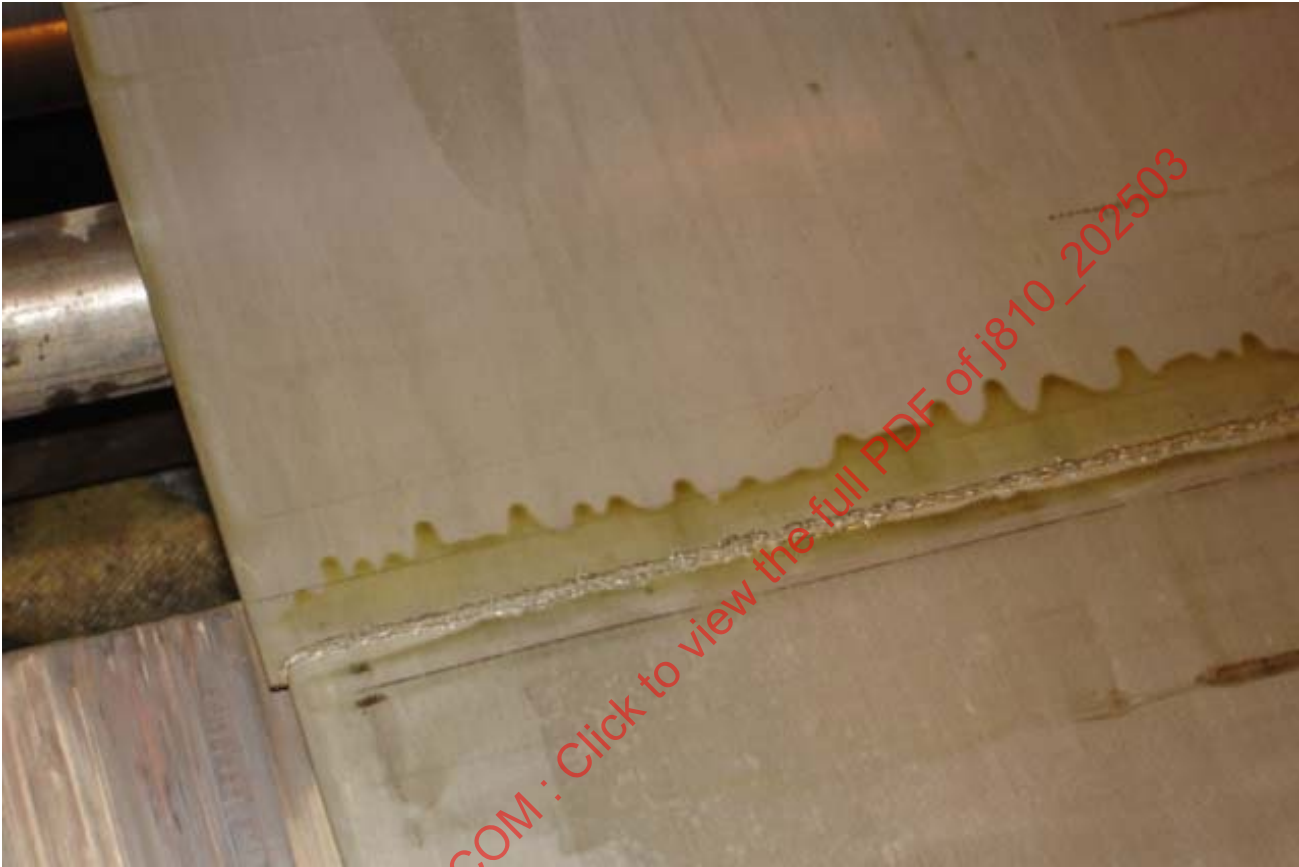
**Figure 31**

| <b>Cause:</b> | Two sections of coil being joined together. |
| <b>Similar Imperfection:</b> | Welds; Fold-Over; Creases. |

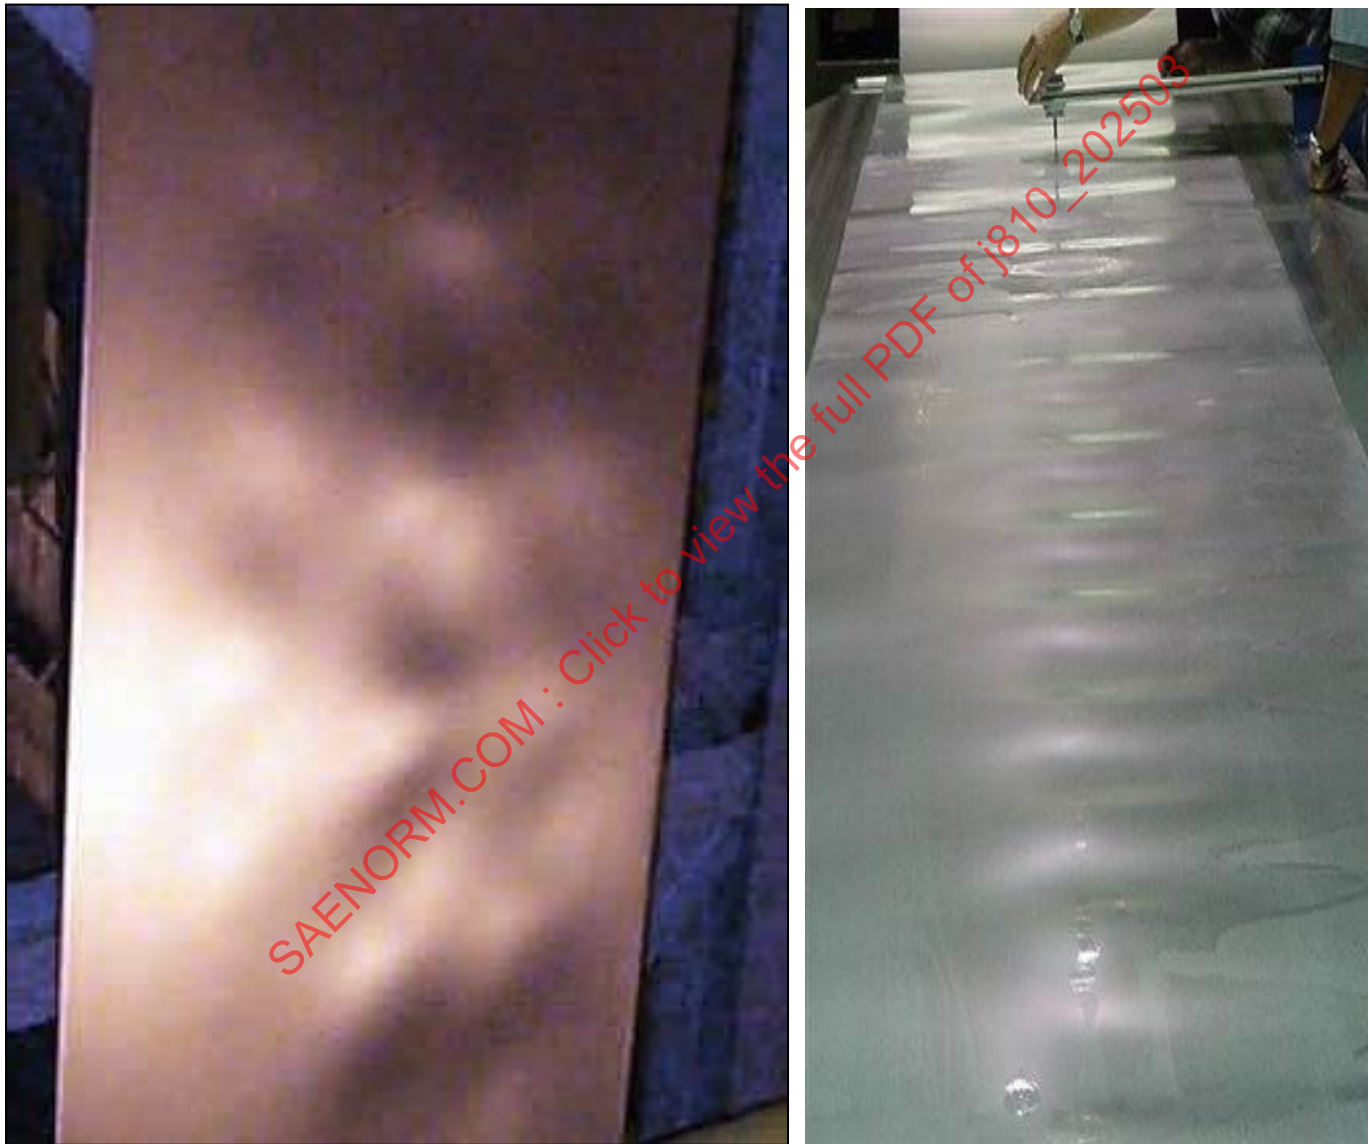
Figure 32

| <b>Cause:</b> | Buckles are caused by hardness variations of hot rolled sheet due to uneven cooling of the steel or mill rolls, build-up, or poor rolling practice. |
| <b>Similar Imperfection:</b> | Edge Wave; Oil Canning; Ridge Buckle; Center Buckle; Full Center. |

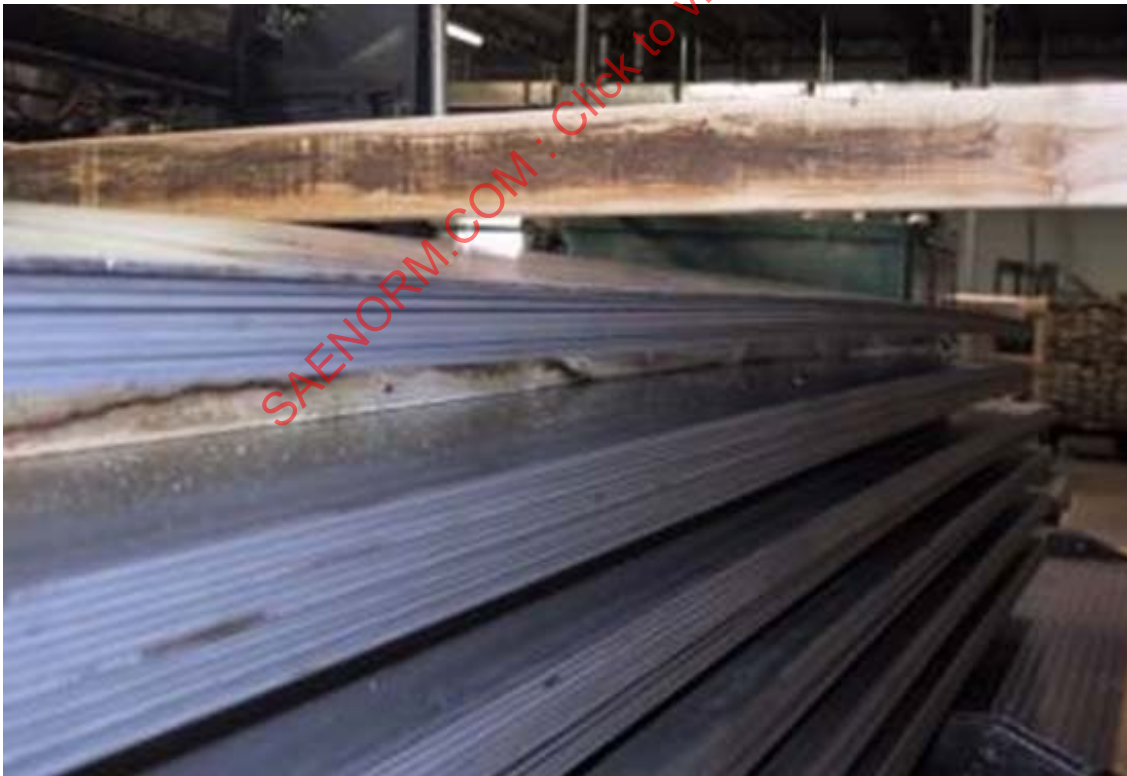
Figure 34

| <b>Description:</b> | A concave curvature with the center of the width being the high point and the edge being the low point. Reverse cross-bow is where the curvature condition is in the opposite direction to cross-bow. |
| <b>Cause:</b> | Cross-bow is typically found with steel sheet supplied in coil form resulting from coil set. Cross-bow can be caused by improper rolling and tension control and can be minimized with proper post-flattening or leveling operations. |
