# SURFACE VEHICLE INFORMATION REPORT

J810™

(R) Classification of Common Imperfections in Sheet Steel

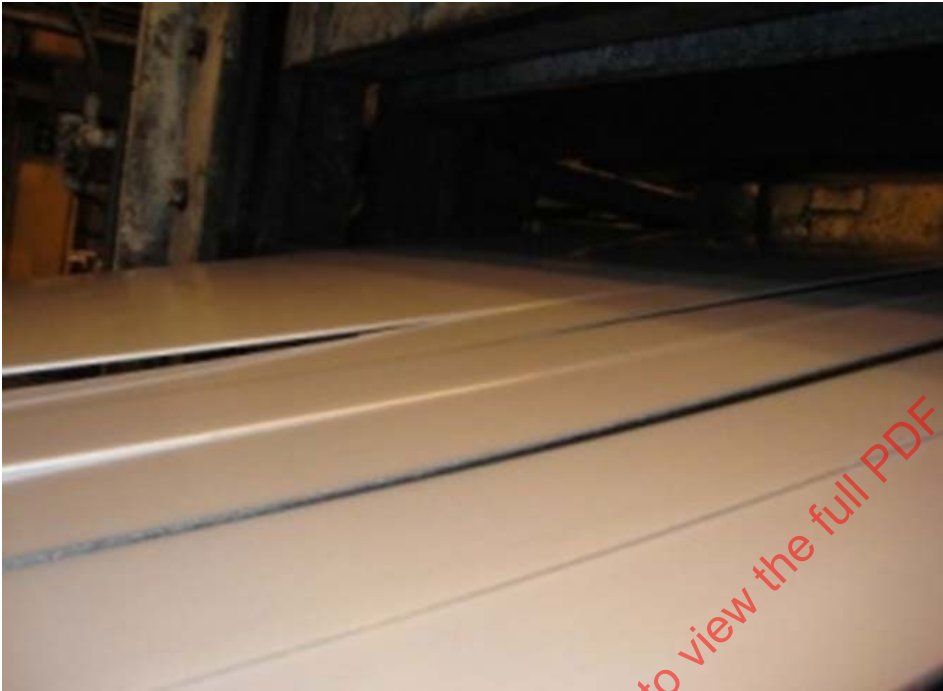
*Figure 41*

| <b>Cause:</b> | Poor clearance on slitter knives or shear blade. May also be caused by dull or damaged knives and blades. |
| <b>Product Affected:</b> | All products mechanically slit, sheared, or trimmed. |

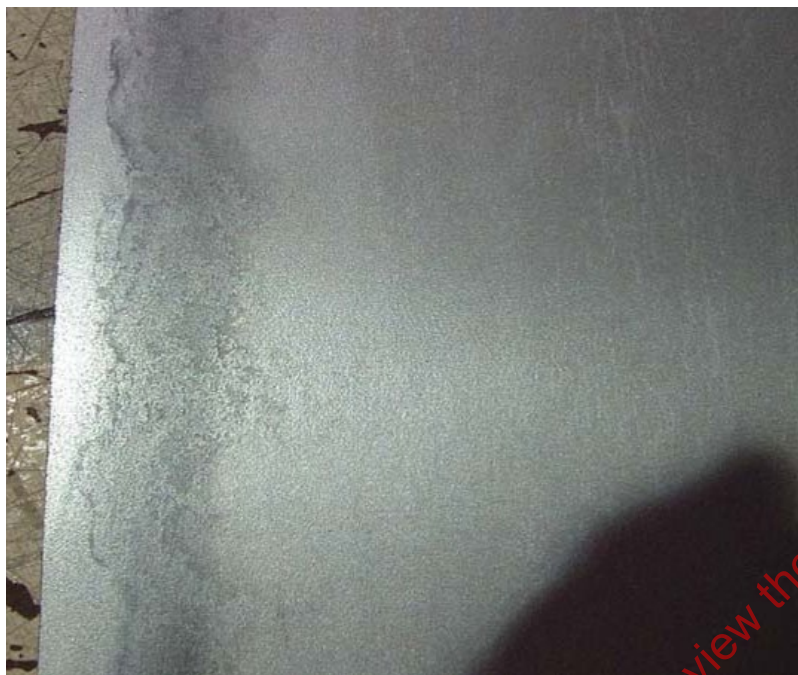
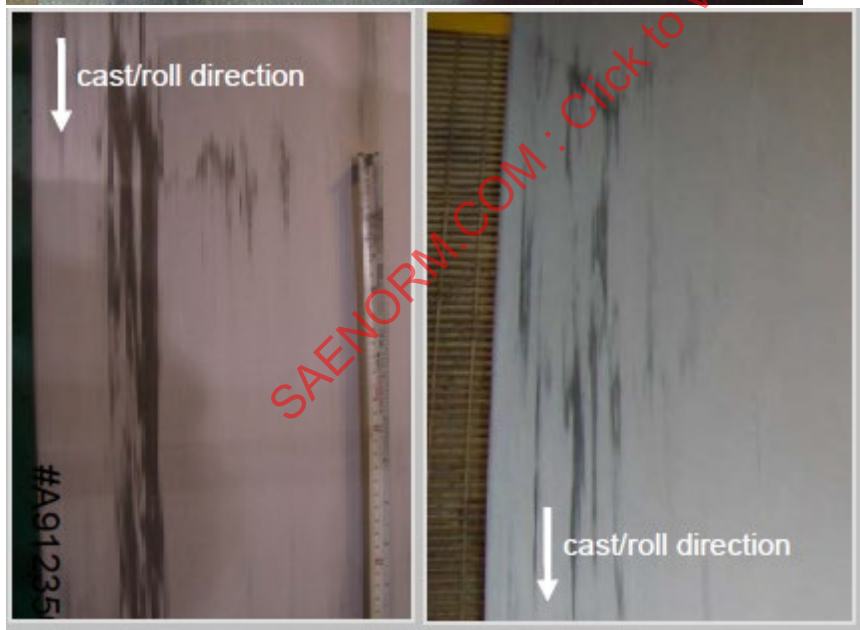
Figure 42

| <b>Description:</b> | Carbon stain appears as smutty black or gray stains. |
| <b>Cause:</b> | Carbon stain is the result of residual rolling oils reduced in the annealing process. |

| Processing Imperfections | Similar Imperfections | Figure |
|---|---|---|
| Carbon Stain | Snake Edge; Solution Stain; Carbon Border; Carbon Smut | 42 |

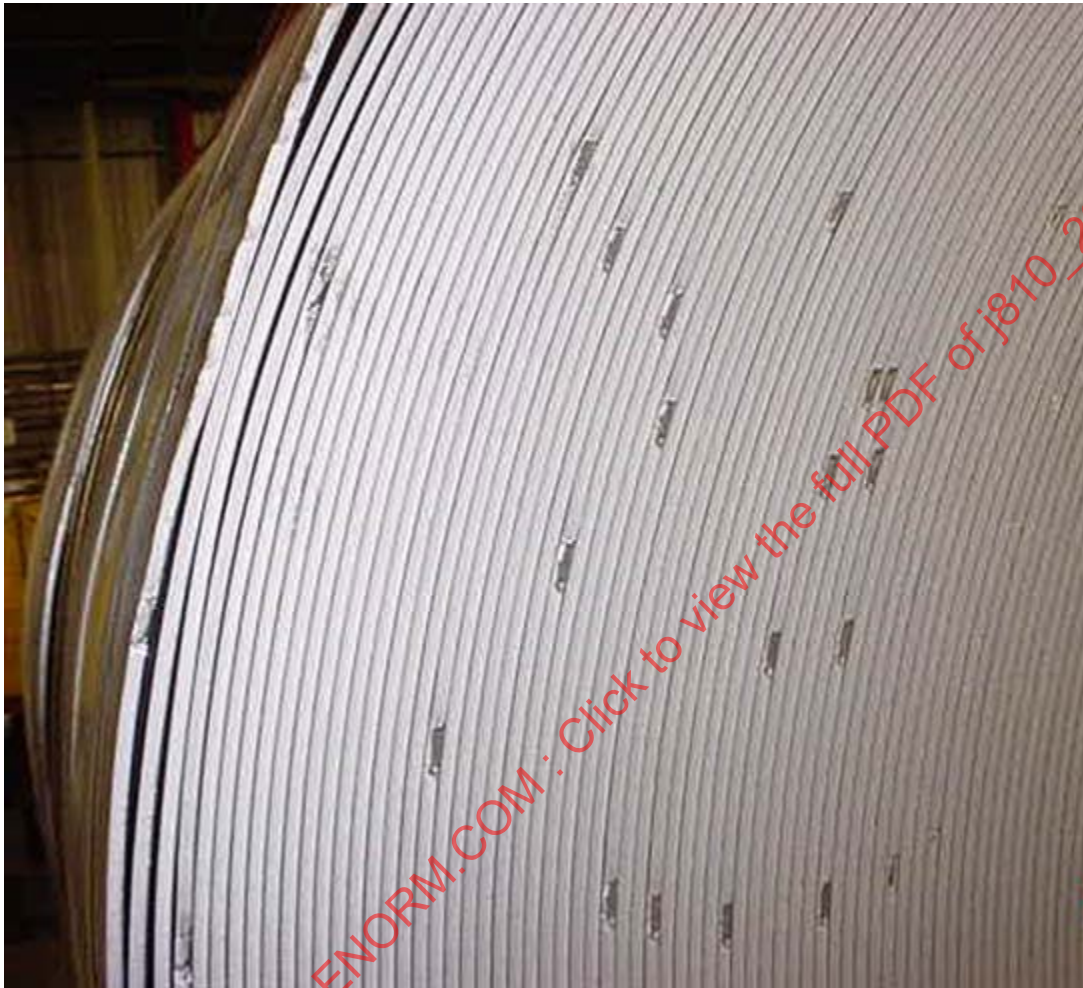
**Figure 43**

| <b>Description:</b> | This condition will appear as a periodic variance in the slit edge. The distance of the variance will correlate to the distance between knife defects or, if only one knife, the circumference of the knife. Severity can range from a light blemish to a heavy burr. |
| <b>Cause:</b> | This condition is the result of a chipped slitter knife. |

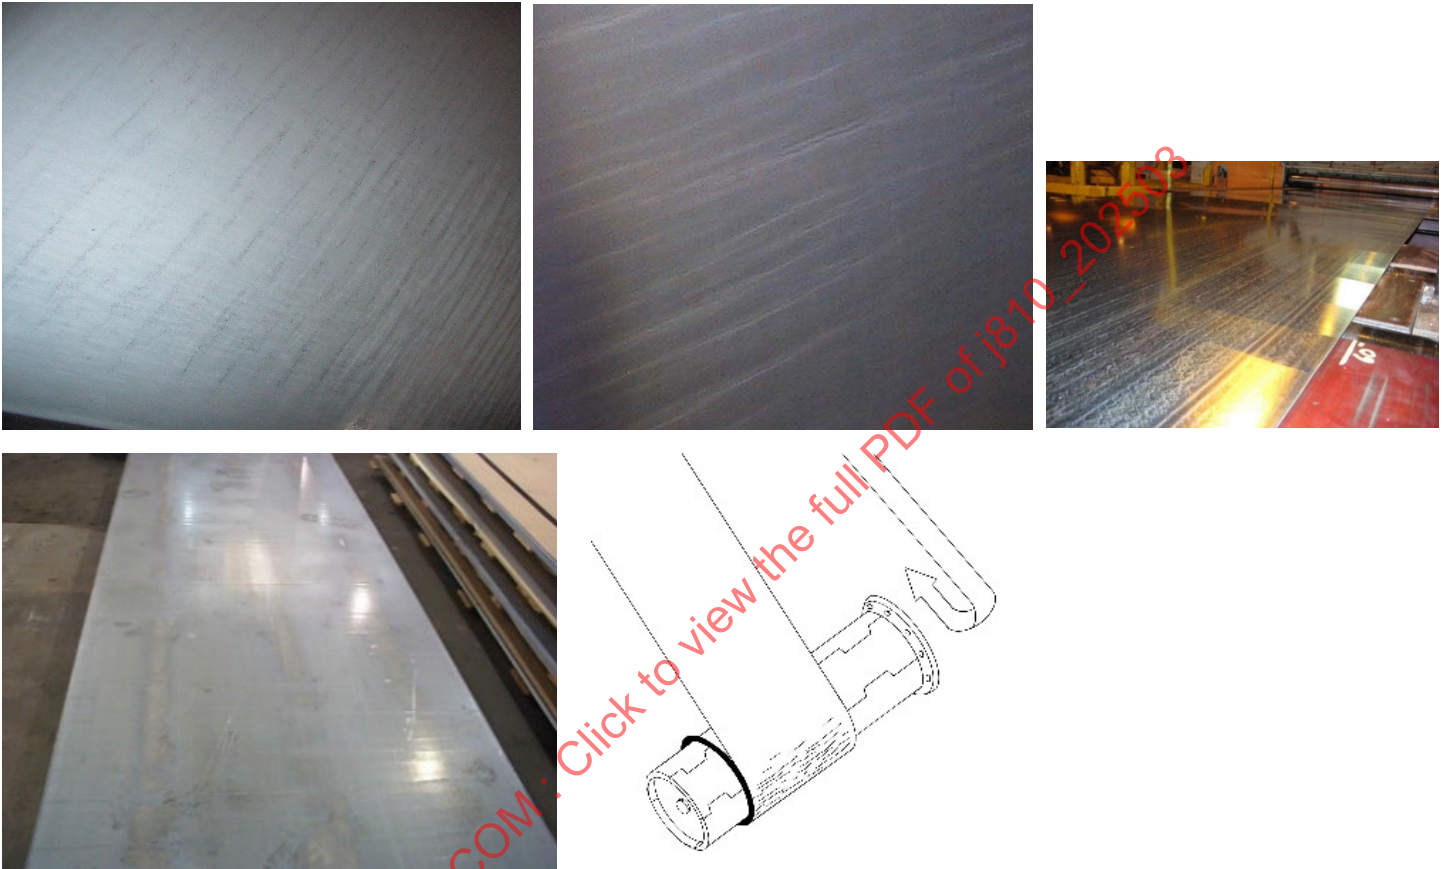
Figure 44

| <b>Cause:</b> | Coil breaks are formed during coiling or uncoiling when the extension exceeds the elastic limit of the steel and yield point elongation is present. |

Coil Break on Hot Band (left); Coil Break on finished product (right)

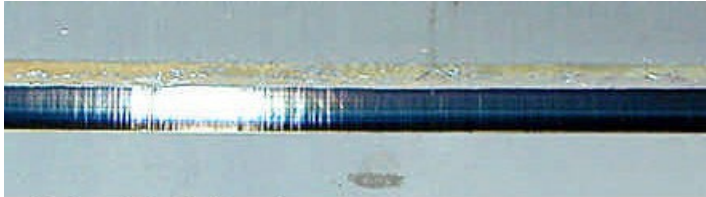
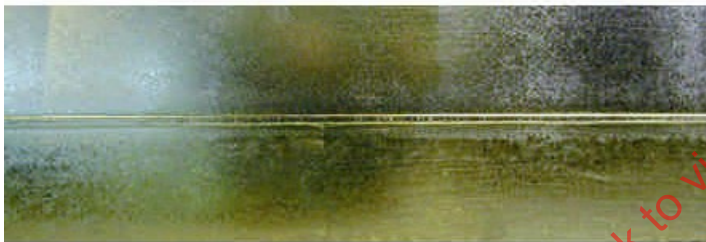
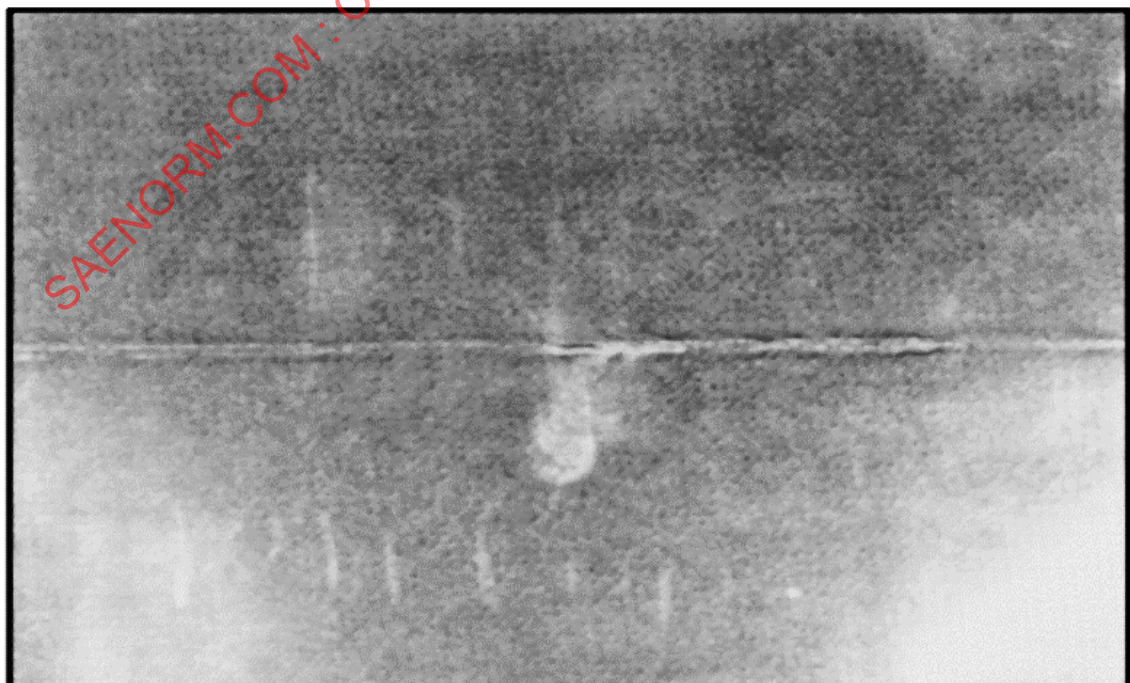
Figure 45

| <b>Cause:</b> | Two coils are joined or fused together by heat. Cold reduced butt weld or lap welds should be undetectable in the cold rolled or coated stage. |

Pickle Weld (Butt)

EGL Weld (Butt)

HDG Weld (Lap)

↑  
↓  
Rolling  
Direction

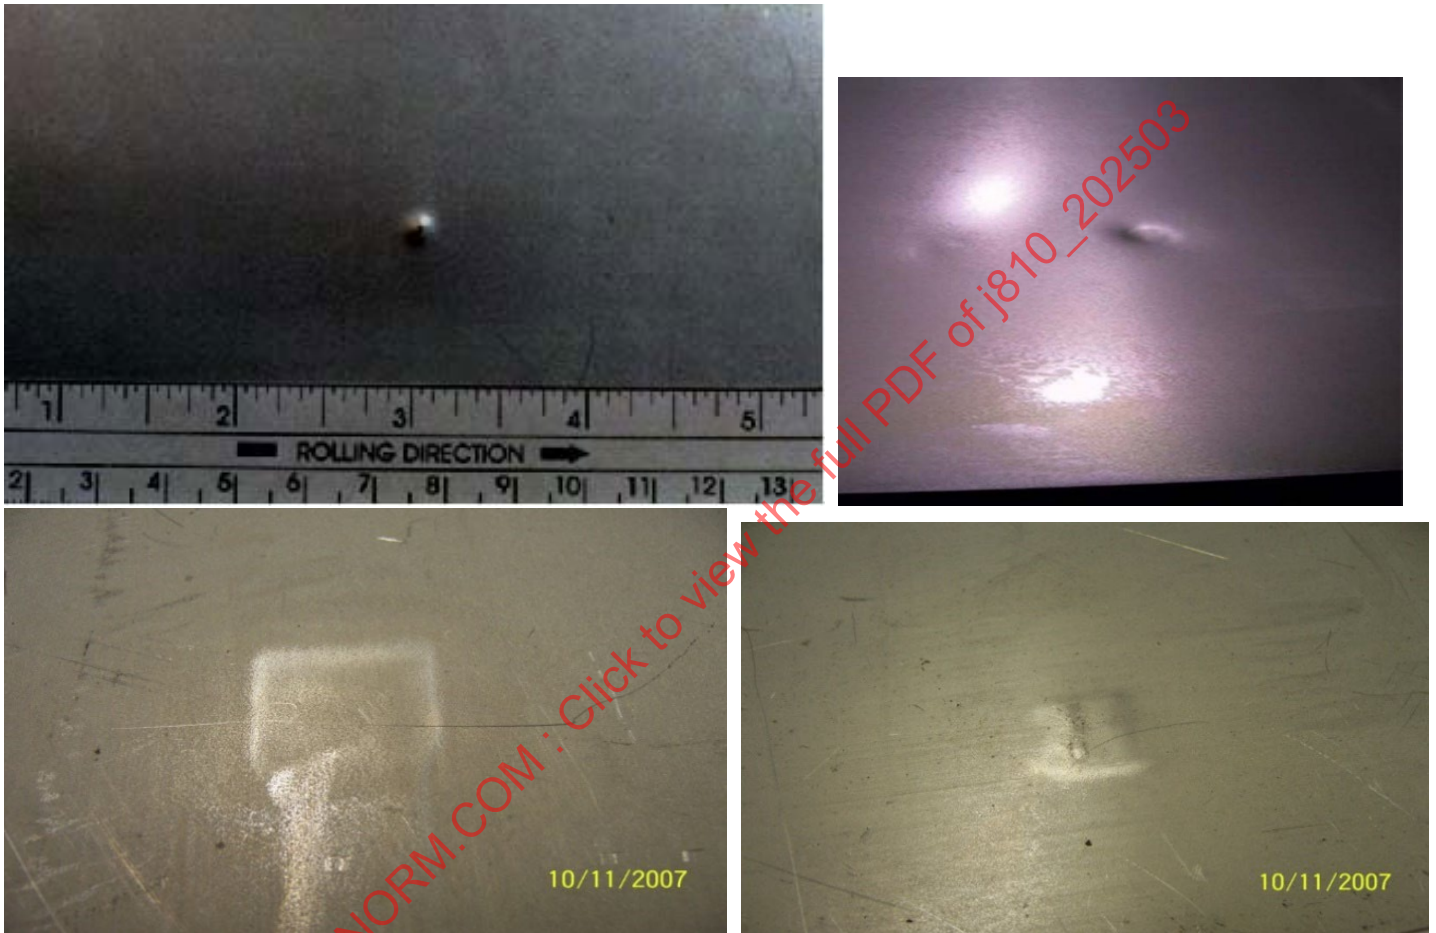
Figure 47

| <b>Cause:</b> | Dents are caused when debris on a roll is mechanically pressed into the surface of the sheet. Common causes are foreign objects between the coil laps, coil sitting on strap clip, and ID (inside diameter) damage from a mandrel. |

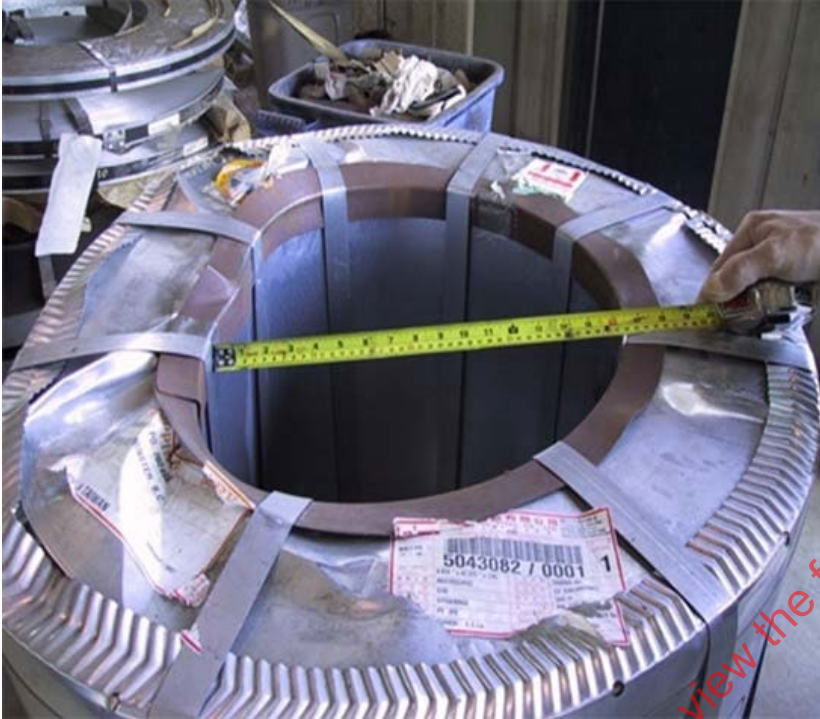
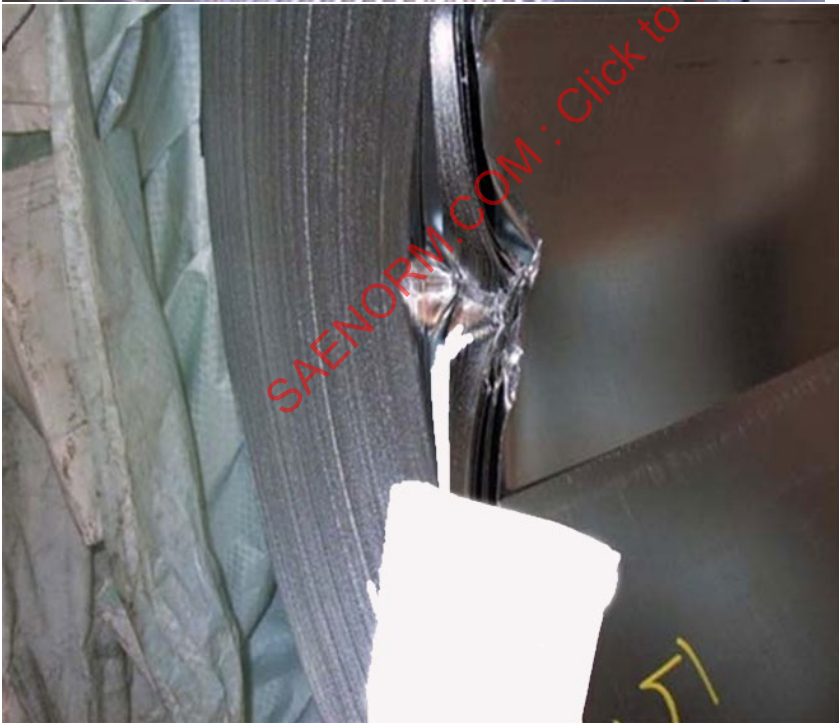
Figure 50

| <b>Cause:</b> | Storage and/or transportation practices. |
| <b>Similar Imperfection:</b> | Chain Damage; Coil Damage; Crane Damage; Floor Damage; Dropped Coil. |

| Processing Imperfections | Similar Imperfections | Figure |
|---|---|---|
| Handling Damage | Chain Damage; Coil Damage; Crane Damage; Floor Damage; Dropped Coil | 50 |

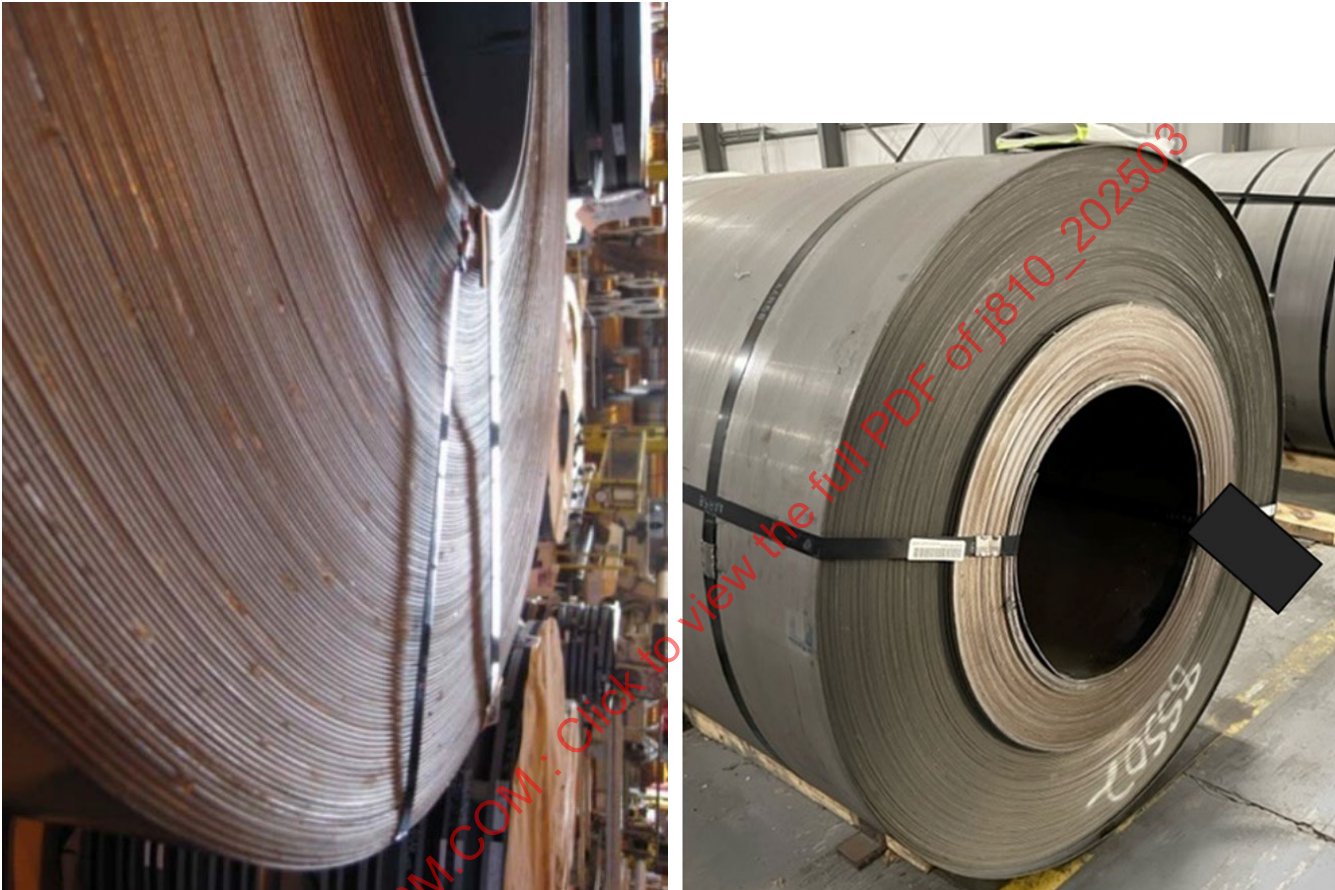
Figure 51

| <b>Product Affected:</b> | Slit products. |
| <b>Similar Imperfection:</b> | Insufficient Trim of Mill Edge. |

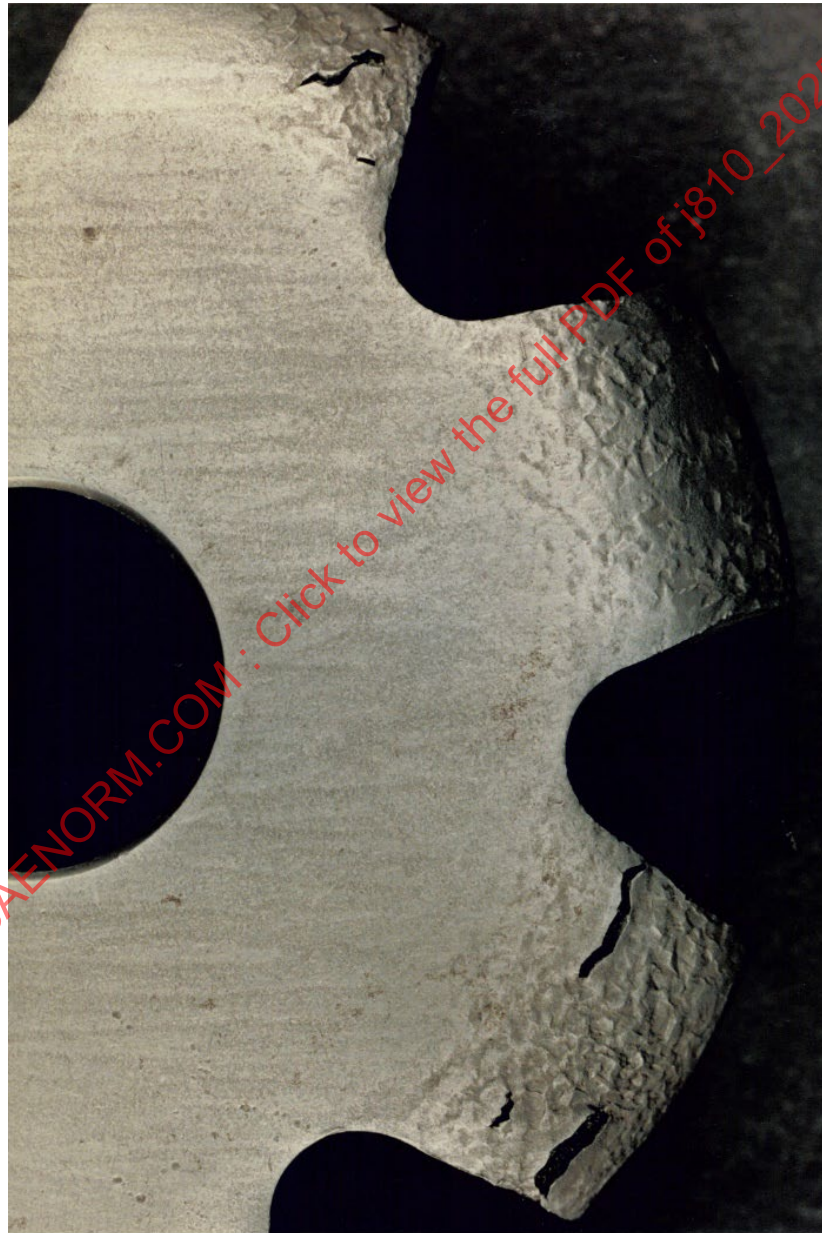
Figure 53

| <b>Product Affected:</b> | Hot rolled. |

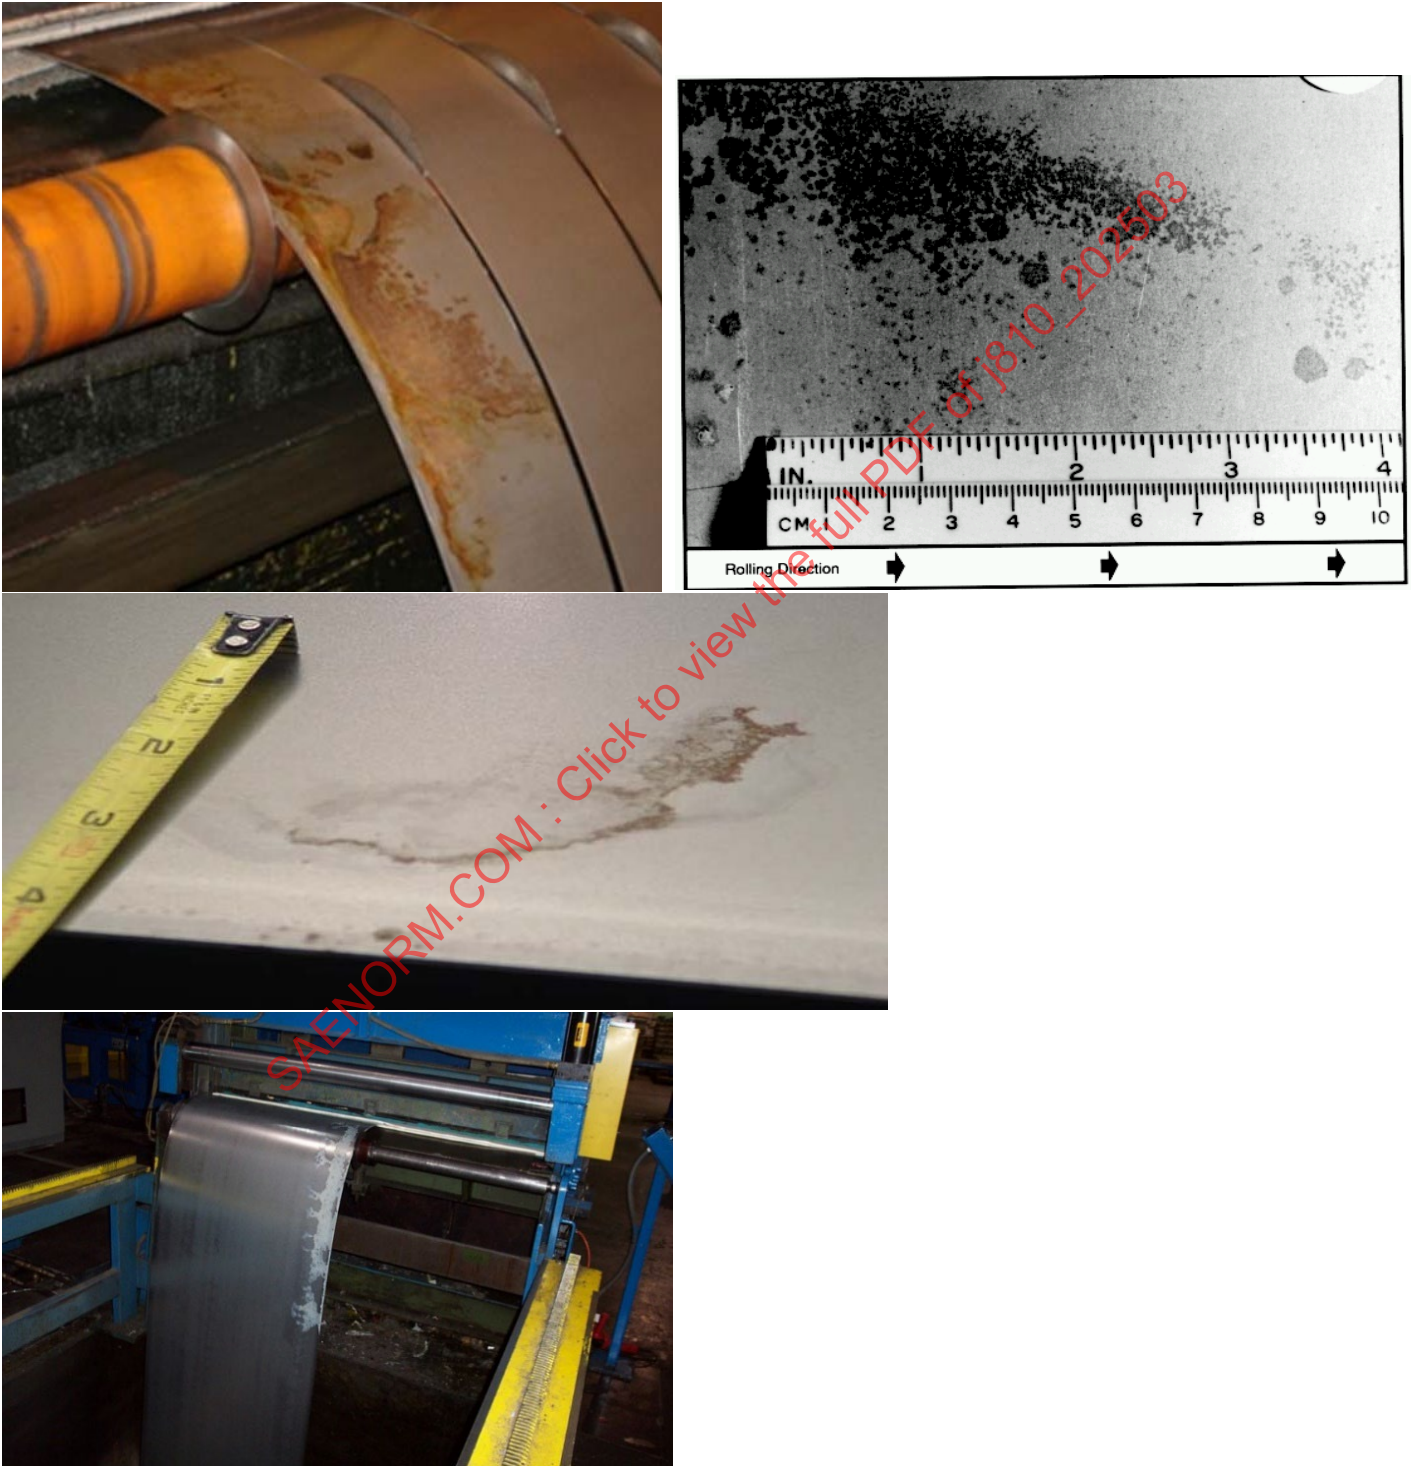
Figure 58

| <b>Description:</b> | Rust is an oxide that forms on the surface of the sheet. |
| <b>Cause:</b> | Rust is caused when steel comes in contact with moisture. |

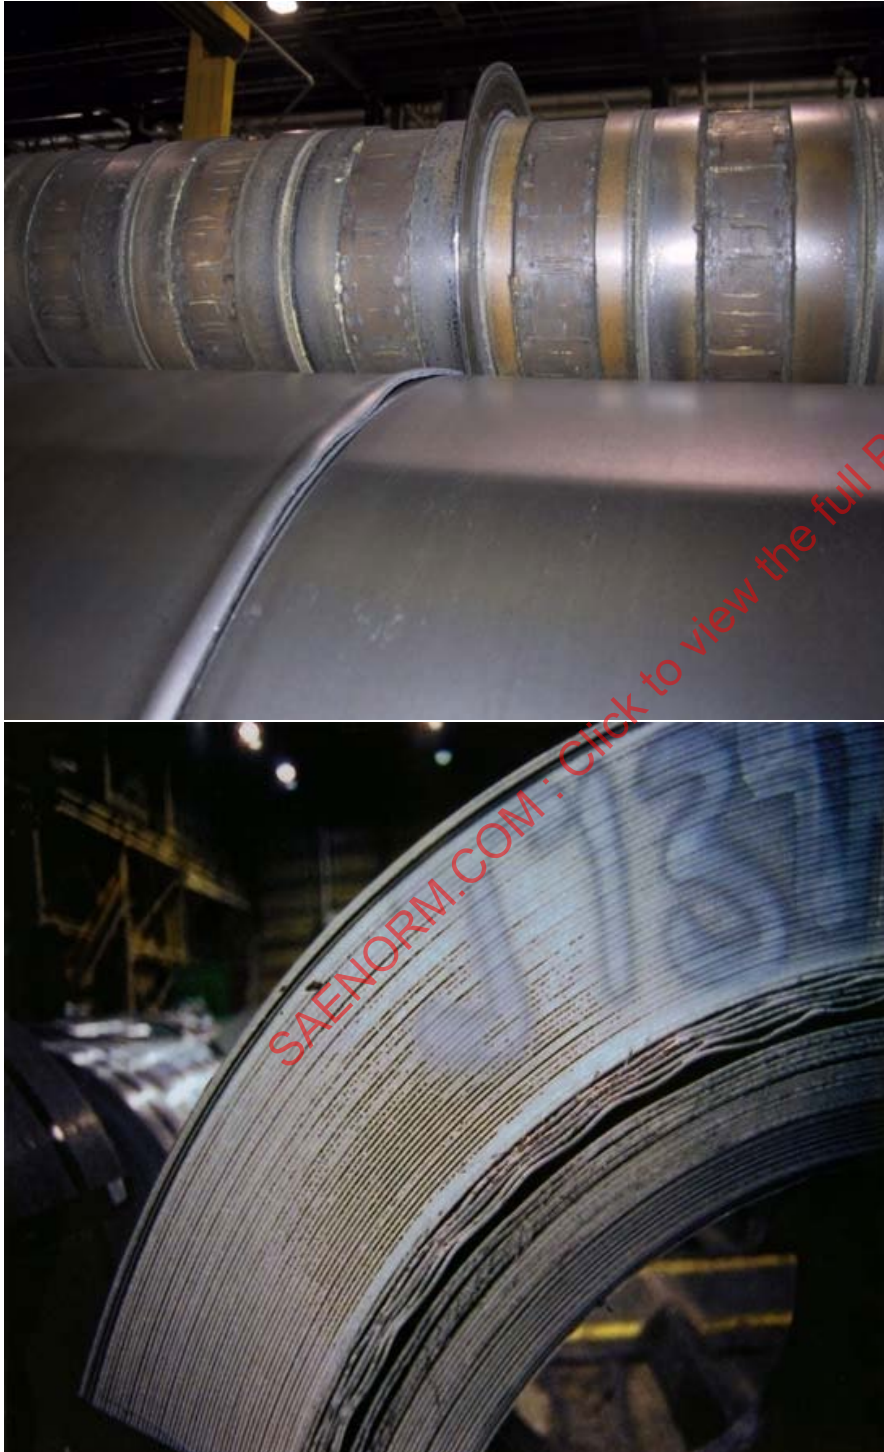
Figure 59

| <b>Description:</b> | Separator disk damage typically appears as crescent shaped markings on the coil sidewall. In severe cases, it will appear as an abrasion with small filings on the sidewall. |
| <b>Cause:</b> | Separator disk damage is caused by a damaged separator disk in the trimming or slitting operation. |

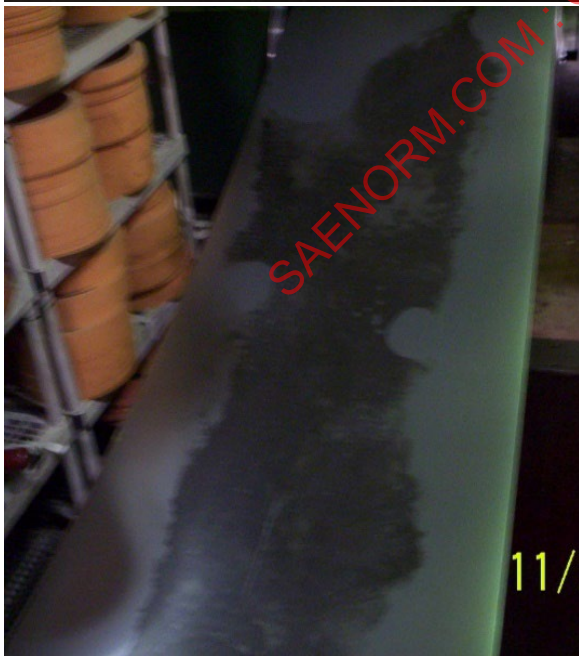
Figure 61

| <b>Description:</b> | Solution stain can vary in severity from light gray to brown or black discoloration of the steel surface and can result in poor paintability. |
| <b>Cause:</b> | Solution stain is caused by inadequate blow-off of the rolling solution used during tandem or temper mill rolling which results in a wet strip before oiling. The residue subsequently stains or etches the strip's surface. |

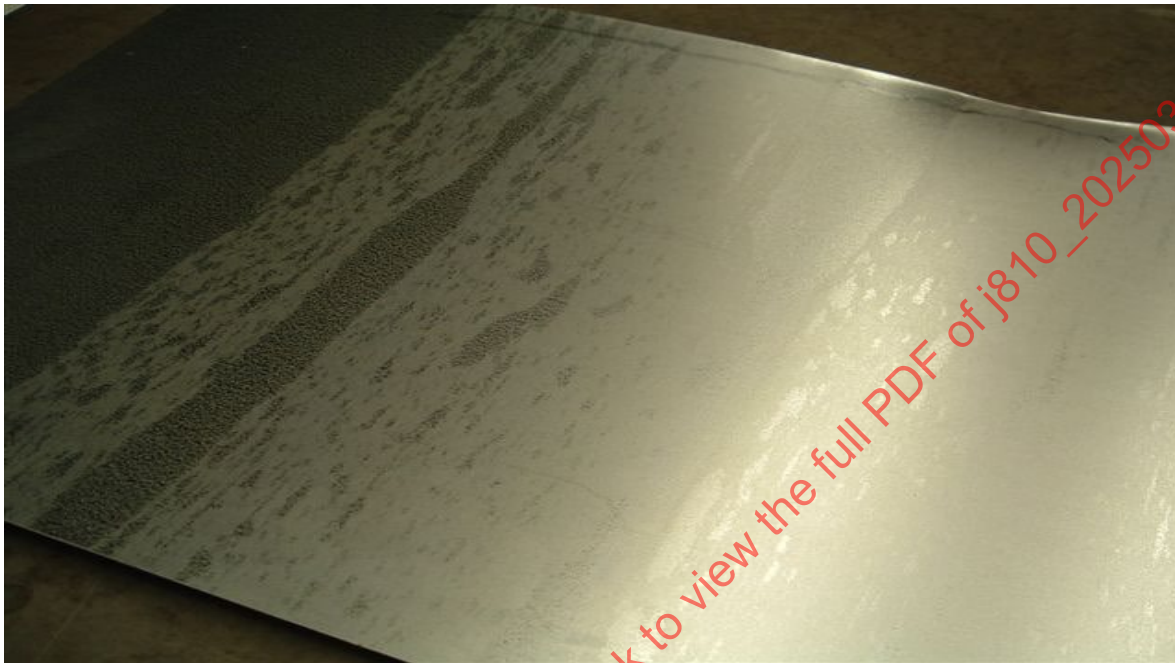
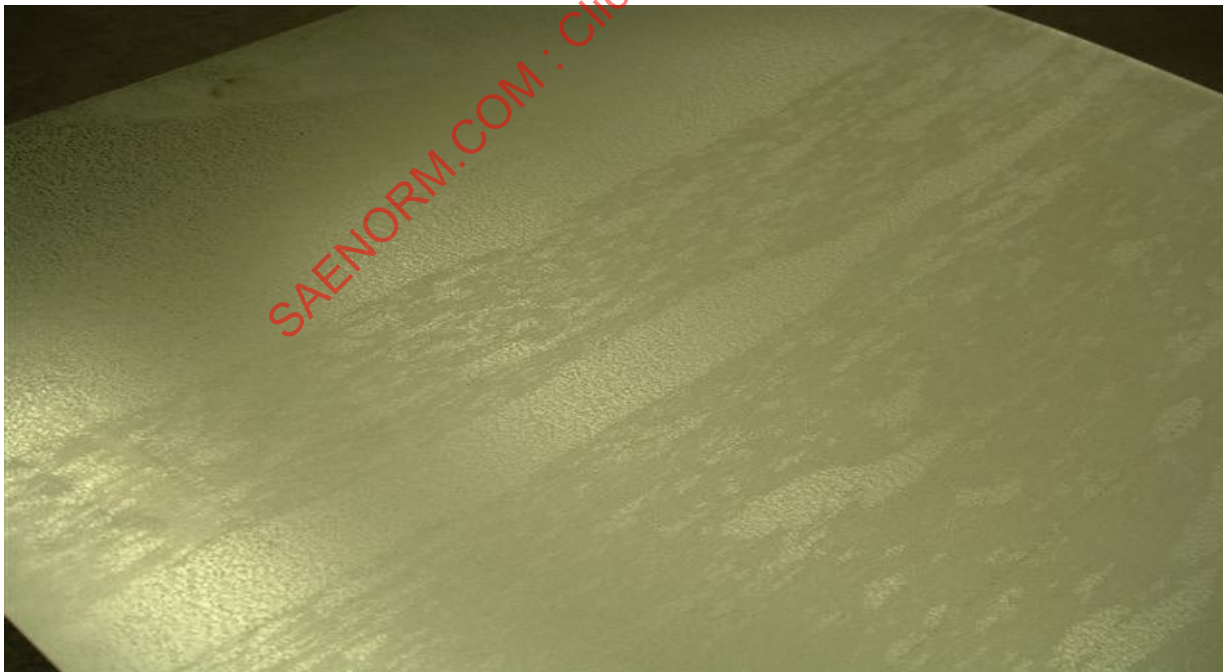
**Figure 62**

| <b>Description:</b> | Solution starve will appear as a difference in surface texture and may also cause poor shape in the area affected. Solution starve may be followed by pick-up or roll marks because of damage to the rolls involved. |
| <b>Cause:</b> | Solution starve is caused by insufficient flooding ahead of the roll bite in a reducing mill. Steel comes in direct contact with rolls, and the friction causes galling as the two surfaces stick, then friction weld together, and then tear apart. |

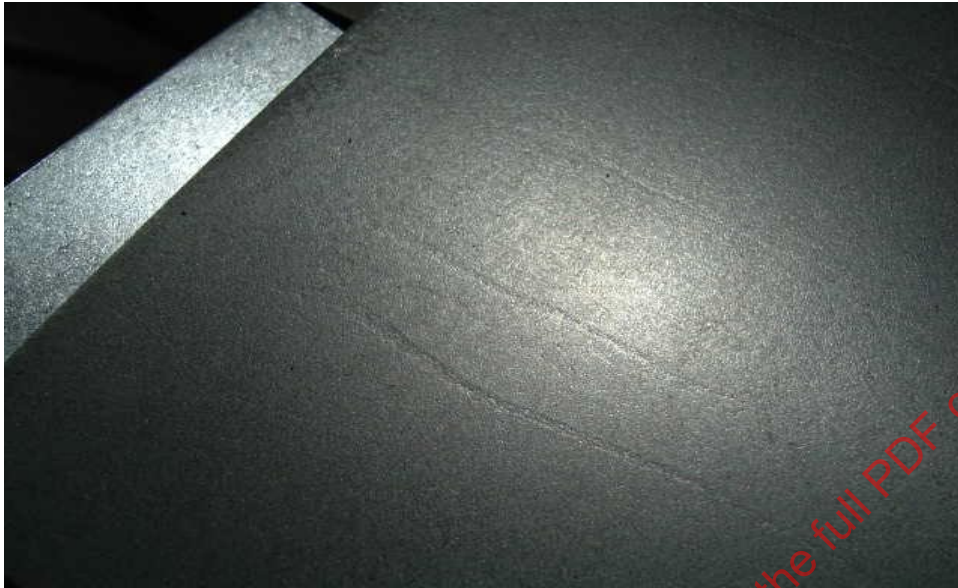
Figure 66

| <b>Cause:</b> | Strain is a result of yield point elongation during stretcher leveling or forming operations. |
