# INTERNATIONAL STANDARD

**Hydraulic turbines, storage pumps and pump-turbines – Rehabilitation and performance improvement**

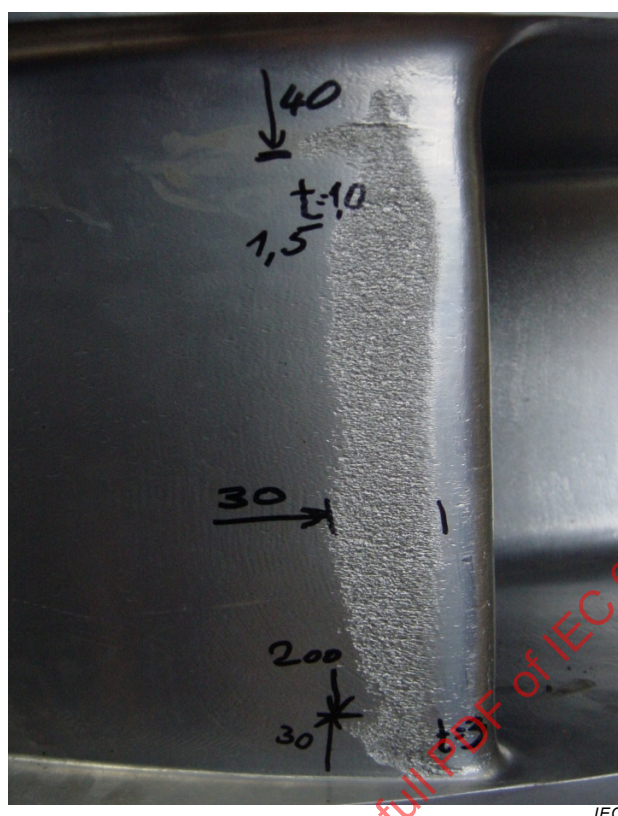
**Figure 15 – Leading edge cavitation erosion on a Francis pump-turbine caused by extended periods of operation at very low loads**

Typical cavitation erosion in the turbine mode is shown in Figure 15. This is particularly true for an installation which has a wide range of specific hydraulic energy and for which the demand in the turbine mode covers a wide range of load. Erosion on the pressure side, downstream of the blade inlet in the turbine mode is typical of units required to operate for long periods at speed-no-load or at very low loads. Erosion on the suction side, downstream of the blade inlet in the turbine mode is typical of units required to operate for long periods at very high loads. In the pumping mode, the risk of cavitation erosion on the suction side of the blade, near the entrance, increases as the downstream level diminishes.

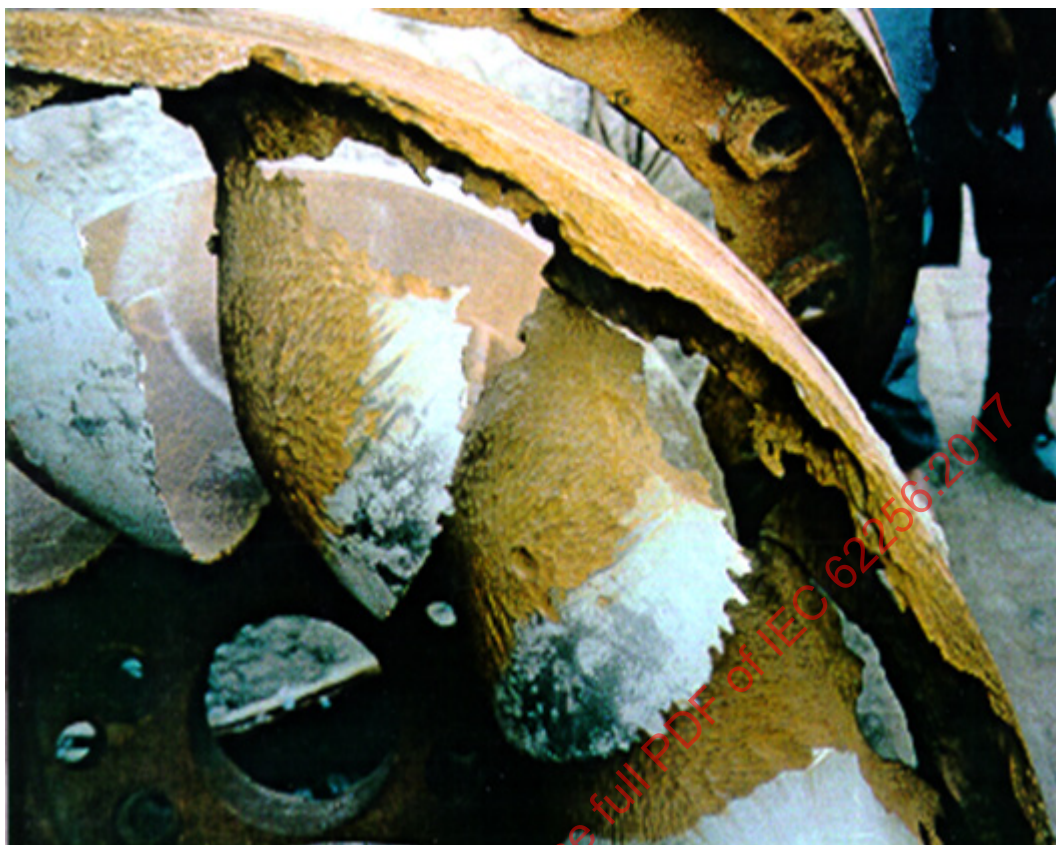
**Figure 16 – Severe particle erosion damage in a Francis runner**

The flow through turbines carrying suspended sediments can result in erosion on the water passage components exposed to high velocities. Severe erosion (see Figure 16) can result in substantial production losses due to the need for frequent repair welding or frequent component replacement. The key parameters governing the severity of erosion damage are sediment concentration, the density, hardness and shape of sediments and flow velocity. The flow velocity parameter divides the turbine into two areas which are subject to varying degrees of particle erosion: the components with low velocities such as spiral case and draft tube liner and those with high velocities or sudden flow directional changes such as the stay ring (particularly the stay vanes), guide vanes, headcover, bottom ring, discharge ring, runner and rotating wearing rings. Typically for Francis turbines, the worst erosion occurs in the runner, runner wearing rings, guide vane body extremities (surfaces adjacent to the headcover and bottom ring), headcover (particularly the stationary wearing ring), and bottom ring (particularly the stationary wearing ring).
