**Rolling bearings — Damage and  
failures — Terms, characteristics and  
causes**

# Rolling bearings — Damage and failures — Terms, characteristics and causes

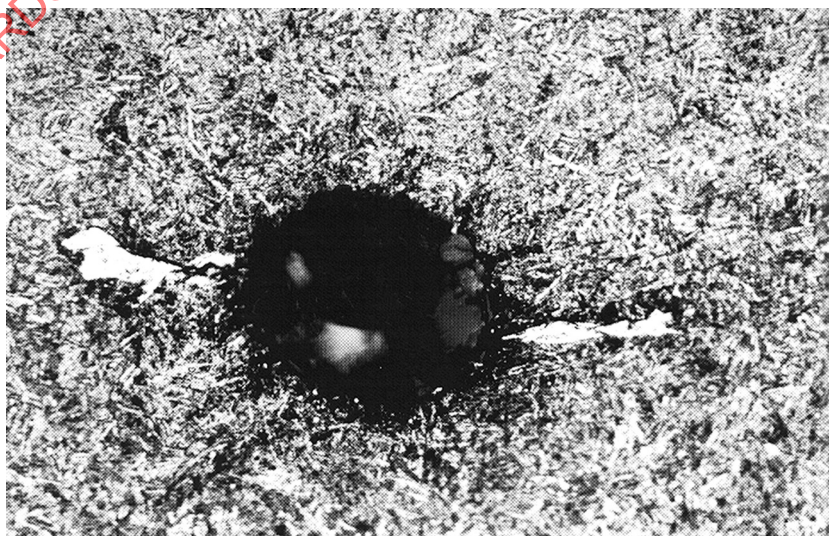
Figure 2 — Subsurface microcrack with the “butterfly phenomenon” (white etched area) (Scale 500:1)

Under the influence of loads in rolling contacts, described by the Hertzian Theory, structural changes will occur and microcracks will be initiated at a certain depth under the surface, i.e. subsurface. The initiation of the microcracks is often caused by inclusions in the bearing steel (see Figure 2). The microcracks, which are observed at the edge of the white etched areas (butterflies), will normally propagate to the rolling contact surface producing flaking, spalling (pitting) and then peeling (see Figure 3).

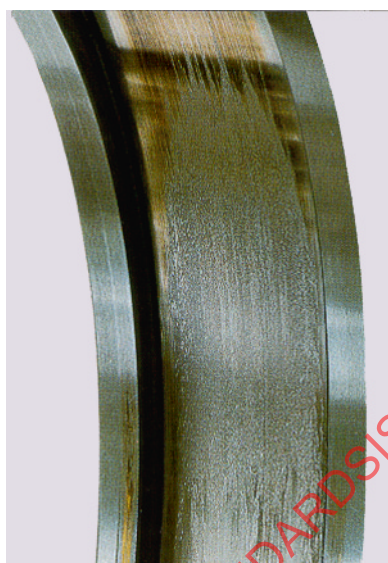
**Figure 8 — Smearing on raceway surfaces**

Smearing (skidding) can occur between rolling elements and raceways due to the fact that the rolling elements are lightly loaded and subjected to severe acceleration on their re-entry into the load zone (see Figure 8). Smearing can also occur between rolling elements and raceways when the load is too light in relation to the speed of rotation.

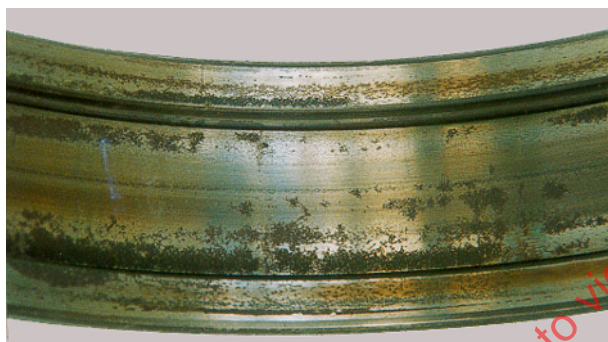
Figure 11 — Corrosion on a roller bearing outer ring

When steel, used for rolling bearing components, is in contact with moisture, e.g. water or acid, oxidation of surfaces takes place. Subsequently the formation of corrosion pits occurs and finally flaking of the surface (see Figure 11).

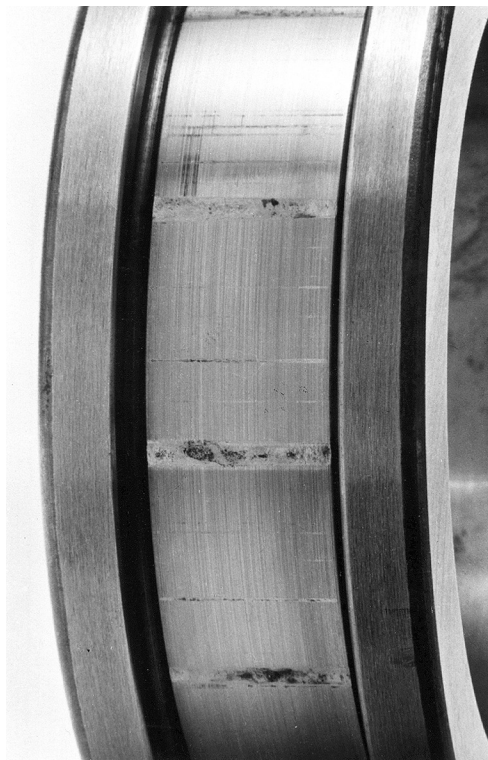
**Figure 15 — False brinelling on inner ring raceway of cylindrical roller bearing**

In the case of a stationary bearing, the depressions appear at rolling element pitch and can often be discoloured reddish or shiny (see Figure 15).

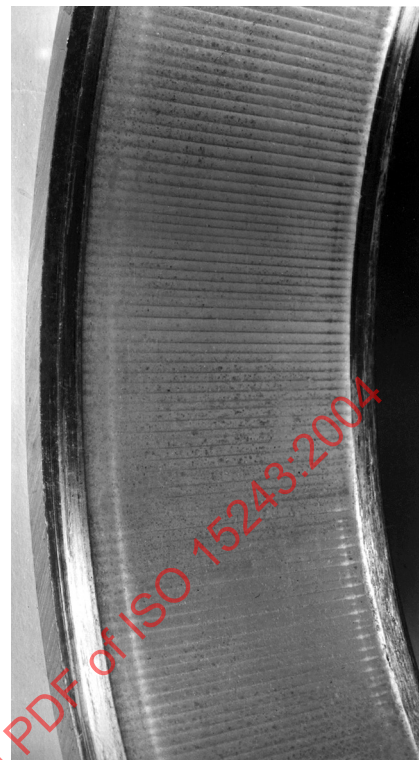
**Figure 16 — False brinelling — Fluting on outer ring of tapered roller bearing**

False brinelling caused by vibrations occurring during rotation shows itself in closely spaced flutes (see Figure 16). These should not be mistaken for electrically caused flutes (see 5.4.3 and Figure 19). The fluting resulting from vibration has bright or fretted bottoms to the depressions compared to fluting produced by the passage of electric current, where the bottoms of the depressions are dark in colour. The damage caused by electric current is also distinguishable by the fact that the rolling elements are also marked.

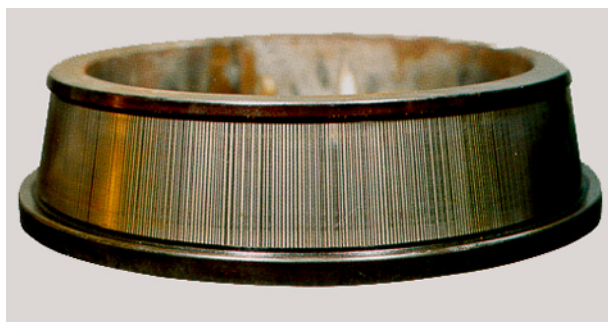
**Figure 19 — Craters formed by current leakage resulting in fluting**

Initially the surface damage takes the shape of shallow craters, which are closely positioned to one another and small in size. This happens even if the intensity of the current is comparatively low. Flutes will develop from the craters in time, as shown in Figure 19. They can be found on roller and ring raceway contact surfaces, but not on balls, which have dark colouration only (see Figure 20). The flutes are equally spaced. The raceways are dark in the bottoms of the depressions (see Figures 20 and 21). Eroded patches, next to the flutes on Figure 21, indicated by the pencil point, were caused by contact of the cage ribs with the inner ring.
