## Rolling bearings — Damage and failures — Terms, characteristics and causes

# Rolling bearings — Damage and failures — Terms, characteristics and causes

This document classifies different modes of failure occurring in service for rolling bearings made of standard bearing steels. For each failure mode, it defines and describes the characteristics, appearance and possible root causes of failure. It will assist in the identification of failure modes based on appearance.

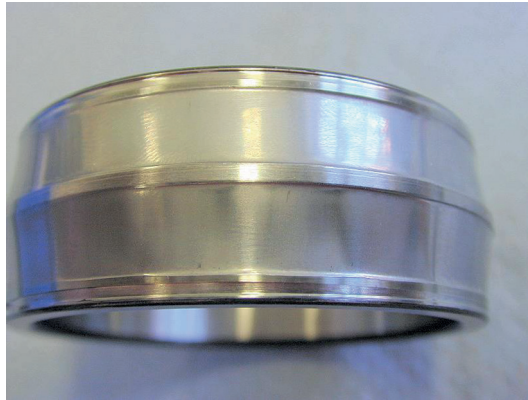
**Figure 8 — Abrasive wear on the inner ring of a spherical roller bearing**

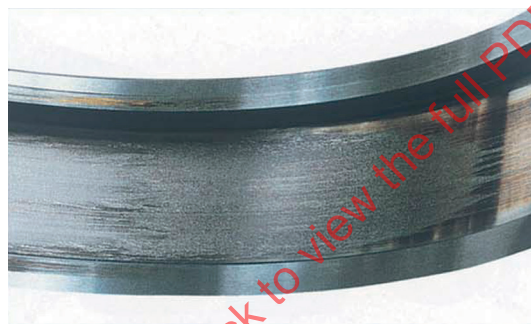
**Figure 11 — Smearing on the outer ring raceway of a cylindrical roller bearing**

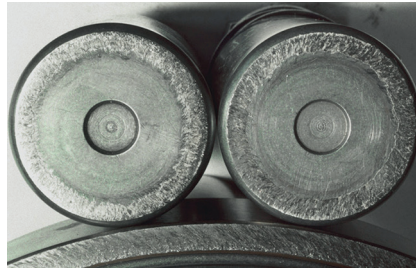
**Figure 13 — Smearing on the side face of rollers of a cylindrical roller bearing**

Smearing can also occur on the rib faces and on the ends of the rollers due to inadequate lubrication (see [Figure 13](#)). In full complement (cageless) bearings, smearing can also occur in the contacts between rolling elements, depending on lubrication and rotation conditions.

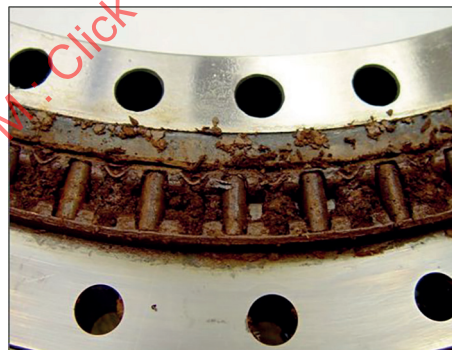
**Figure 14 — Moisture corrosion on the cage and rollers of a needle roller thrust bearing**

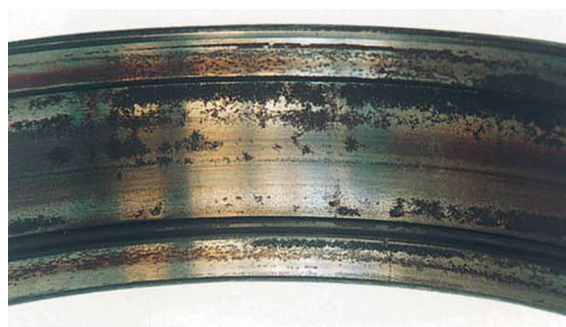
**Figure 15 — Moisture corrosion on the outer ring raceway of a cylindrical roller bearing**

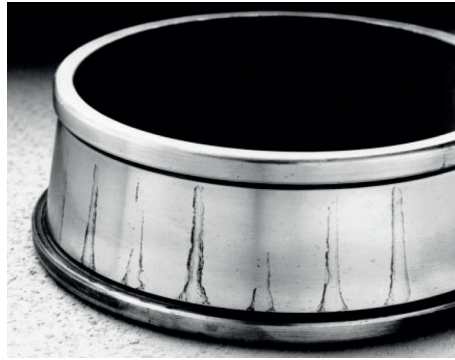
**Figure 16 — Contact corrosion at roller pitch on the inner ring raceway of a tapered roller bearing**

A specific form of moisture corrosion can be observed in the contact areas between rolling elements and bearing rings where the water content in the lubricant or the degraded lubricant reacts with the surfaces of the adjacent bearing elements. During static periods, the advanced stage will result in dark discolouration of the contact areas at intervals corresponding to the ball/roller pitch (see [Figure 16](#)); eventually producing corrosion pits.

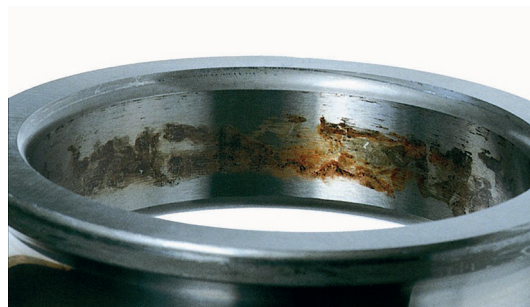
**Figure 17 — Fretting corrosion in the inner ring bore of a deep groove ball bearing**

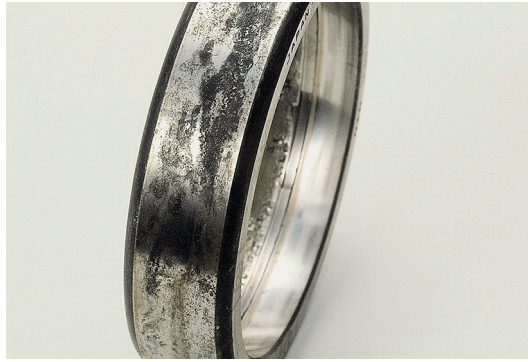
**Figure 18 — Fretting corrosion on the outer diameter of a roller bearing**

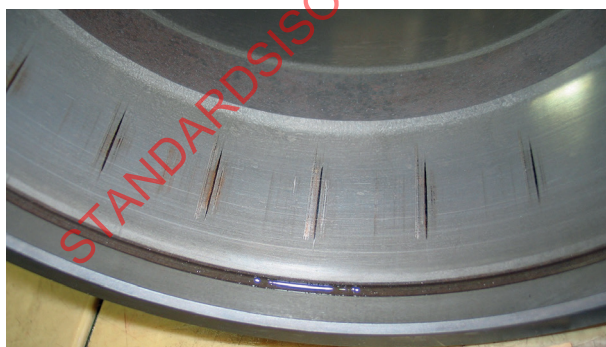
**a) Outer ring of a tapered roller bearing**

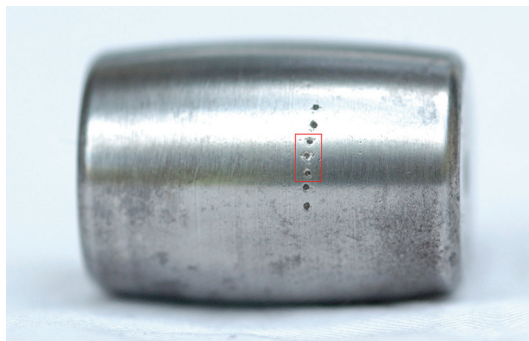
Figure 21 — Roller of a spherical roller bearing — Craters formed by the passage of excessive electric current

This damage (electrical pitting) may appear as a series of craters with diameters of up to 500  $\mu\text{m}$  (see [Figures 21](#) and [22](#)). The craters are duplicated on the rolling element and raceway contact surfaces, typically in bead-like procession in the rolling direction (see [Figure 21](#)).

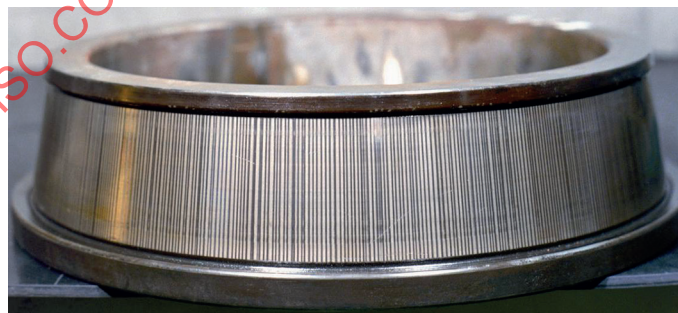
Figure 23 — Fluting (washboarding) as a result of current leakage on the inner ring raceway of a tapered roller bearing

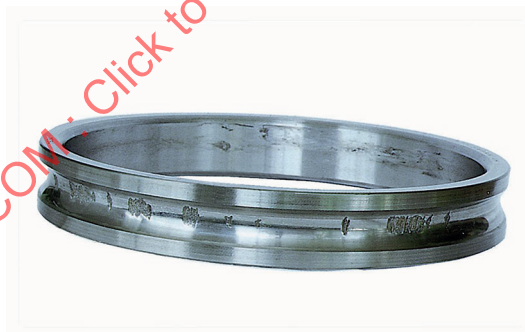
**Figure 27 — Spalling as a result of shock load deformation on the inner ring raceway of an angular contact ball bearing, resulting from impacts in radial direction, which further developed in spalling**

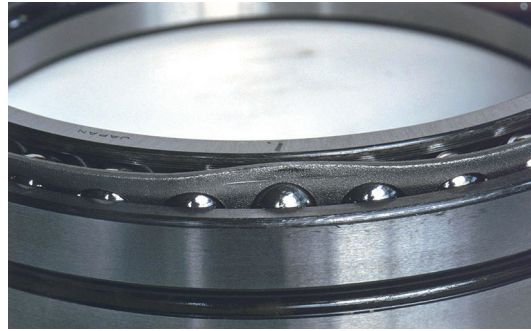
**Figure 28 — Cage deformation of an angular contact ball bearing caused by a shock load during handling**

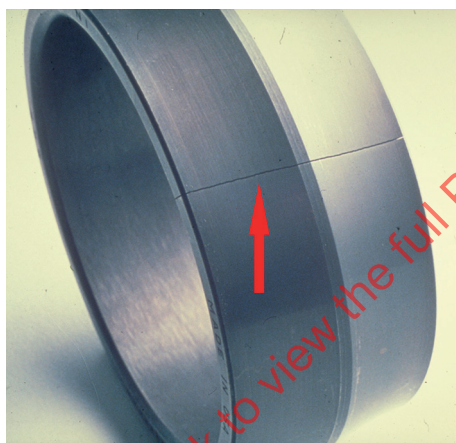
NOTE Fracture caused by an excessive interference fit during mounting, for example, by driving a tapered bore inner ring too far up the shaft taper.

Forced fracture is due to a stress concentration in excess of the material (tensile) strength and is caused by local over-stressing, e.g. from impact (see [Figure 33](#)), or by over-stressing due to an excessive interference fit, e.g. too high hoop stress (see [Figure 34](#)).

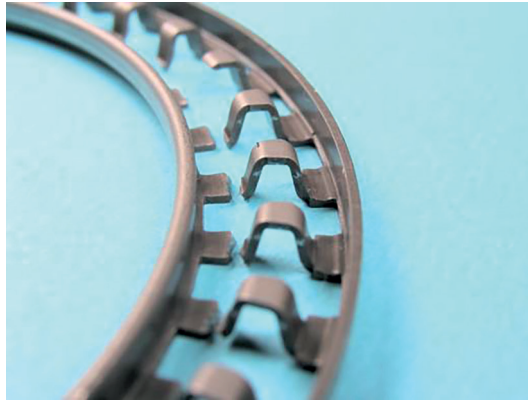
**Figure 36 — Fatigue fracture of cage bars of a needle roller thrust bearing**

Frequent exceeding of the fatigue strength limit under bending, tension or torsion conditions results in fatigue cracking. A crack is initiated at a stress raiser and propagates in steps over a part of the component cross-section, ultimately resulting in a forced fracture. Fatigue fracture occurs mainly on rings (see [Figure 35](#)) and cages (see [Figure 36](#)).

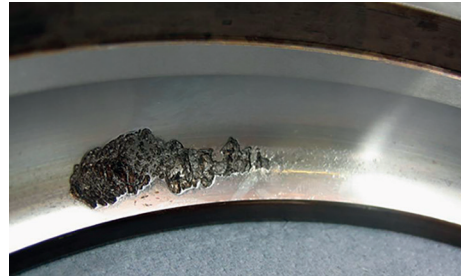
#### A.2.2.1.4 Spalling resulting from subsurface initiated fatigue at two diametrically opposite locations — On the outer ring raceways of a self-aligning ball bearing

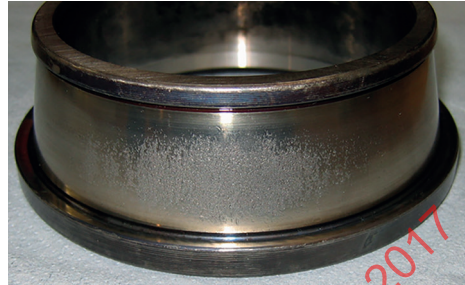
**A.2.2.2.3 Surface initiated fatigue on roller raceways of a needle roller bearing****Cause of failure**

- Improve lubrication.
- Realign the shaft and/or housings.

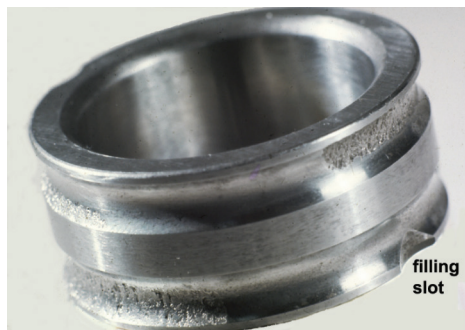
#### A.2.2.2.5 Spalling on the inner ring raceway of an angular contact ball bearing

- Improve the sealing.
- Review the lubrication for the operating conditions.

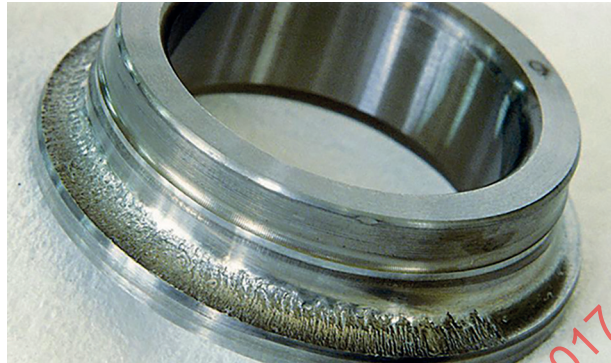
#### A.2.2.2.6 Spalling (peeling) on the inner ring raceways of a tapered roller bearing

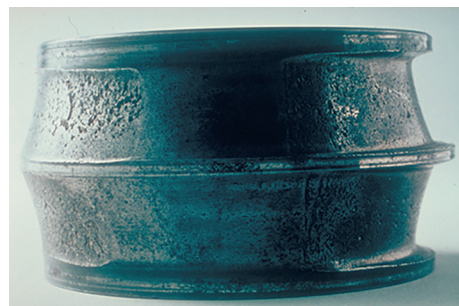
**A.2.3.1.2 Abrasive wear on the end face of a cylindrical roller****Cause of failure**

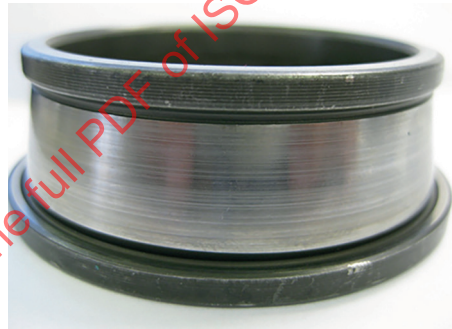
**A.2.3.1.4 Abrasive wear on the cage pockets of a solid metal cage of an angular contact ball bearing****Cause of failure**

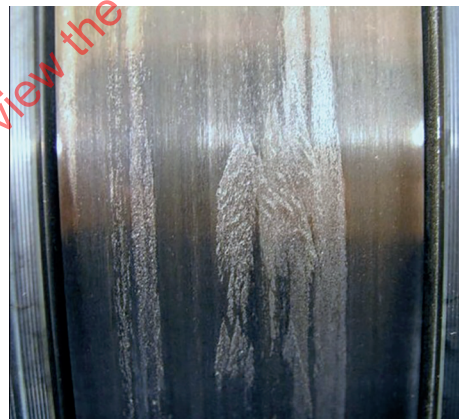
##### A.2.3.2.2 Smearing on the large end face of a tapered roller

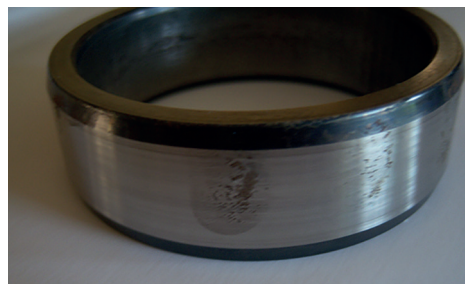
#### A.2.4.1.3 Contact corrosion on the inner ring raceway of an angular contact ball bearing

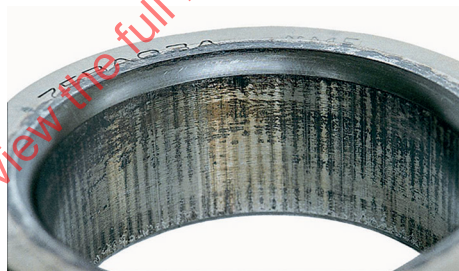
##### A.2.4.2.2 Fretting corrosion on the inner ring bore of a ball bearing

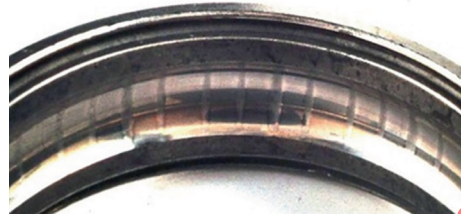
##### A.2.4.3.2 False brinelling on the inner ring raceway of a deep groove ball bearing

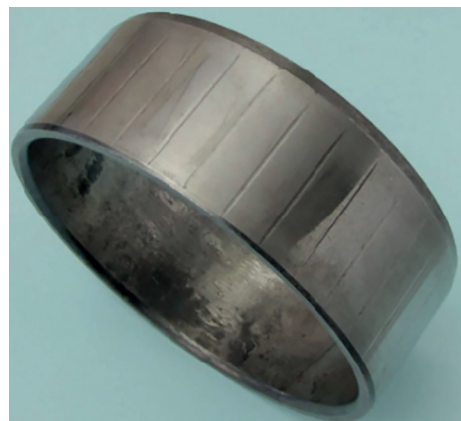
#### A.2.4.3.4 False brinelling on the outer ring raceway of a cylindrical roller bearing
