**Condition monitoring and  
diagnostics of machine systems —  
Thermography —**

**Part 2:  
Image interpretation and diagnostics**

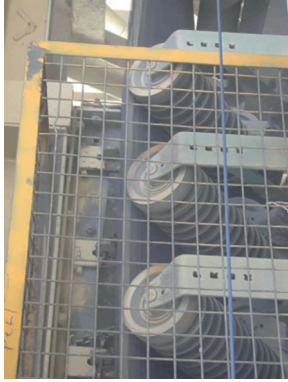
| Diagnostic principle and subclause | Name of the machine or system<br>e.g., calendar, re-former, hydraulic arm, etc. | Name of the component on the machine<br>Thermal characteristic | Degradation or problem or fault | Thermogram | Visual |
|---|---|---|---|---|---|
| <a href="#">10.2.2.2</a> Surface friction | Conveyor | Conveyor<br>High friction between belt and roller and high bearing temperatures | Failed conveyor idler bearing | <br>Figure A.7 a) | <br>Figure A.7 b) |

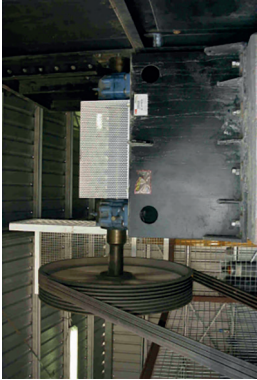
| Diagnostic principle and subclause | Name of the machine or system<br>e.g., calendar, reformer, hydraulic arm, etc. | Name of the component on the machine<br>Thermal characteristic | Degradation or problem or fault | Thermogram | Visual |
|---|---|---|---|---|---|
| <a href="#">10.2.2.2</a> Surface friction | Belt driven fan | Fan<br>High fan side bearing temperatures<br>Note shaft temperature profile indicates heat generation is within the bearing. | Poor lubrication<br>Reduced internal clearance | <br>Figure A.9 a) | <br>Figure A.9 b) |

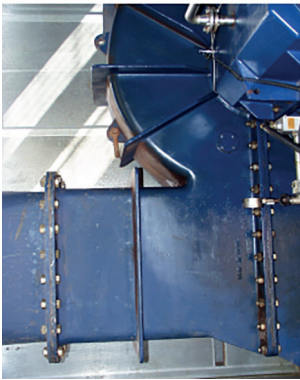
| Diagnostic principle and subclause | Name of the machine or system<br>e.g., calendar, reformer, hydraulic arm, etc. | Name of the component on the machine<br>Thermal characteristic | Degradation or problem or fault | Thermogram | Visual |
|---|---|---|---|---|---|
| <a href="#">10.2.3</a> Fluid friction | Centrifugal air compressor | Casing<br>Non uniform temperature profile on opposite corners | Misalignment of casing to impeller | <br>Figure A.10 a) | <br>Figure A.10 b) |

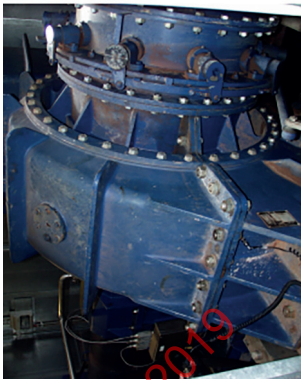
| Diagnostic principle and subclause | Name of the machine or system<br>e.g., calendar, reformer, hydraulic arm, etc. | Name of the component on the machine<br>Thermal characteristic | Degradation or problem or fault | Thermogram | Visual |
|---|---|---|---|---|---|
| <a href="#">10.2.3</a> Fluid friction | Centrifugal air compressor | Casing<br>Non uniform temperature profile on opposite corners | Misalignment of casing to impeller | <br>Figure A.11 a) | <br>Figure A.11 b) |

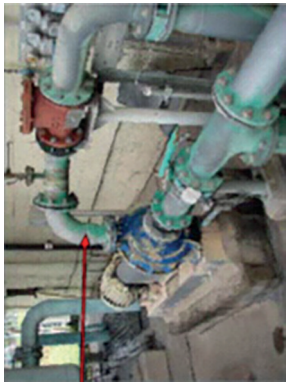
| Diagnostic principle and subclause | Name of the machine or system<br>e.g., calendar, re-former, hydraulic arm, etc. | Name of the component on the machine<br>Thermal characteristic | Degradation or problem or fault | Thermogram | Visual |
|---|---|---|---|---|---|
| 10.2.2.3 Fluid friction | Compressor cooling water pump | Cooling water pump<br>Pump is hotter than suction or discharge indicating recirculating flow. | High backpressure due to blocked cooler downstream | <br>Figure A.13 a) | <br>Figure A.13 b) |

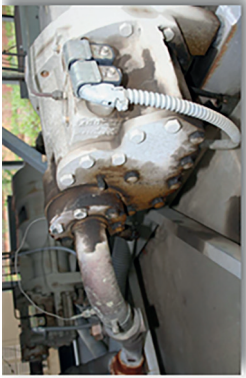
| Diagnostic principle and subclause | Name of the machine or system<br>e.g., calendar, re-former, hydraulic arm, etc. | Name of the component on the machine<br>Thermal characteristic | Degradation or problem or fault | Thermogram | Visual |
|---|---|---|---|---|---|
| <a href="#">10.2.8</a> Compression heating | HVAC unit | Compressor<br>Adiabatic decompression cooling due to leak? | <b>Compressor not working properly</b><br>Compressor not working properly because of a Freon leak. The leak was found with infrared due to oil leaking out with Freon. | <br>Figure A.16 a) | <br>Figure A.16 b) |

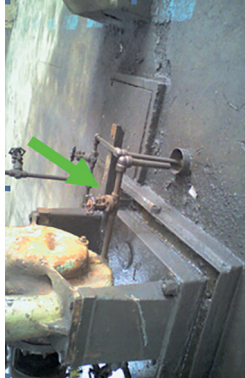
| Diagnostic principle and subclause | Name of the machine or system<br>e.g., calendar, re-former, hydraulic arm, etc. | Name of the component on the machine<br>Thermal characteristic | Degradation or problem or fault | Thermogram | Visual |
|---|---|---|---|---|---|
| <a href="#">10.2.8</a> Compression heating | MEK area | Manual discharge valve<br>Adiabatic cooling | Gas leakage (VOC) detected due to gas expansion<br>The valve is closed during normal operation. | <br>Figure A.17 a) | <br>Figure A.17 b) |

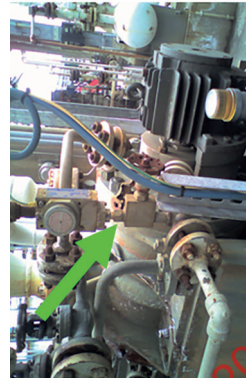
| Diagnostic principle and subclause | Name of the machine or system<br>e.g., calendar, re-former, hydraulic arm, etc. | Name of the component on the machine<br>Thermal characteristic | Degradation or problem or fault | Thermogram | Visual |
|---|---|---|---|---|---|
| <a href="#">10.2.8</a> Compression heating | Vacuum area | Connection<br>Adiabatic cooling | Gas leakage (VOC) detected due to gas expansion | <br>Figure A.18 a) | <br>Figure A.18 b) |

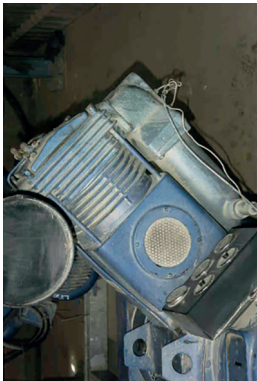
| Diagnostic principle and subclause | Name of the machine or system<br>e.g., calendar, re-former, hydraulic arm, etc. | Name of the component on the machine<br>Thermal characteristic | Degradation or problem or fault | Thermogram | Visual |
|---|---|---|---|---|---|
| 10.2.8 Compression heating | Reciprocating compressor | Compression heating of cylinders with abnormal temperature profile from leaking valve | Valve leak | <br>Figure A.19 a) | <br>Figure A.19 b) |

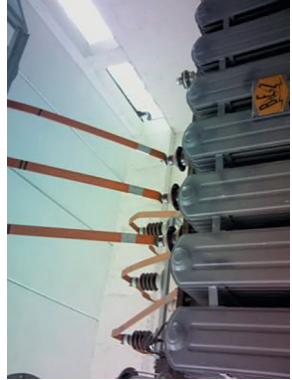
| Diagnostic principle and subclause | Name of the machine or system<br>e.g., calendar, reformer, hydraulic arm, etc. | Name of the component on the machine<br>Thermal characteristic | Degradation or problem or fault | Thermogram | Visual |
|---|---|---|---|---|---|
| <a href="#">10.2.10</a> Electrical resistance heating | Transformer bushing | Terminal connector | High resistance joint | <br>Figure A.22 a) | <br>Figure A.22 b) |

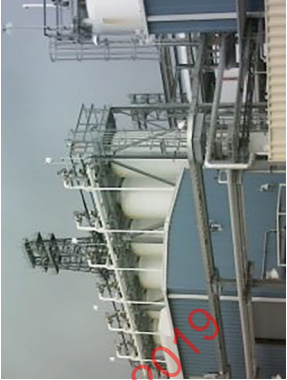
| Diagnostic principle and subclause | Name of the machine or system<br>e.g., calendar, reformer, hydraulic arm, etc. | Name of the component on the machine<br>Thermal characteristic | Degradation or problem or fault | Thermogram | Visual |
|---|---|---|---|---|---|
| <a href="#">10.3</a> Abnormal heat distribution | Coking operation | Safety relief valve<br>Right valve hotter than similar valves on left for comparison<br>Convection heating | Leaking SRV | <br>Figure A.24 a) | <br>Figure A.24 b) |

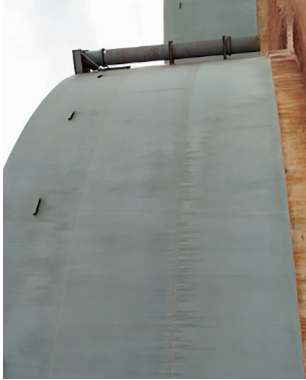
| Diagnostic principle and subclause | Name of the machine or system<br>e.g., calendar, re-former, hydraulic arm, etc. | Name of the component on the machine<br>Thermal characteristic | Degradation or problem or fault | Thermogram | Visual |
|---|---|---|---|---|---|
| <a href="#">10.3</a> Abnormal heat distribution | Mineral processing tank | Acid digestion tank | Failed rubber lining within tank | <br>Figure A.25 a) | <br>Figure A.25 b) |

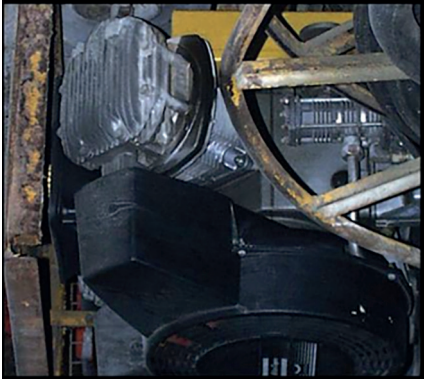
| Diagnostic principle and subclause | Name of the machine or system<br>e.g., calendar, re-former, hydraulic arm, etc. | Name of the component on the machine<br>Thermal characteristic | Degradation or problem or fault | Thermogram | Visual |
|---|---|---|---|---|---|
| <a href="#">10.3</a> Abnormal heat distribution | Air compressor on mining equipment | Compressor cylinder<br>Note high temperatures from air leak, however, apparent high temperatures on casing side wall due to high emissivity of blackened oil coating. | Head gasket leak | <br>Figure A.26 a) | <br>Figure A.26 b) |
