**Plain bearings — Appearance and  
characterization of damage to metallic  
hydrodynamic bearings —**

**Part 2:  
Cavitation erosion and its  
countermeasures**

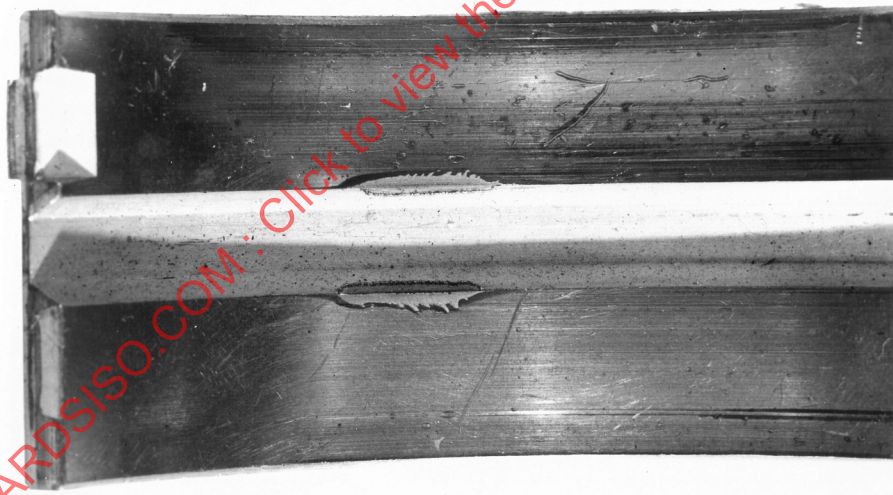
**Figure 6 — Flow cavitation erosion on both groove sides of the lower half of a center main bearing in a turbo charged 6-cylinder diesel engine**

- a) at the edge of oil holes (see Figure 4);
- b) at the downstream end of partial oil grooves in big-end bearings (see Figure 5);
- c) on the side faces and adjacent bearing surface of circumferential oil grooves (see Figure 6);
- d) adjacent to the joint face relief of a big-end bearing and a main bearing (see Figures 7 and 8);
- e) in deep scores and indentation in bearing surfaces.

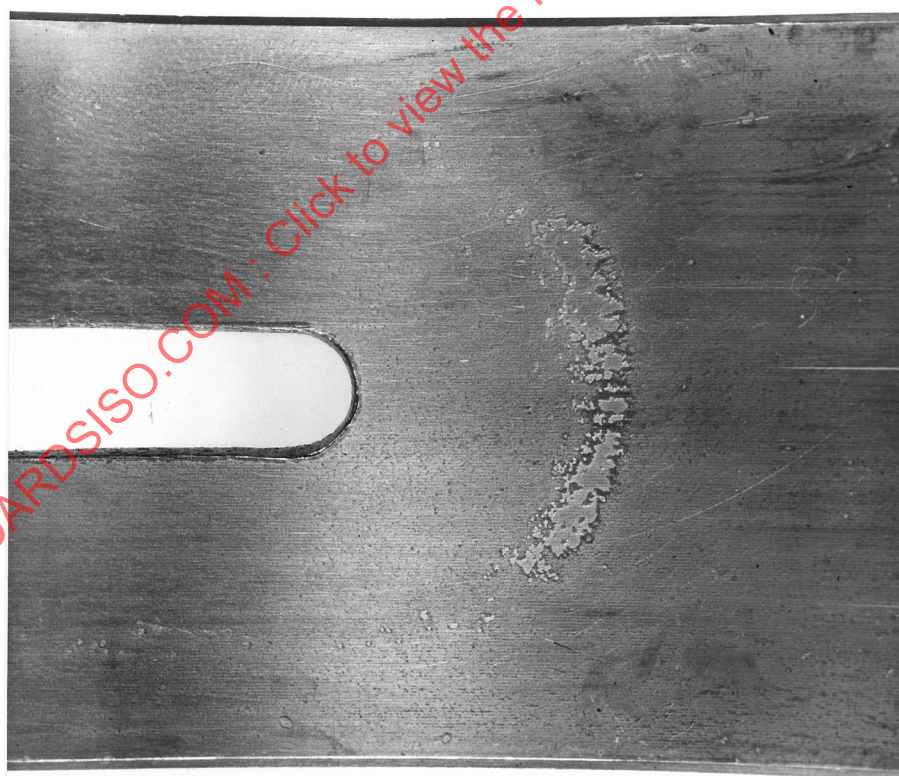
Figure 9 — Impact cavitation erosion at the end of 210° groove in a main bearing

The erosion usually takes the form of a kidney, ring or half-moon. Figure 9 shows a typical example of the impact cavitation erosion behind and at some distance from the downstream end of a partial-circumferential oil groove in a lower half main bearing, where the journal is provided with drillings for supplying oil to a big-end bearing in a high-speed engine. Figure 10 depicts the damage at two circumferentially different spots, as the engine has run at two different constant speeds. Similar erosion has also been experienced near the end of an oil bleed slot in the rod half of a big-end bearing (see Figure 11).

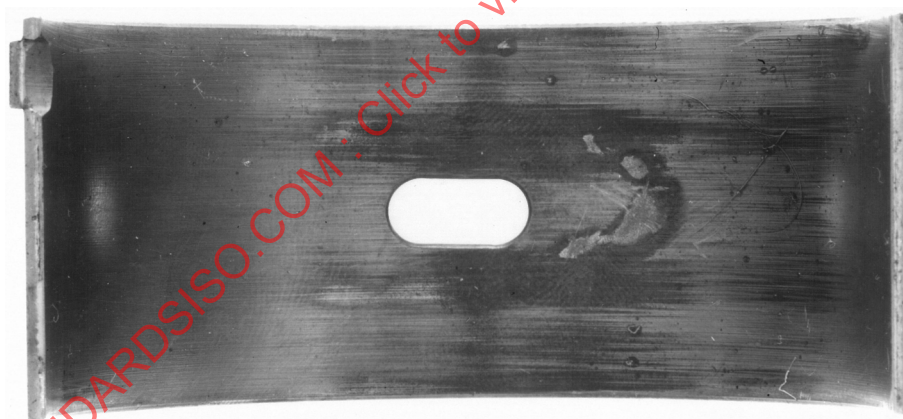
Figure 11 — Impact cavitation erosion near the end of an oil bleed slot in the rod half of a big-end bearing

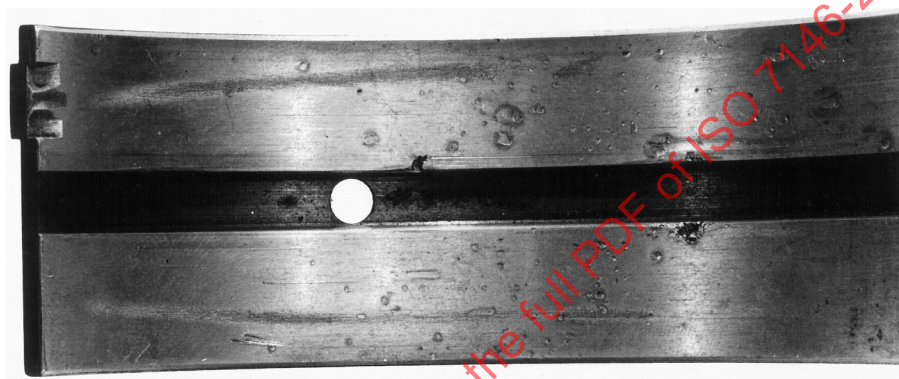
Figure 12 — Suction cavitation erosion in the upper half main bearing of a diesel engine

This erosion takes place only in dynamically loaded bearings. It has been experienced on the upper halves of main bearings and near the circumferential centre lines of the bearing lands. The damage took a long lancet-like form in a mild case (see Figure 12), and other forms (see Figures 13 and 14) in severe cases.
