**Plain bearings — Appearance and  
characterization of damage to metallic  
hydrodynamic bearings —**

**Part 2:  
Cavitation erosion and its  
countermeasures**

# Plain bearings — Appearance and characterization of damage to metallic hydrodynamic bearings —

## Part 2: Cavitation erosion and its countermeasures

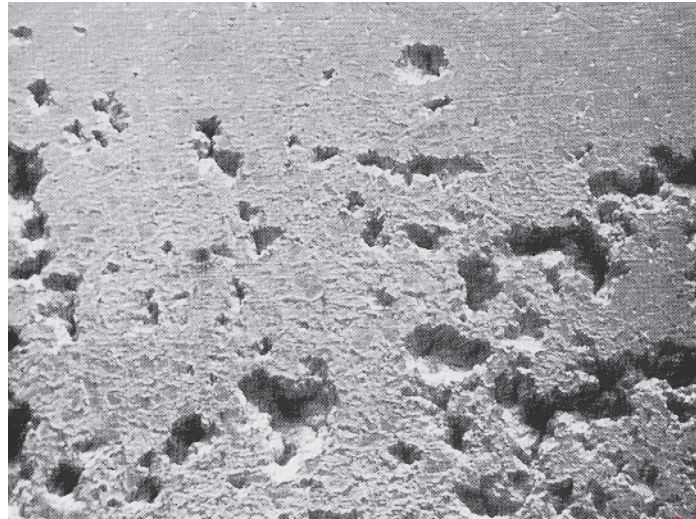
a) View under magnification

b) Cross-section under magnification

c) Cross-section under higher magnification

**Figure 1 — Sliding surface with cavitation erosion****4.2 Classification of cavitation erosion**

When a bearing surface is eroded by cavitation, the colour of the surface changes slightly due to roughening. Then small pores form, and cracks initiate on the surface, especially at grain boundaries. These cracks with sharp edges are spread first on the surface and then deepen according to the properties of the underlying material (see [Figure 1](#)). The cracks are joined together leading to break-out and wash-away of small particles of bearing materials.

When the damage is caused solely by collapsing cavities, the attacked areas show a rough texture. Metallurgical section often shows signs of local work-hardening and fatigue cracking due to hammer blows caused by cavity collapse. But if particles are trapped in the damage pockets, the surface can be eroded and exhibits a smooth and polished appearance. The place of cavitation erosion is usually limited locally and spreads seldom to a broader region. The cavitation erosion usually appears in the unloaded areas of the bearing.

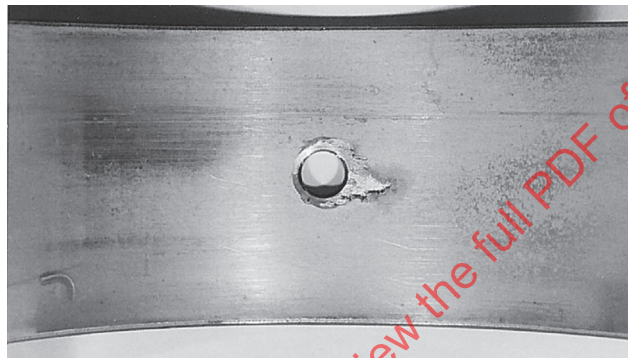
**Figure 4 — Flow cavitation erosion at the oil hole of a rod half big-end bearing in a petrol engine (material: steel/Al-Sn)**

- e) at the edge of oil holes (see [Figure 4](#));
- f) at the downstream end of partial oil grooves in big-end bearings (see [Figure 5](#));
- g) on the side faces and adjacent bearing surface of circumferential oil grooves (see [Figure 6](#));
- h) adjacent to the joint face relief of a big-end bearing and a main bearing (see [Figures 7](#) and [8](#));

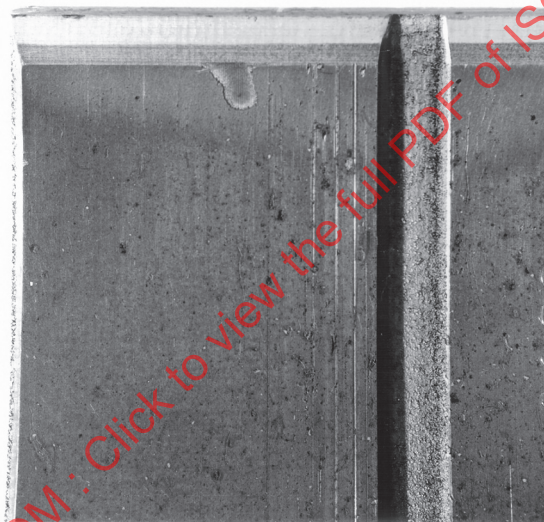
**Figure 7 — Flow cavitation erosion at the joint face relief in a big-end bearing**

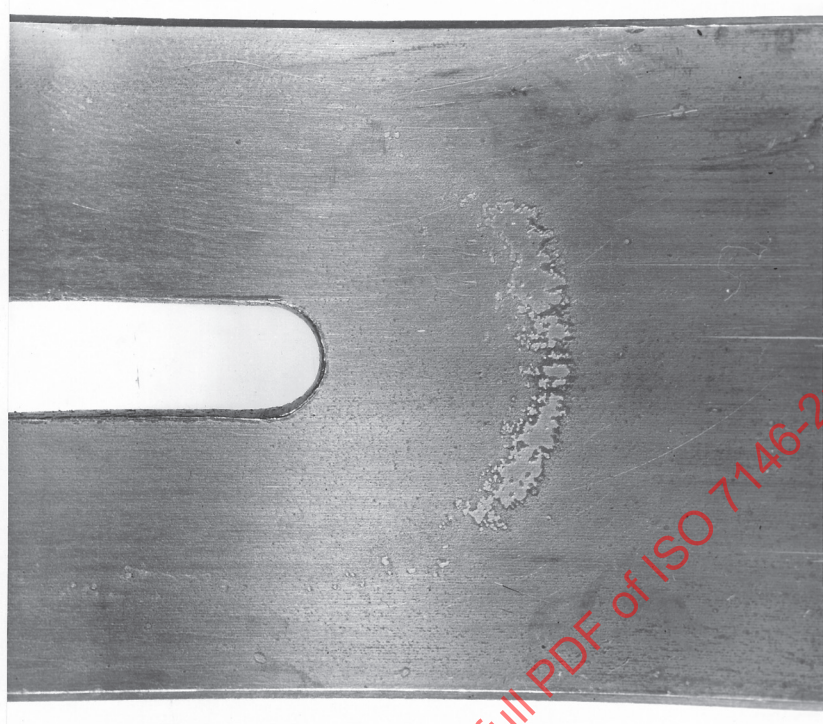
Figure 9 — Impact cavitation erosion at the end of 210° groove in a main bearing

The erosion usually takes the form of a kidney, ring or half-moon. [Figure 9](#) shows a typical example of the impact cavitation erosion behind and at some distance from the downstream end of a partial-circumferential oil groove in a lower half main bearing, where the journal is provided with drillings for supplying oil to a big-end bearing in a high-speed engine. [Figure 10](#) depicts the damage at two circumferentially different spots, as the engine has run at two different constant speeds. Similar erosion has also been experienced near the end of an oil bleed slot in the rod half of a big-end bearing (see [Figure 11](#)).

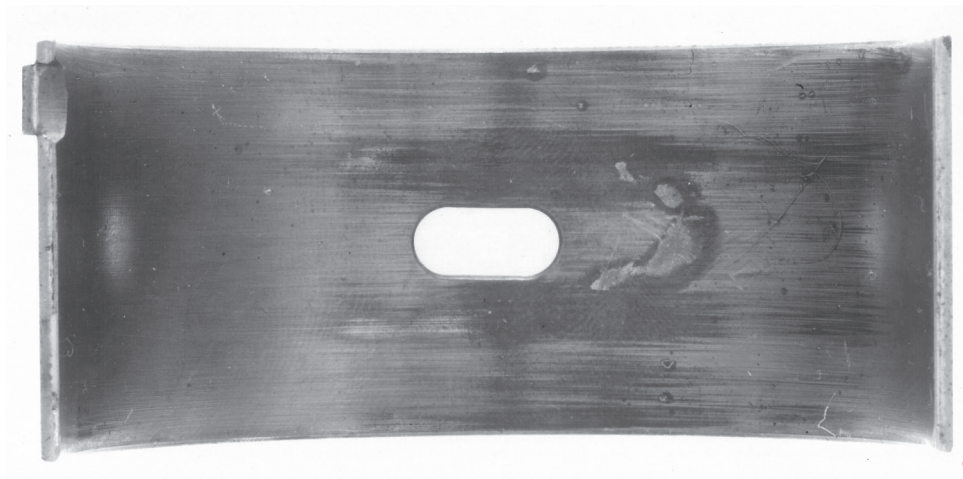
**Figure 11 — Impact cavitation erosion near the end of an oil bleed slot in the rod half of a big-end bearing**
