| | <b>SURFACE<br/>VEHICLE<br/>RECOMMENDED<br/>PRACTICE</b> | <b>SAE</b> <b>J2990 NOV2012</b> |
| Hybrid and EV First and Second Responder Recommended Practice | | |

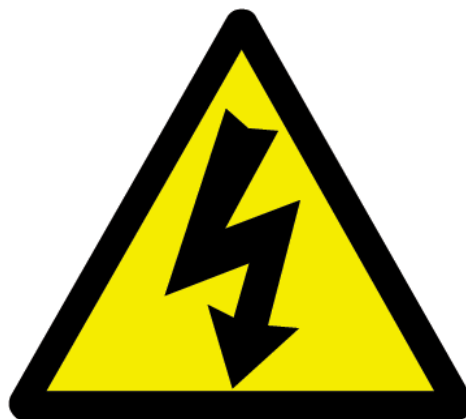
FIGURE 1 - EXAMPLE OF A UNIQUE MARKER

An example of an interior marker design that could be considered would be an ISO icon triangle with lightning bolt on a yellow background as shown in Figure 1.

In lieu of use of the above designs, an OEM desiring to identify the interior of their xEV for first and second responders may utilize a unique symbol, word or name plate as their interior marker. Unique name plates are permitted so long as said vehicle name is not utilized on any other vehicle with a propulsion system that is not an xEV type of system. Examples of unique vehicle names currently used include Chevrolet 'Volt' and Nissan 'Leaf'. Prior to use of a unique xEV name plate as the interior marker, the OEM should validate the first and second responder community's human factors comprehension of said unique xEV name plate and marker as indicating a hybrid or electric vehicle as per SAE Standard J2830 or ISO 9186-1:2007.

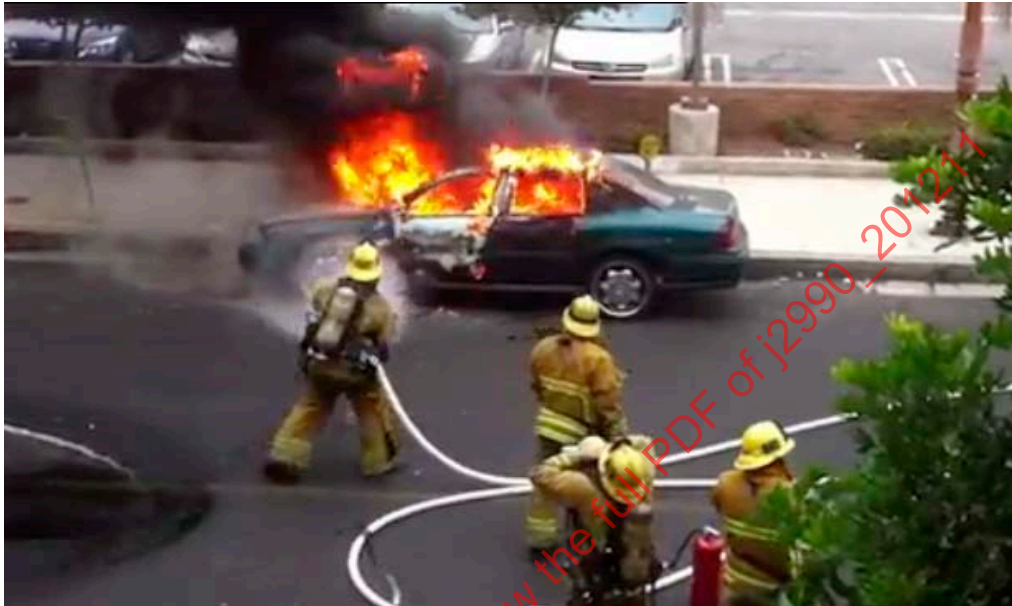
Although not an element of the baseline scenario, the possibility of first responders encountering a hybrid or electric vehicle involved in fire has been considered by the taskforce. Study of the 2012 document, U.S. VEHICLE FIRE TRENDS AND PATTERNS, produced by the National Fire Protection Association, Quincy, MA allowed this taskforce to reach consensus that interior markers or other identification of the burning vehicle as a hybrid or electric vehicle would not be considered effective due to the probable destruction of the interior of the burning vehicle.

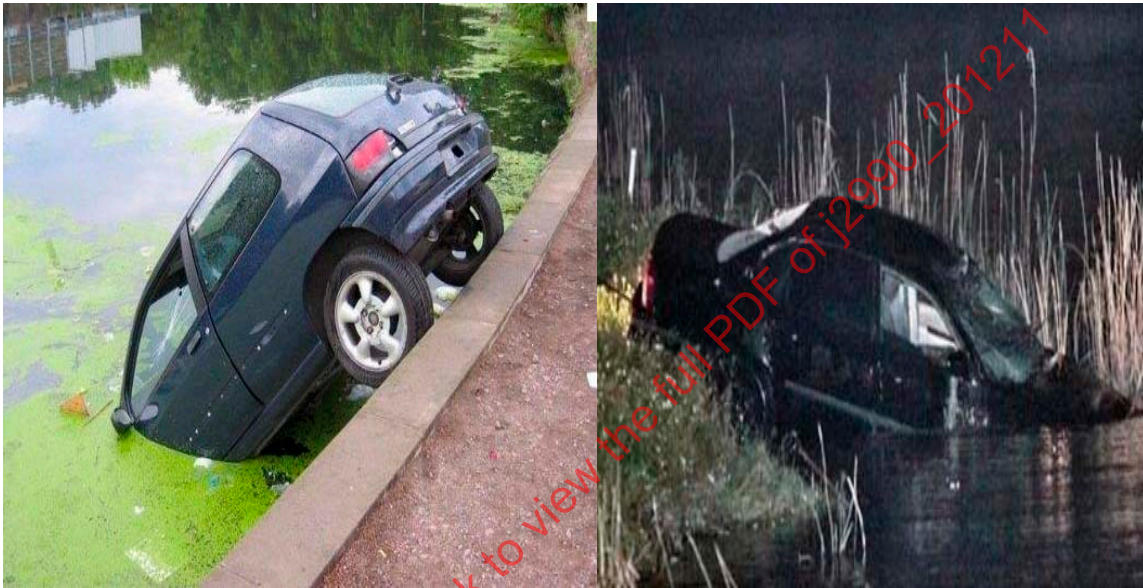
Another potential situation that is not an element of the baseline scenario is that of first responders encountering a hybrid or electric vehicle submerged either partially or fully in water. Current state and national training programs as well as interim guidelines for the National Highway Traffic Safety Administration advise first responders to remove the vehicle from the water and then accomplish specific safety procedures on the hybrid or electric vehicle. In this case, exterior badging, securely affixed to the vehicle, will provide the most reliable means of identification for first responders.

During our analysis, there was no data made available to suggest submersion in fresh vs. salt water alters the risk to responders. No actual submersion test data has been made available to the task force. Future revisions may re-examine this issue if data is made available to the task force.
